What scientific information on the seismic risk to non-structural elements do people need to know?

Part 1: Compiling an inventory on damage to non-structural elements

Mónica Amaral Ferreira^{*,1}, Fabrizio Meroni², Raffaele Azzaro³, Gemma Musacchio², Rajesh Rupakhety⁴, Bjarni Bessason⁴, Sòlveig Thorvaldsdottir⁴, Mário Lopes¹, Carlos Sousa Oliveira¹, Stefano Solarino⁵

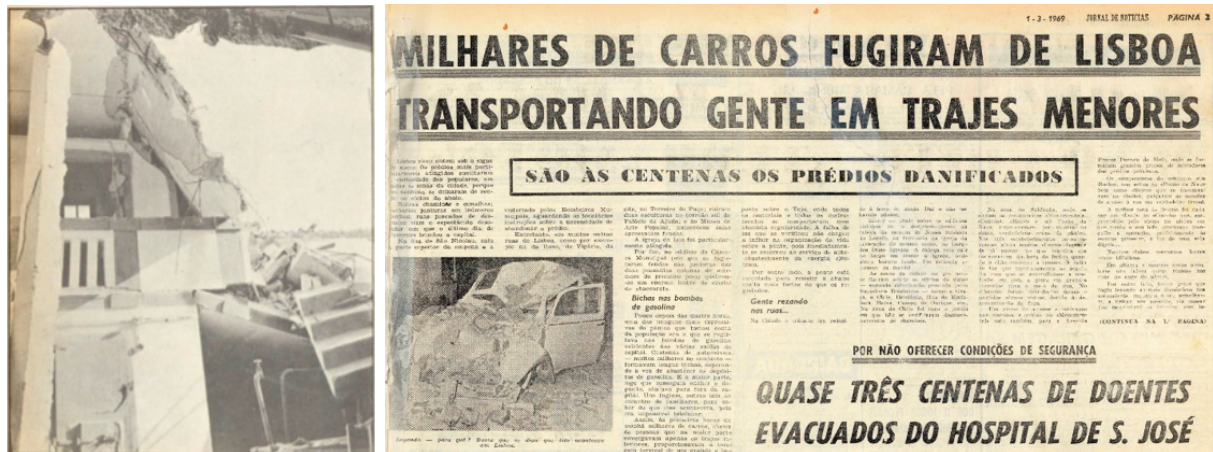
Figure 7. Archival information about the 1969 earthquake. Left: Roof collapse of the ice factory (in RC) located at Travessa da Madalena in Faro, (“O Século Ilustrado” March 8, 1969). Right: Car damaged by falling chimneys (Hemeroteca, Digital newspaper archive)

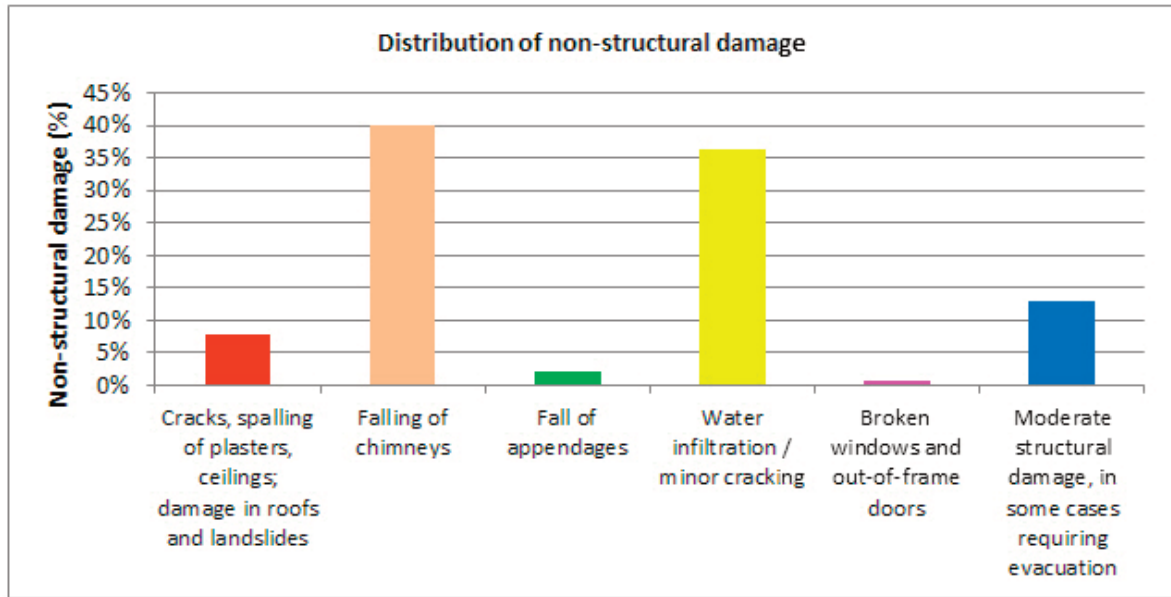
Figure 8 reports the damage inflicted, in Lisbon, during the 1969 earthquake according to the Fire Headquarter’s files, as recorded on the first month after the event [Oliveira, 1982]. In the following months, an average of 70 cases/month were reported. Even ten years later, some accounts of damage were still being reported. It was found that 1.8% of the total received calls reporting damage due to the earthquake were false [Oliveira, 1982].

Figure 8. Typical NSD inflicted in Lisbon.

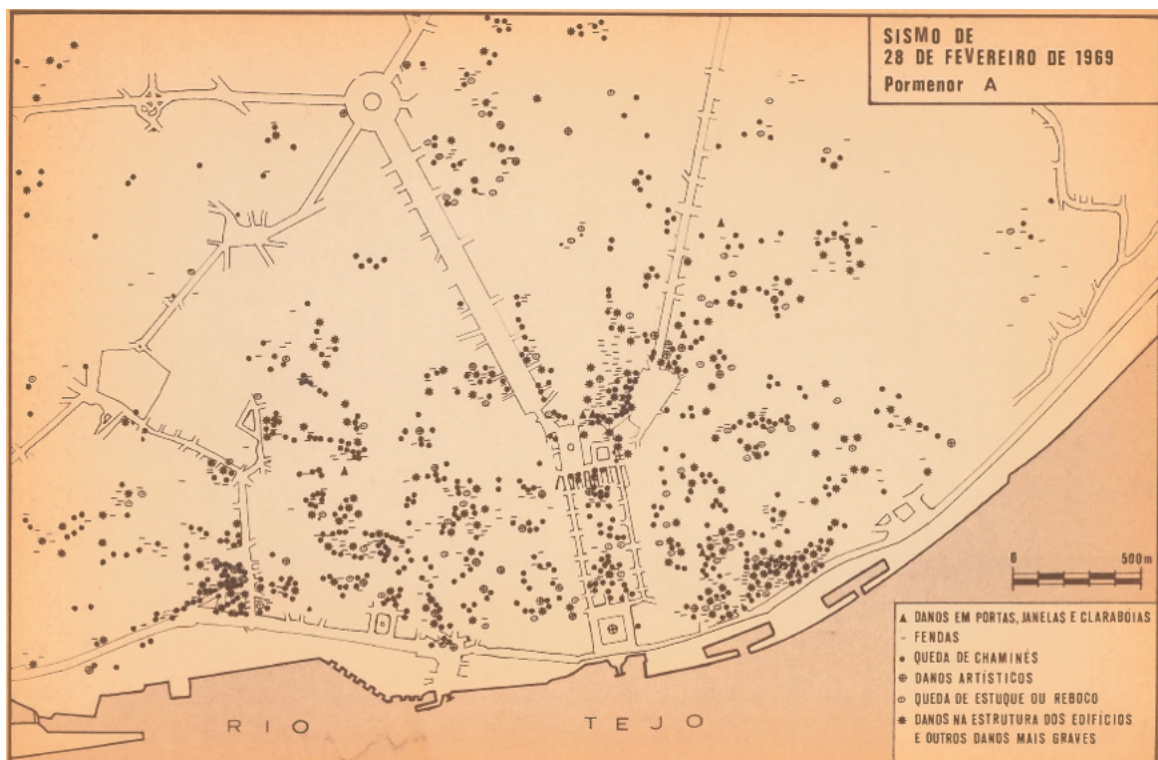
Figure 9 shows the damage distribution in Lisbon downtown based on data in Annex 2.

Figure 9. Typical damage to non-structural elements - Lisbon downtown (detailed info in Annex 2) [Oliveira, 1982].

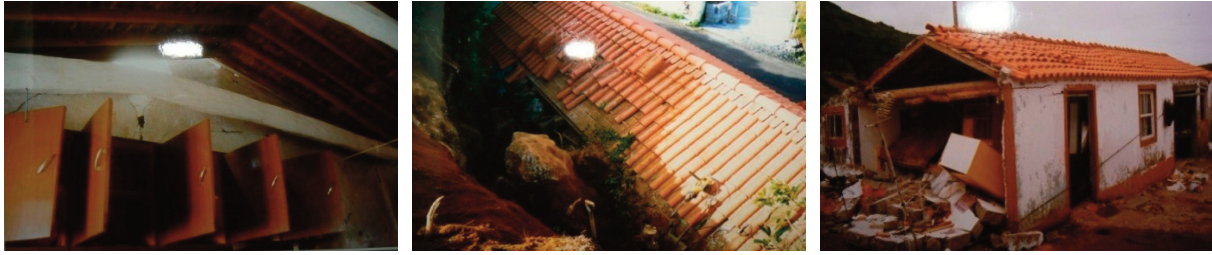
- interior fixtures, including kitchen and bathrooms (for example, lack of latches to prevent cabinet doors from opening);
- falling of pieces of plaster;
- cracking and overturning of roof chimneys;
- damage to exterior walls around windows;
- falling of non-anchored masonry veneer;
- displacement of roof tiles;
- failure of walls and various types of building contents.

Figure 12. Typical damage to non-structural elements in Azores: a) cabinet doors not latched; b) sliding roof tiles; c) out-of-plan edge walls showing falling cabinets. (Auto de Vistoria post-earthquake survey).
