A photographic collection of the coseismic geological effects induced by the 21 August 2017, M=4, Casamicciola earthquake (Ischia island, Italy)

Emergeo Working Group*

Accepted 19th July 2019 | *Accettato il 19 luglio 2019*

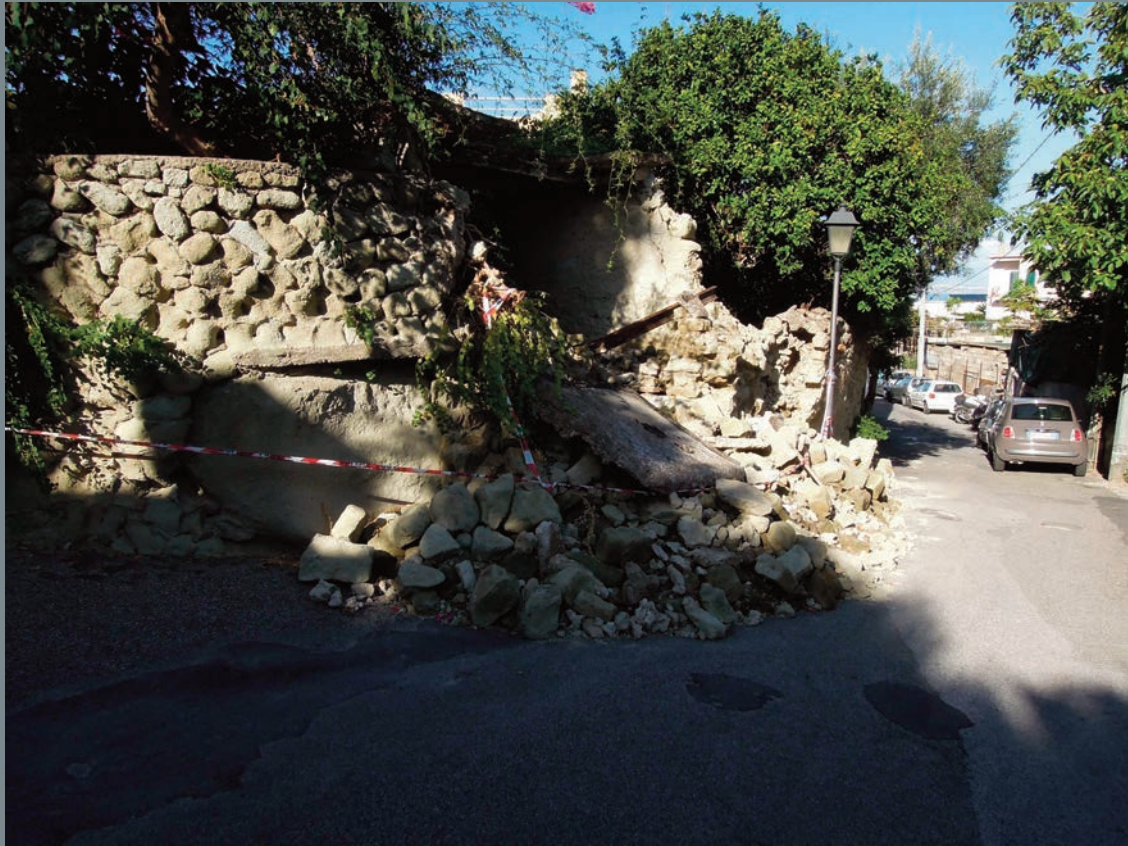
Photo 1

Collapsed sidewall in Via Fango.

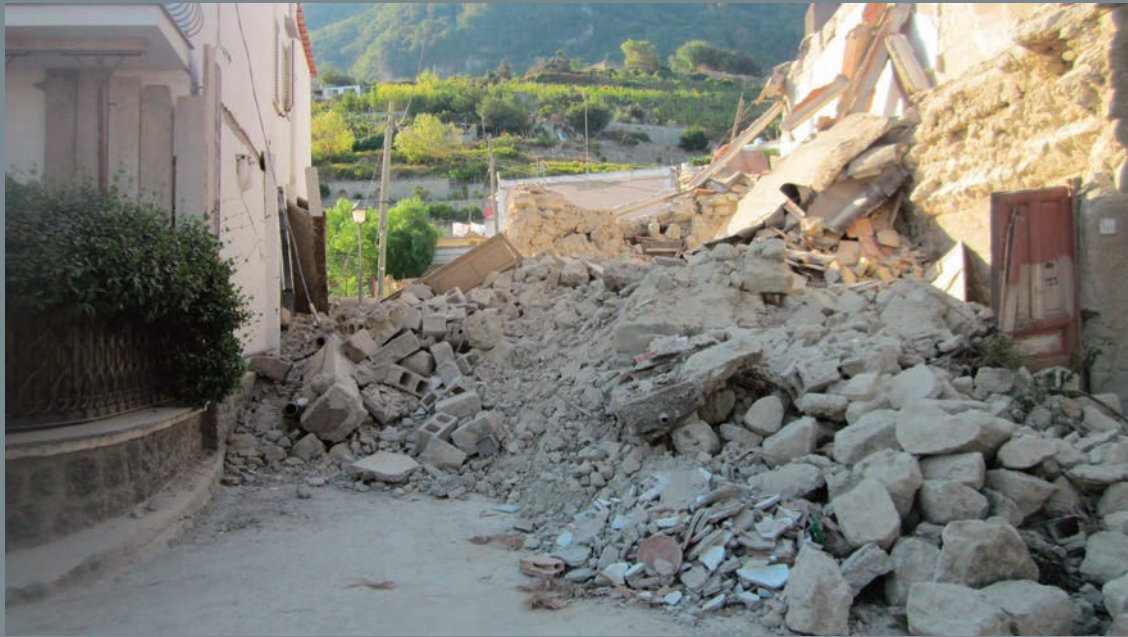
Photo 2
(40.742235° 13.884543°)
Severely damaged and collapsed houses along Via Borbonica.

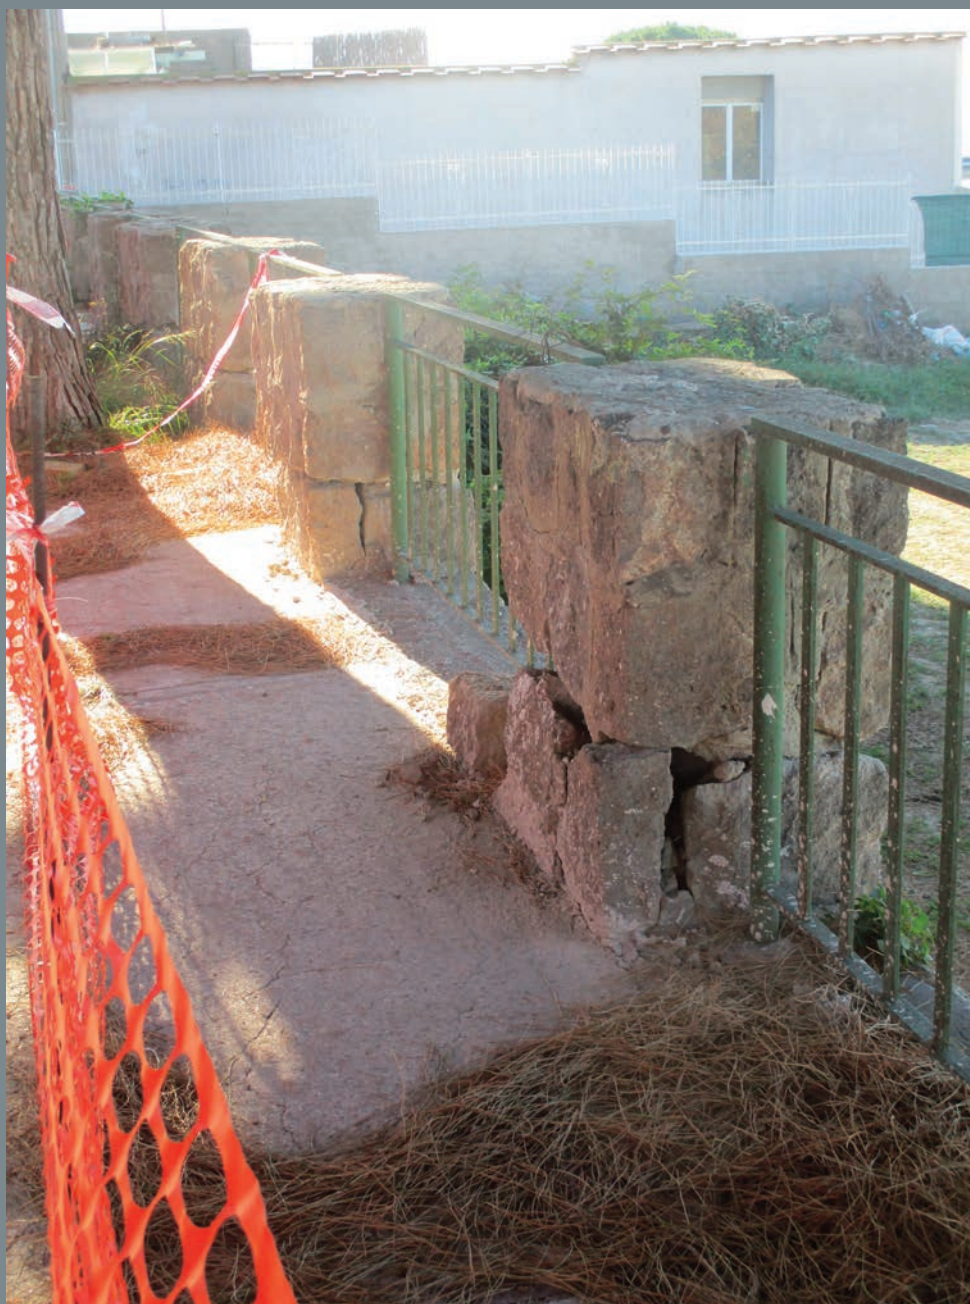
Photo 3

Fractured pillars along the sidewalk of the Via Borbonica.

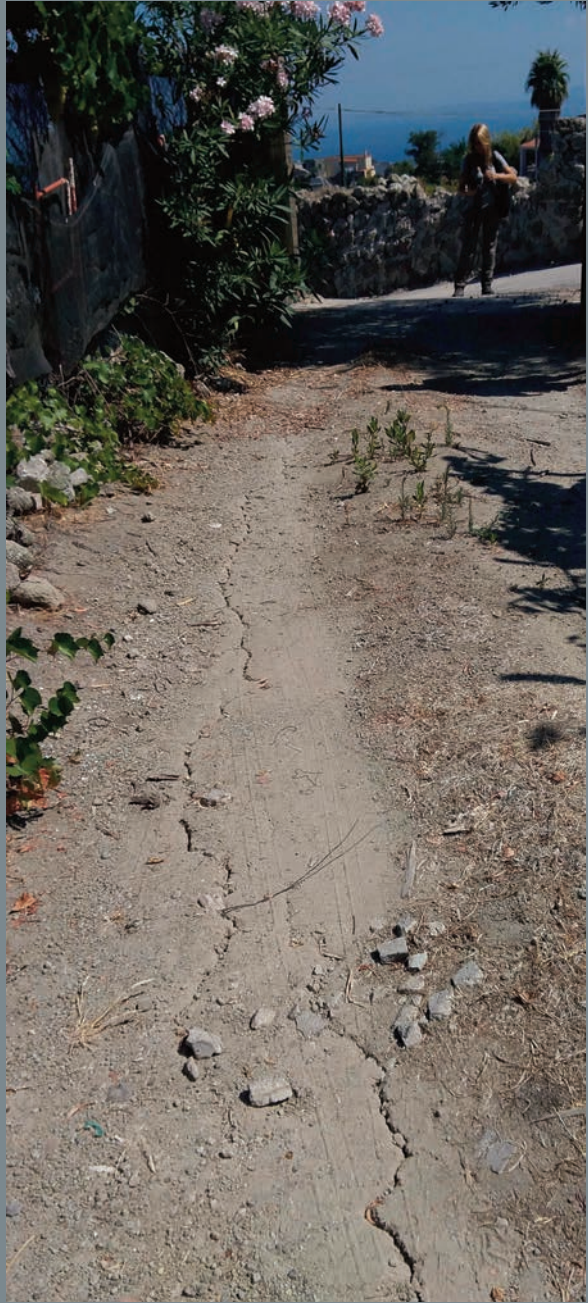
Photo 4

Coseismic rupture in the ground in the driveway of private property (Via Crateca, Fango) with total length of about 30 m.

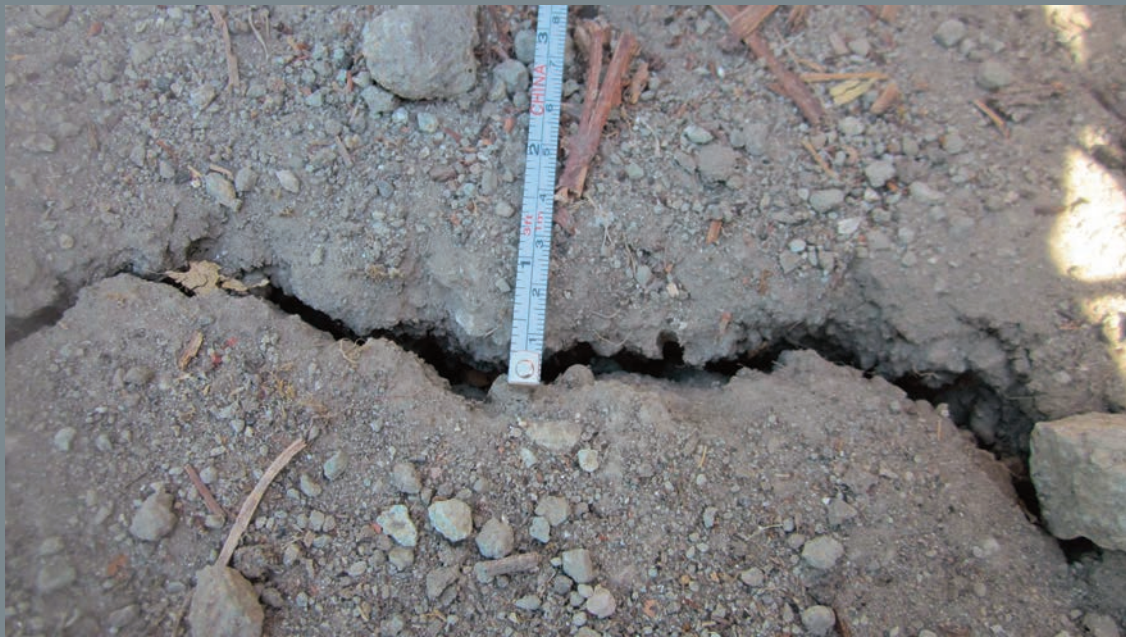
Photo 5

Detail of photo 4: open rupture in the soil with evidence of about 1 cm of opening.

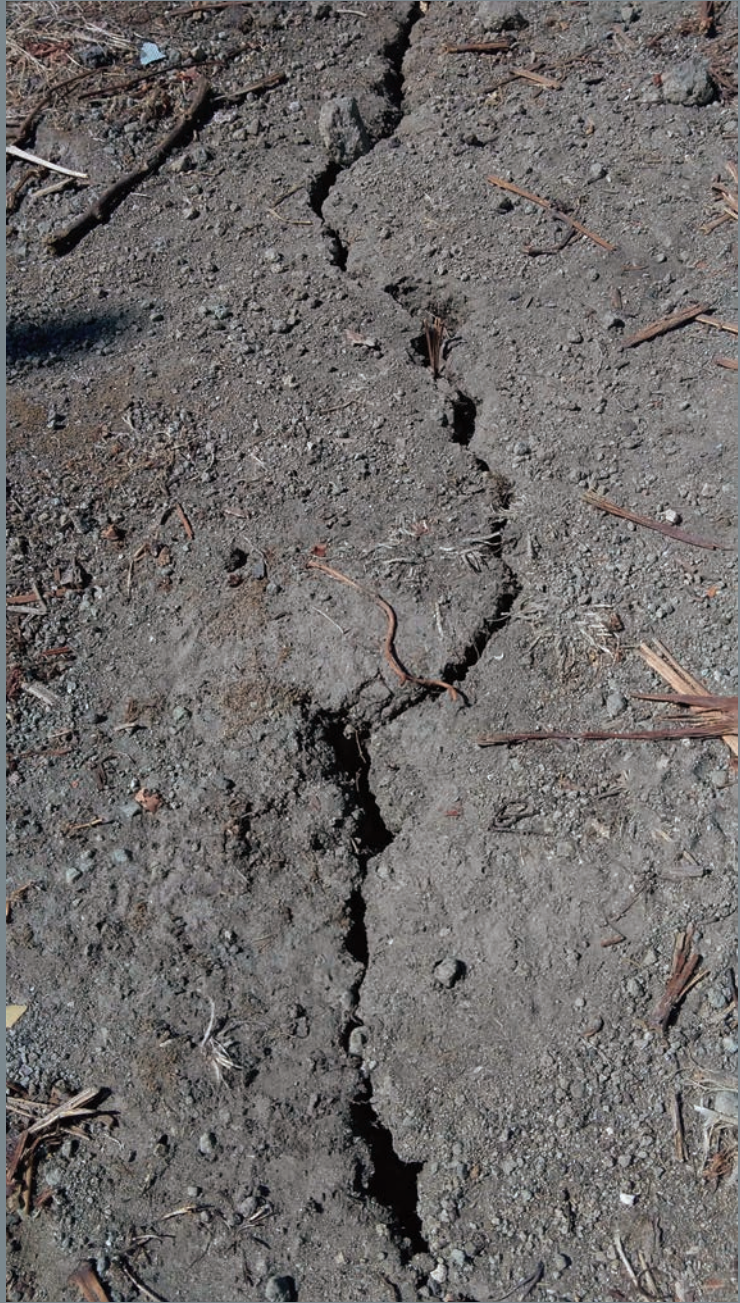
Photo 6
(40.741751° 13.886823°)
Coseismic rupture in the soil in the driveway of the same private property of photo 4
(Via Crateca, Fango).

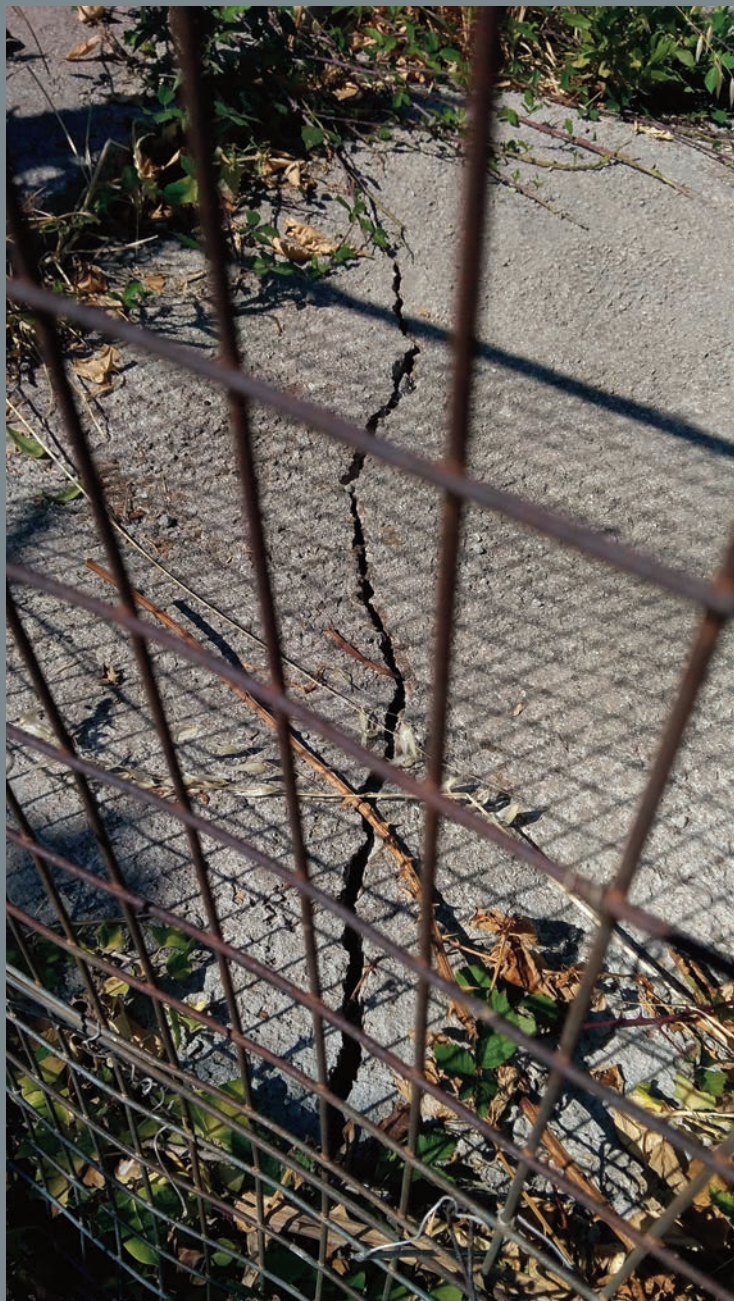
Photo 7

Rupture in the ground adjoining to the private property of photo 4 with about 2 cm wide, extending along a concrete pavement.

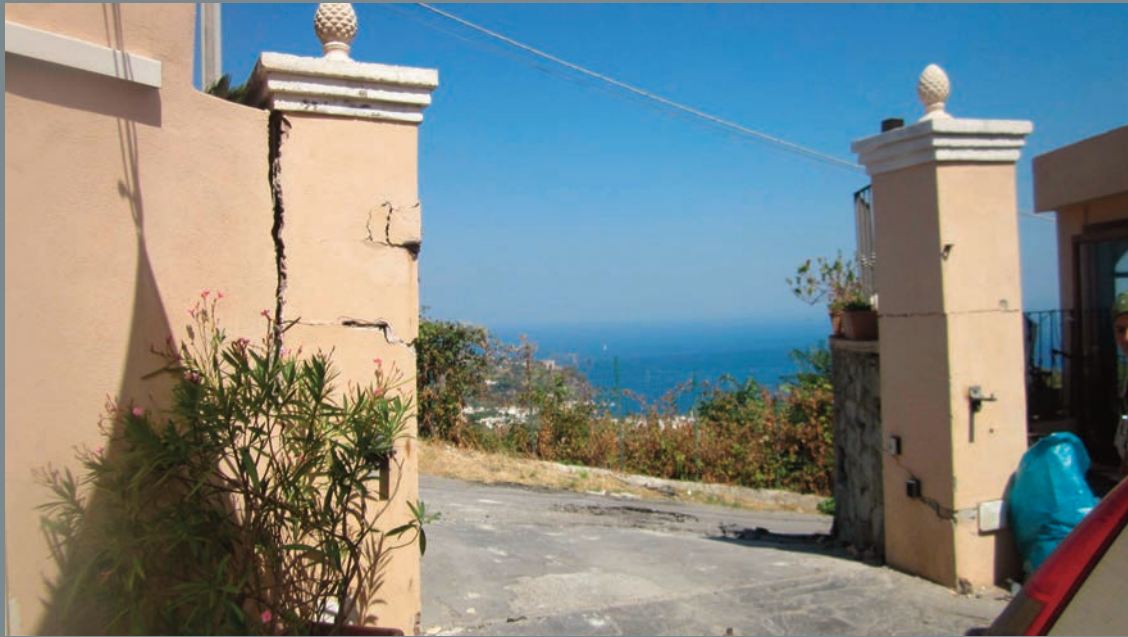
Photo 8

Open fractures affect two pillars bordering the entrance of n. 28 Via Crateca. This property showed fractures in the paving slab at the entrance with paving stones lifting of a few cm.

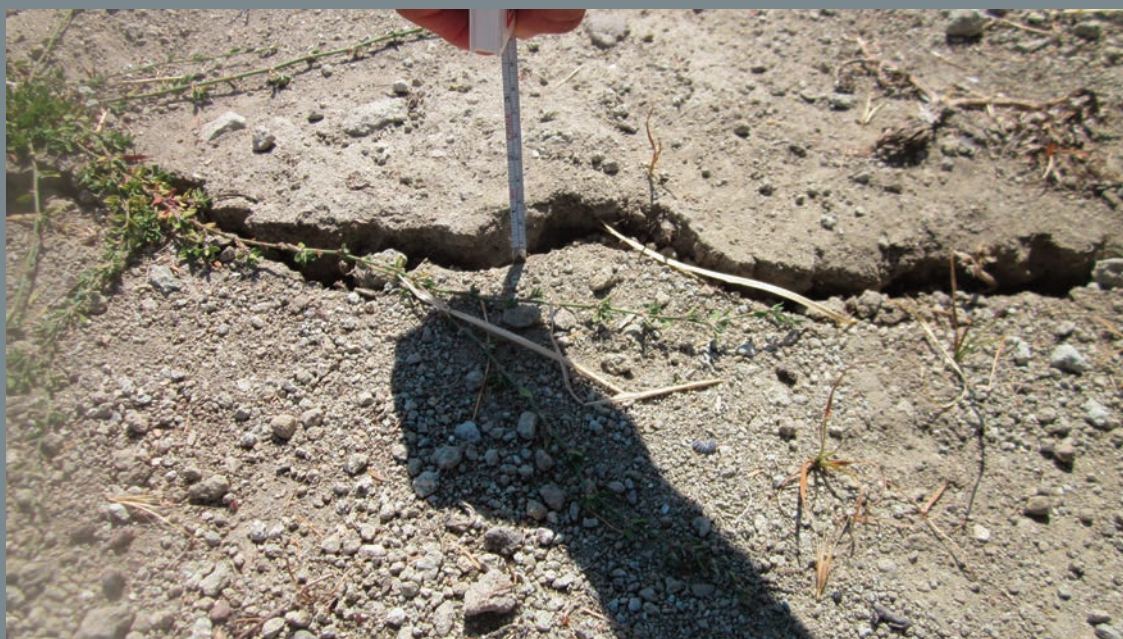
Photo 9

Property at n. 26 Via Crateca: coseismic rupture with direction N70E and total length of about 10 meters, open and vertical downthrow of about 2/3 cm towards North.

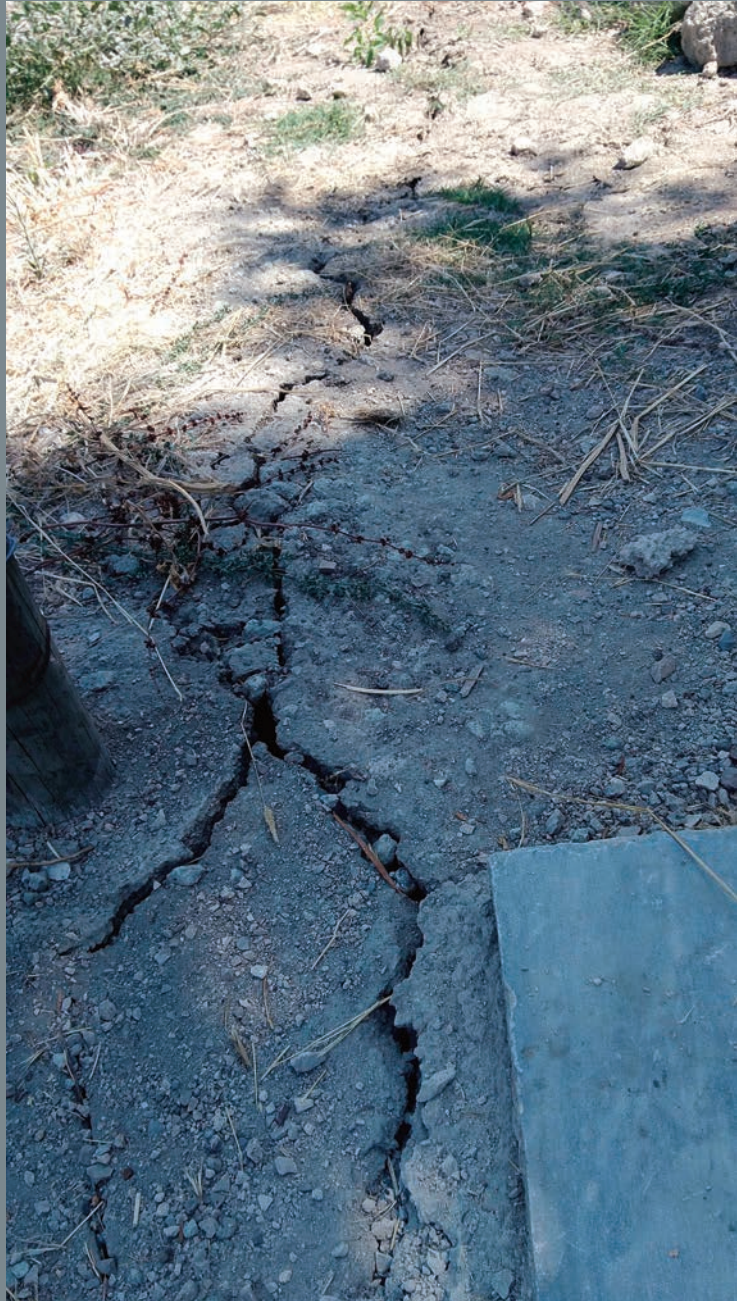
Photo 10

N70E rupture of about 18 meters long with horizontal opening of about 2 cm and vertical downthrow of about 2 cm towards North. This rupture shows a vertical deepening into the ground of about 35 cm.

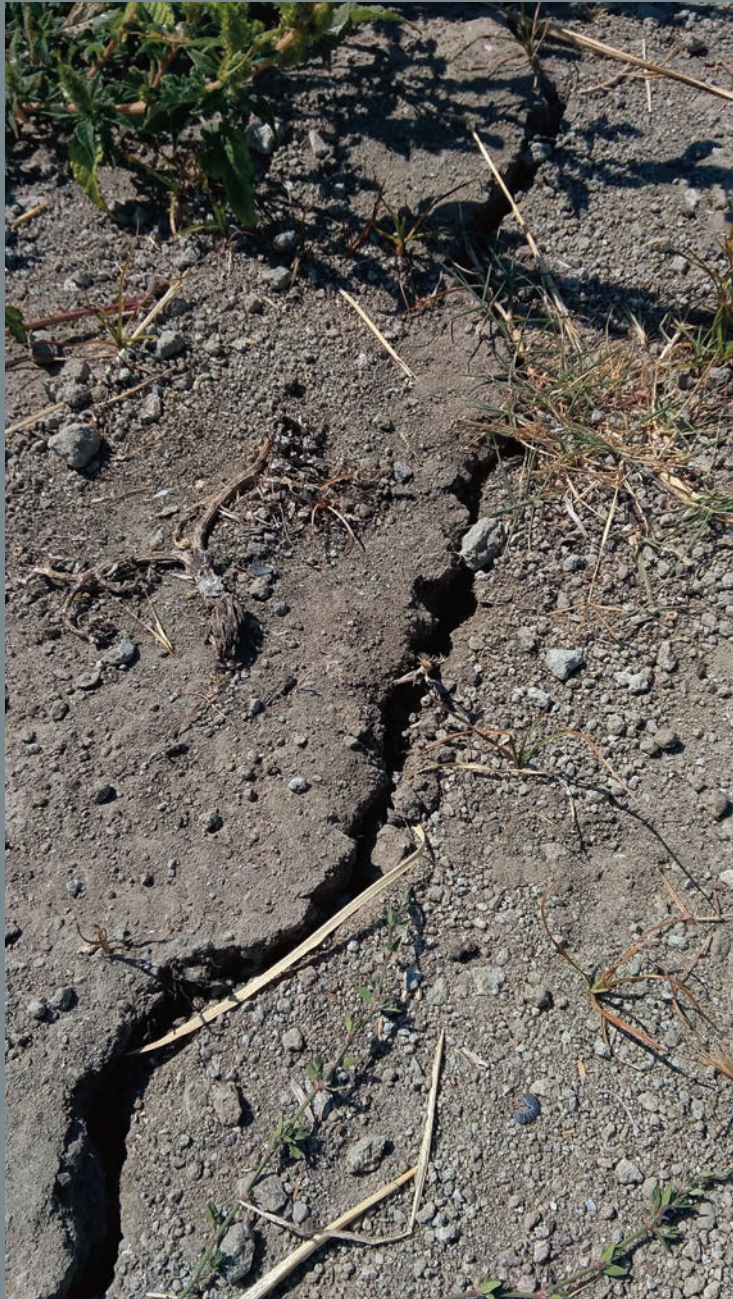
Photo 11

Details of photo n.10 with evidence of block lowering.

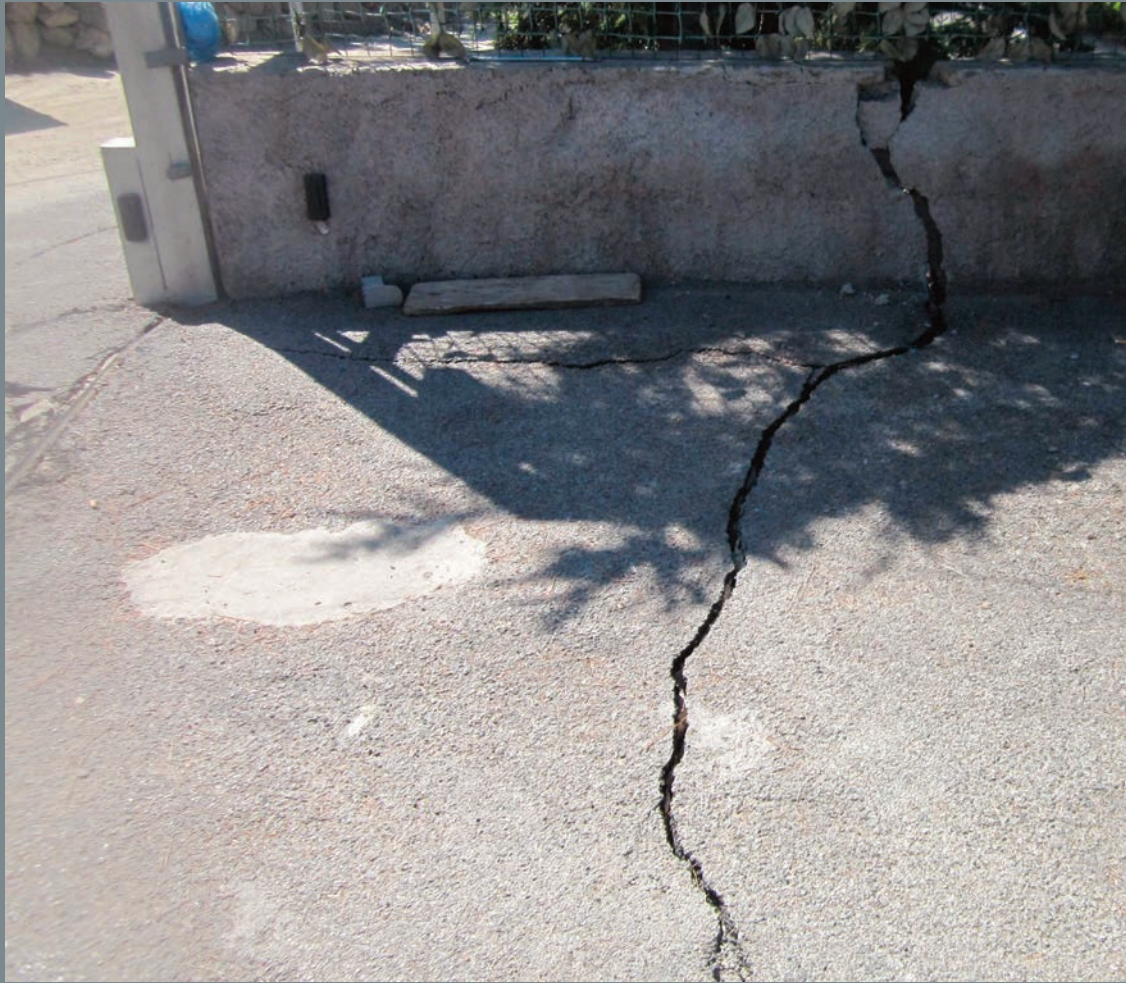
Photos 14

Coseismic rupture with horizontal opening on a paved road along Via dei Carri, also affecting the courtyard wall.

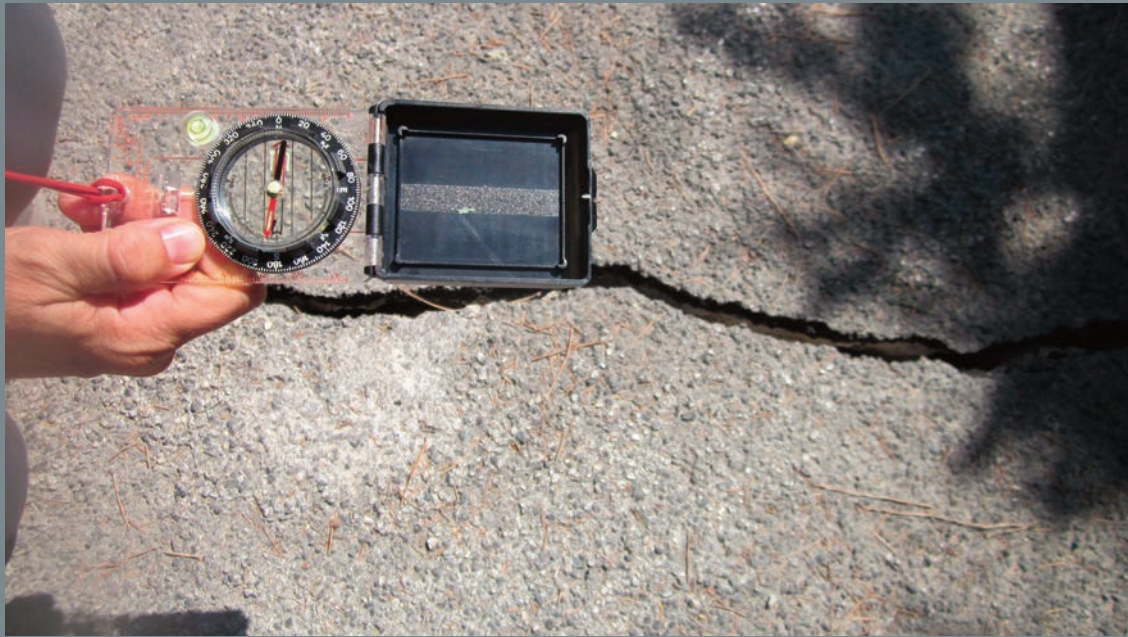
Photo 15

Detail measurement of the rupture strike, as in photo 14.

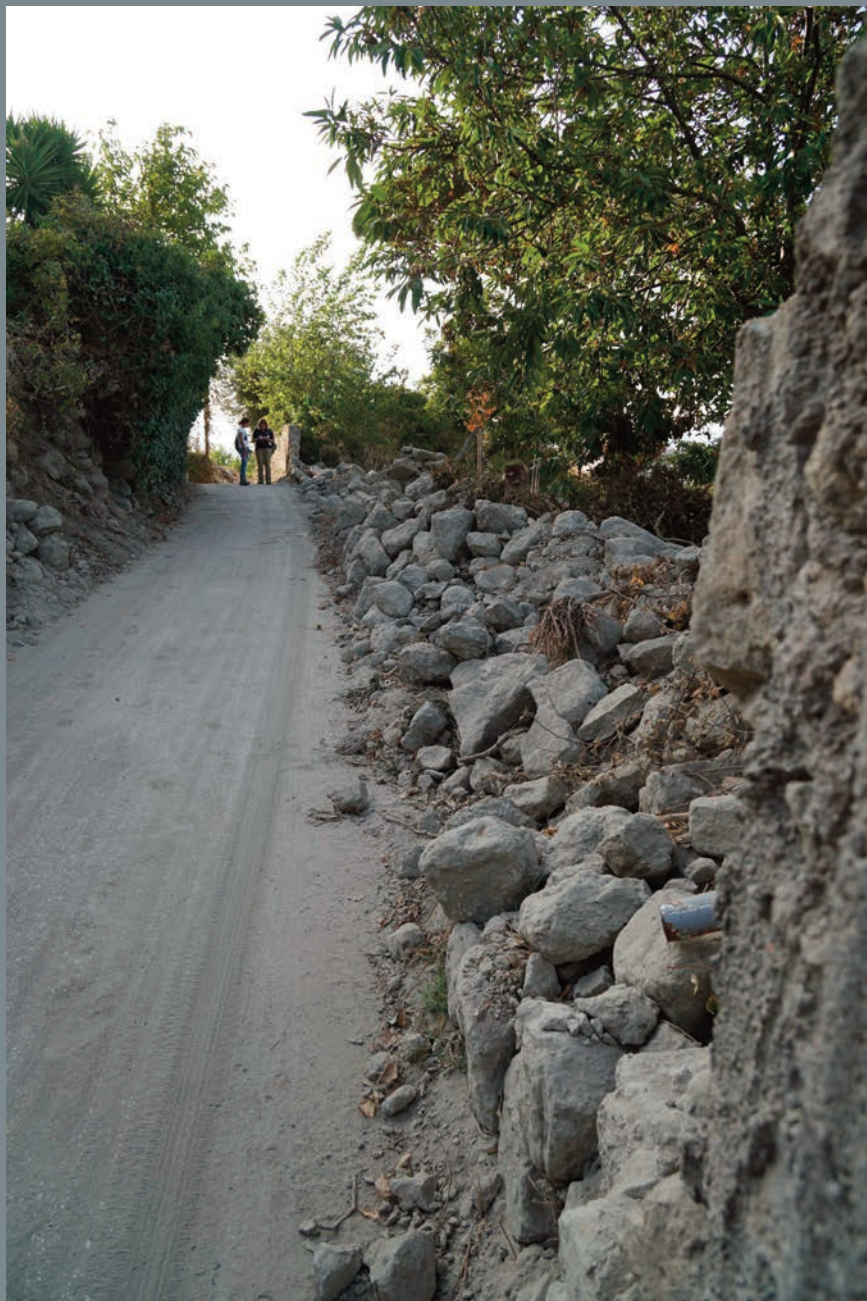
Photo 16

Secondary coseismic effects, along Via dei Carri: collapse of drywalls, known locally as “parracine”.

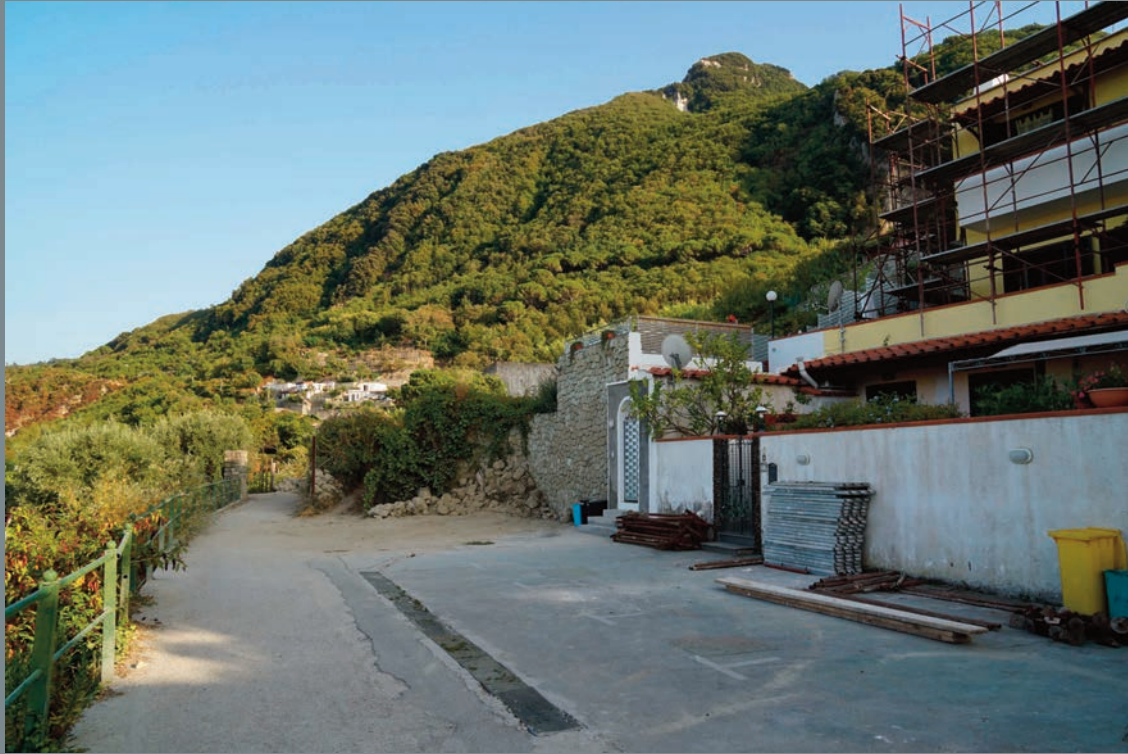
Photo 18

Collapse of the external wall of the damaged house shown in Photo 17.

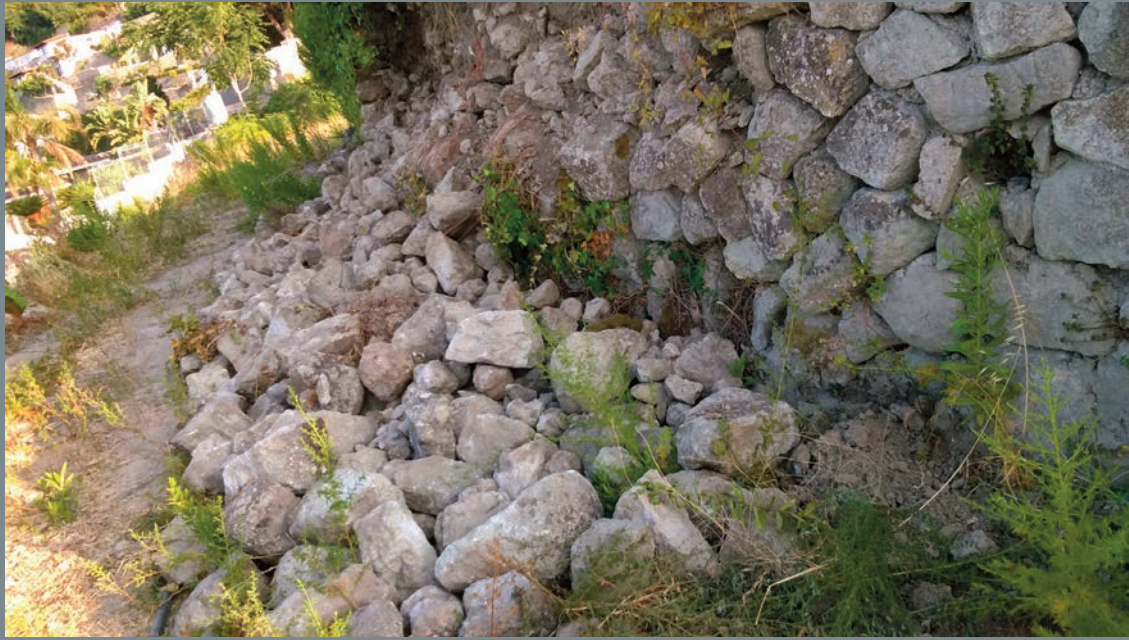
Photo 19

Collapse of drywalls as secondary seismic effects along Via dei Carri.

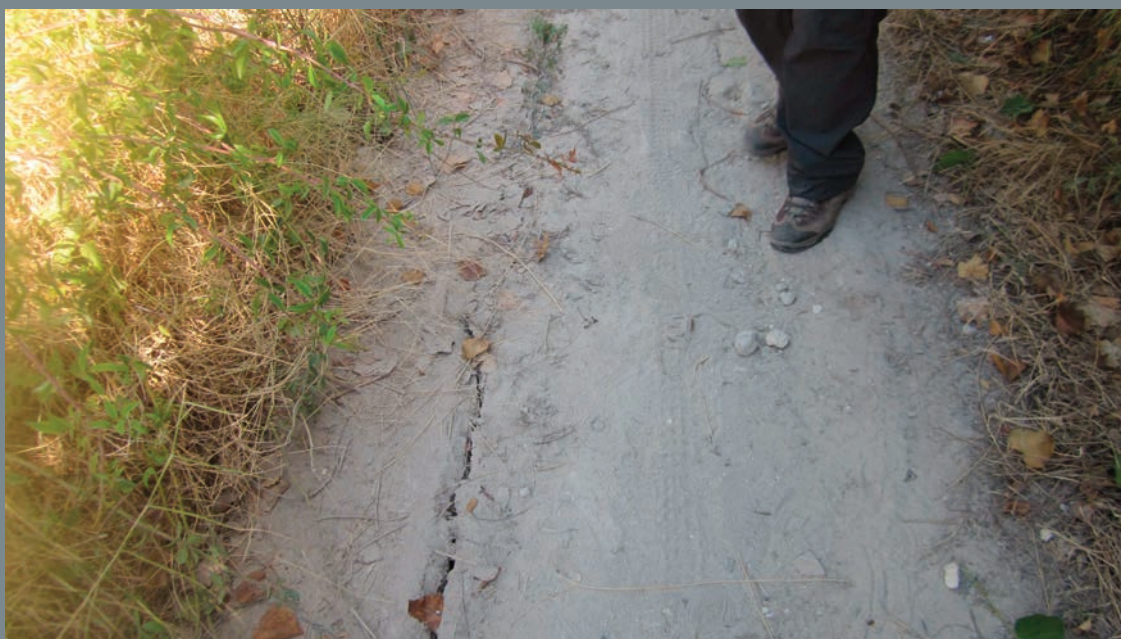
Photo 23

Coseismic fracture in volcanic ash soil, showing an open horizontal displacement along
Via dei Carri.

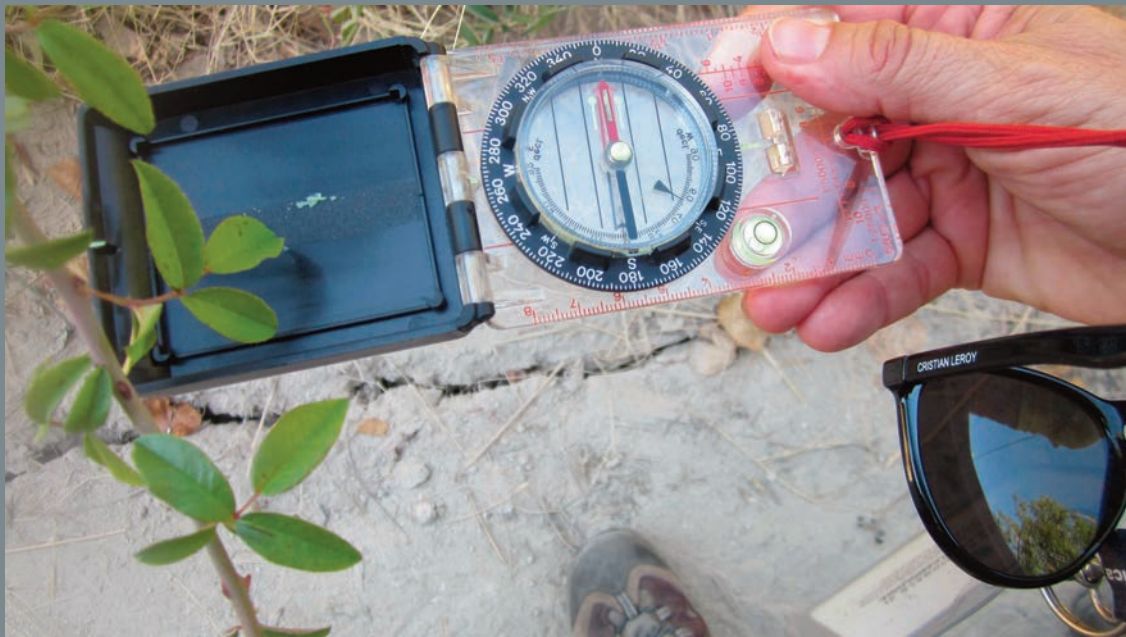
Photo 24

Detail measurement of the fracture in photo 23.

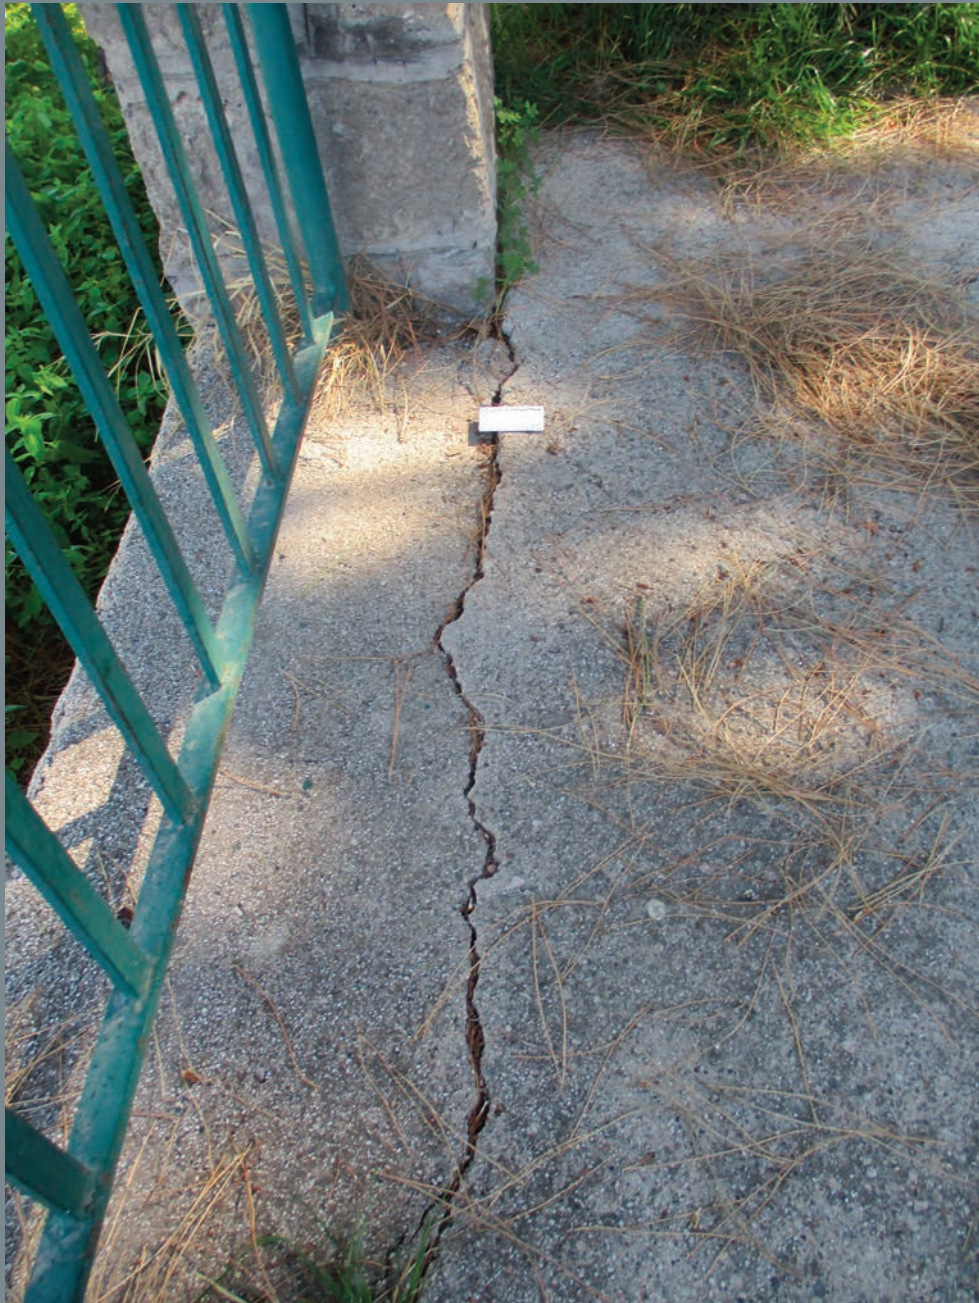
Photo 25

Fracture on concrete pavement causing its detaching from the handrail pillar,
along Via Montecito.

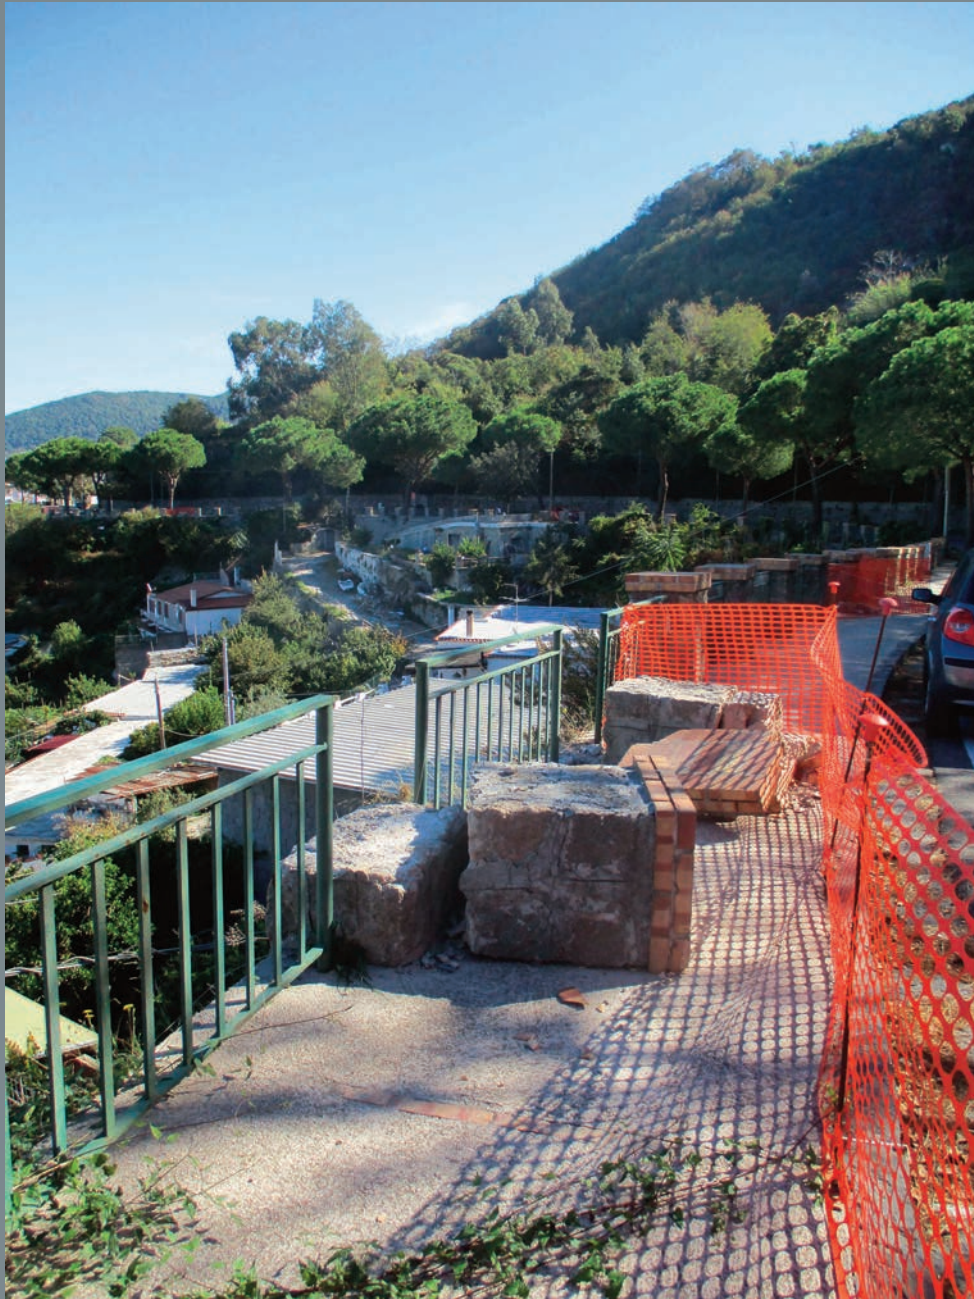
Photo 26

Rollover of small pillars of the handrail.

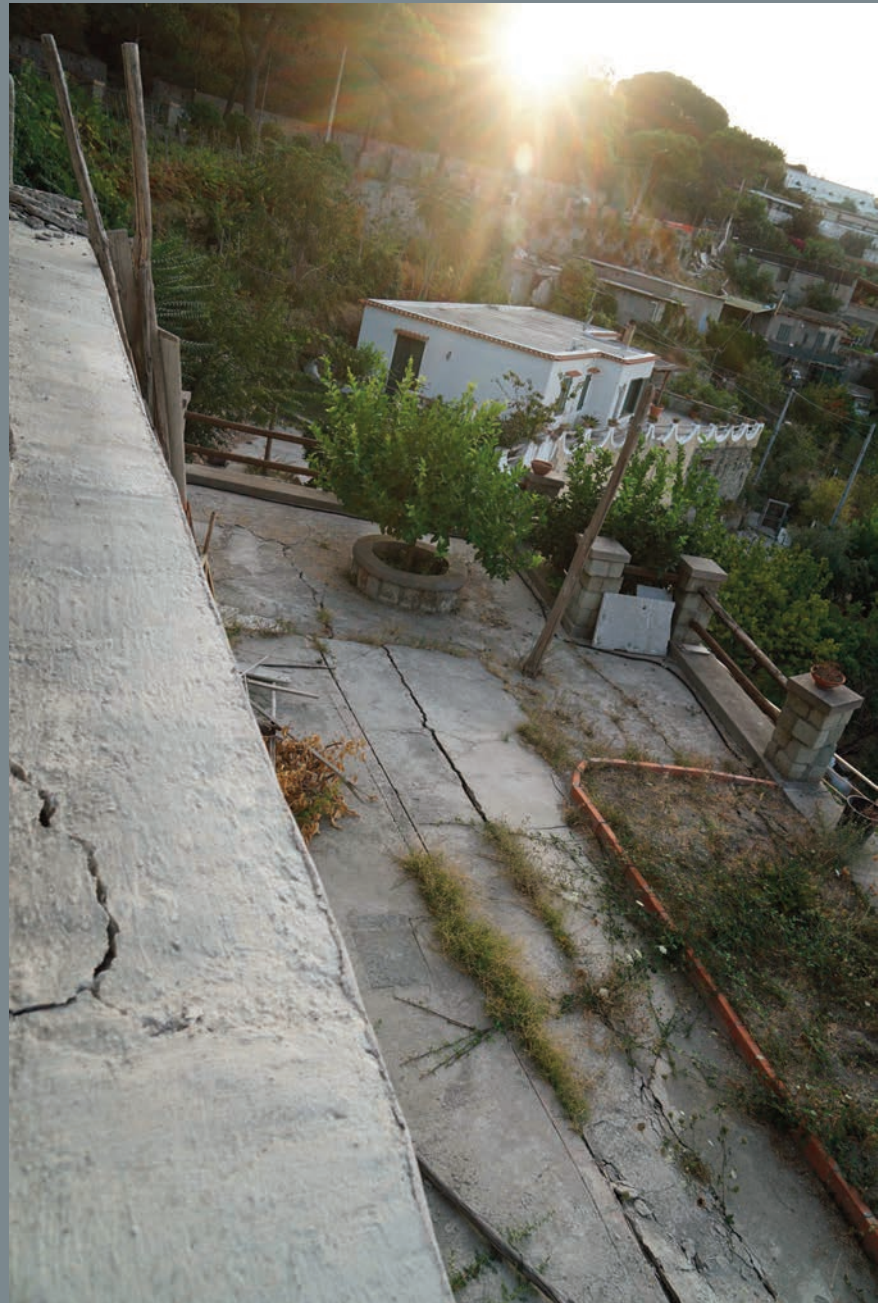
Photo 27
(40.740769° 13.894643°)
Coseismic ruptures affecting both concrete basement and ground soil, in a villa
along Via Montecito.

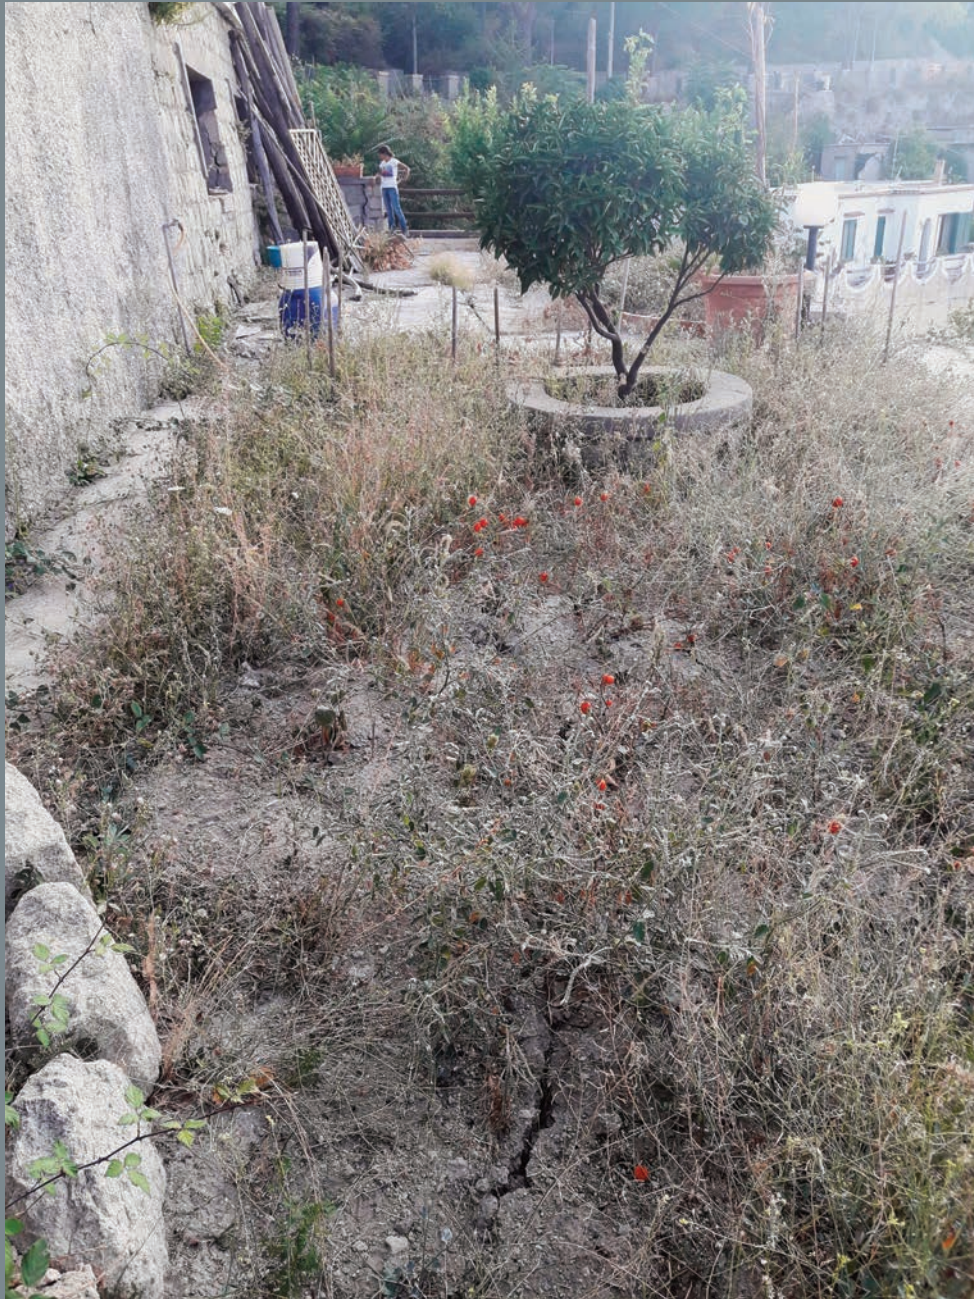
Photo 28

Detail on the fracture affecting the garden soil.

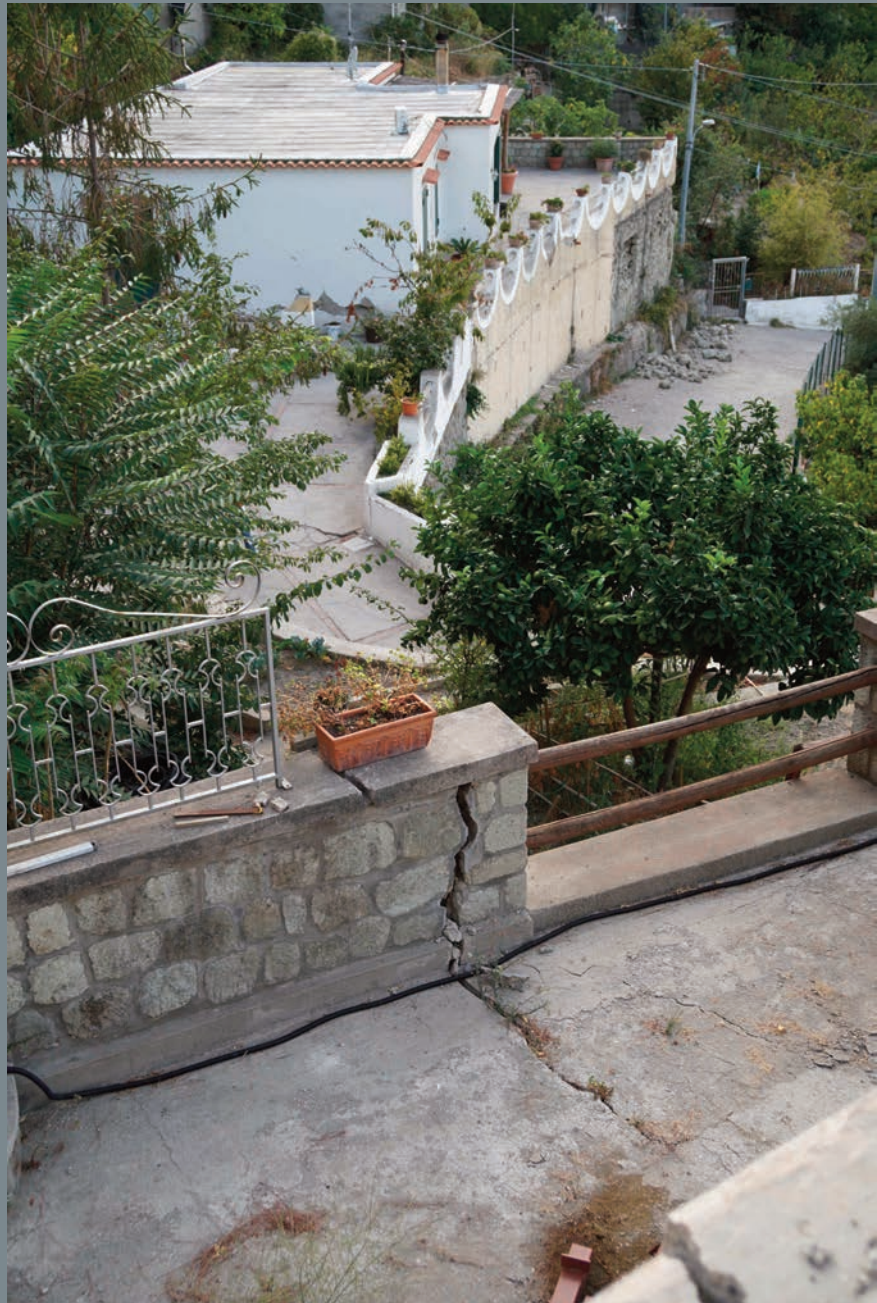
Photo 29

Coseismic effects involving the concrete basement and the adjacent handrail wall.
