A photographic collection of the coseismic geological effects induced by the 21 August 2017, M=4, Casamicciola earthquake (Ischia island, Italy)

Emergeo Working Group*

Accepted 19th July 2019 | *Accettato il 19 luglio 2019*

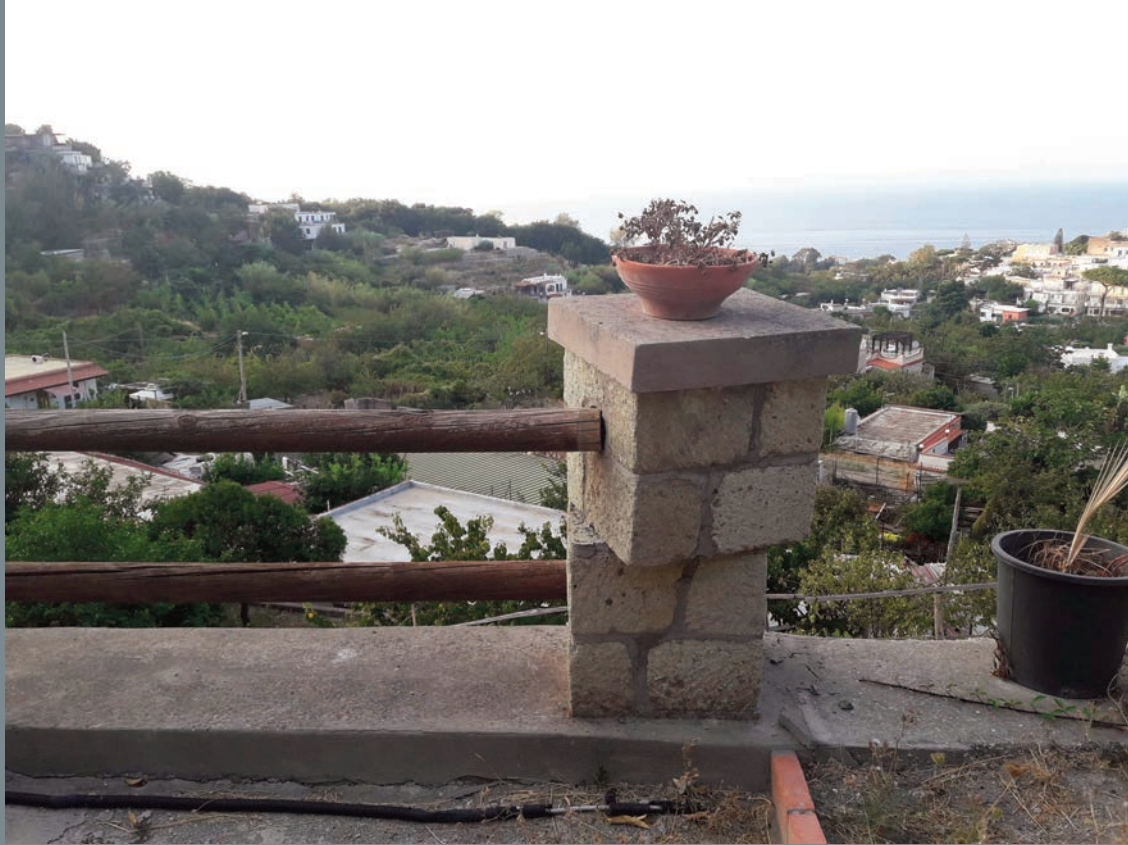
Photo 30

Detachment and rotation of the top of a handrail pillar.

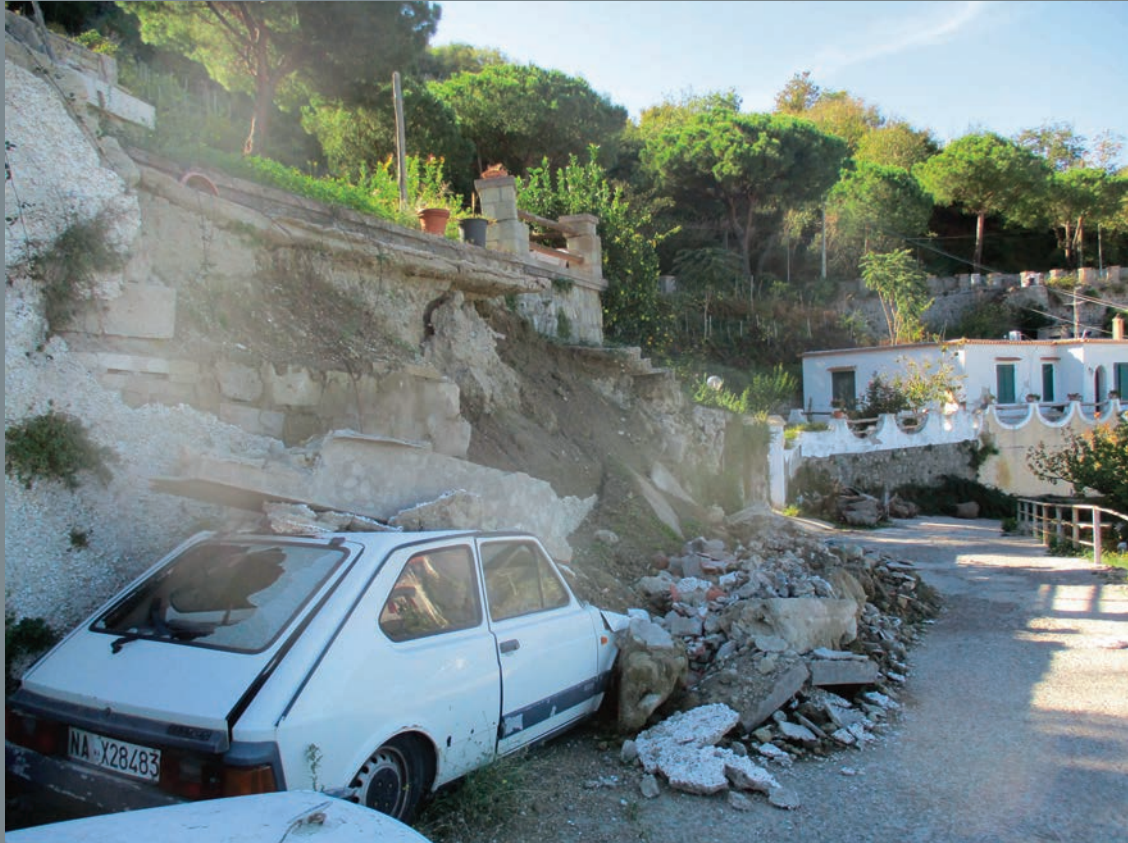
Photo 31

Collapse of the external wall of a damaged villa, downstream of Via Montecito.

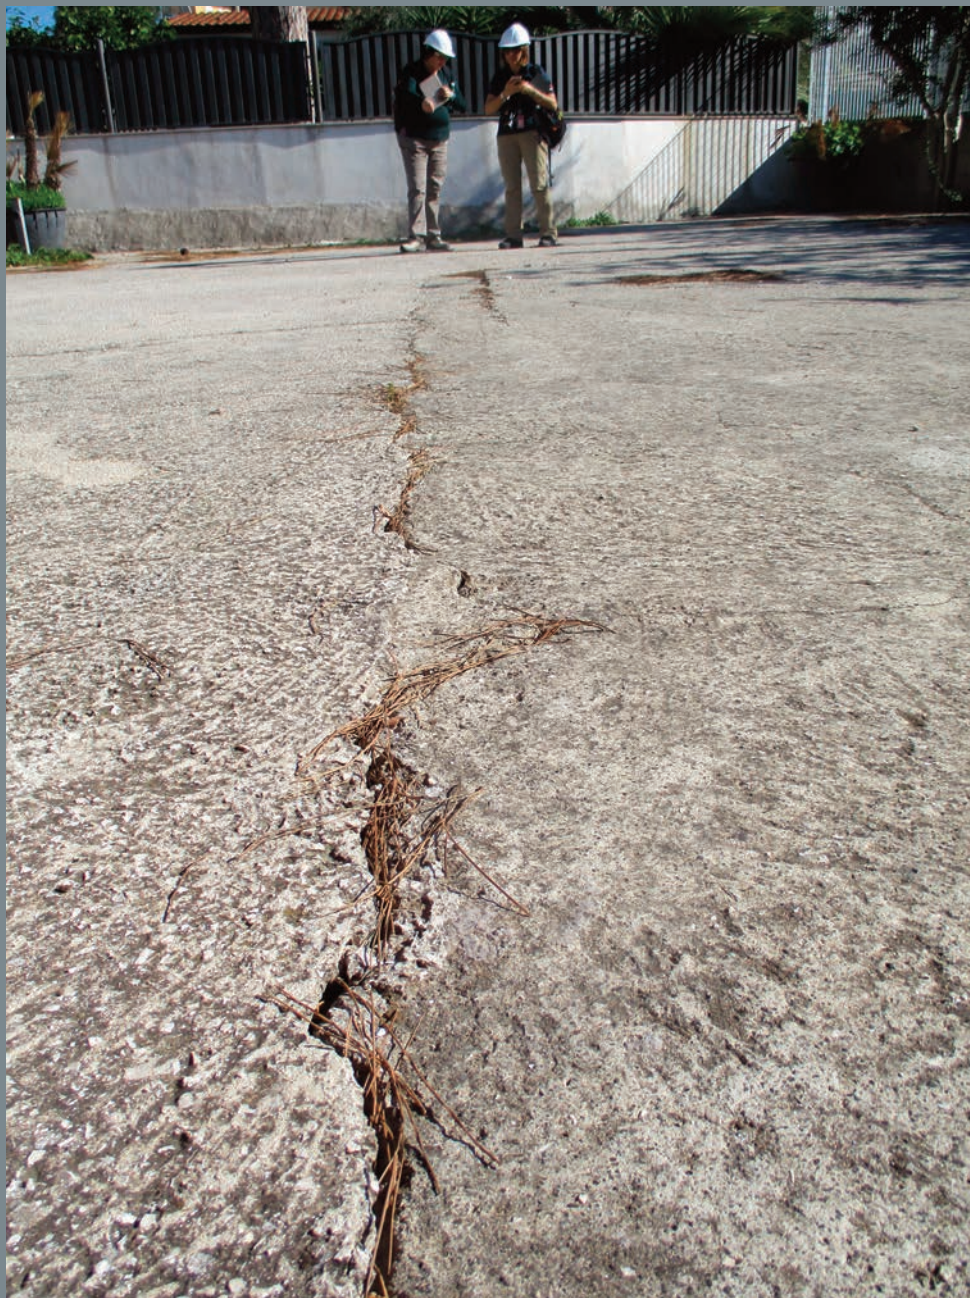
Photo 32

Coseismic ruptures on paved road with horizontal opening, in Via D'Aloisio parking area.

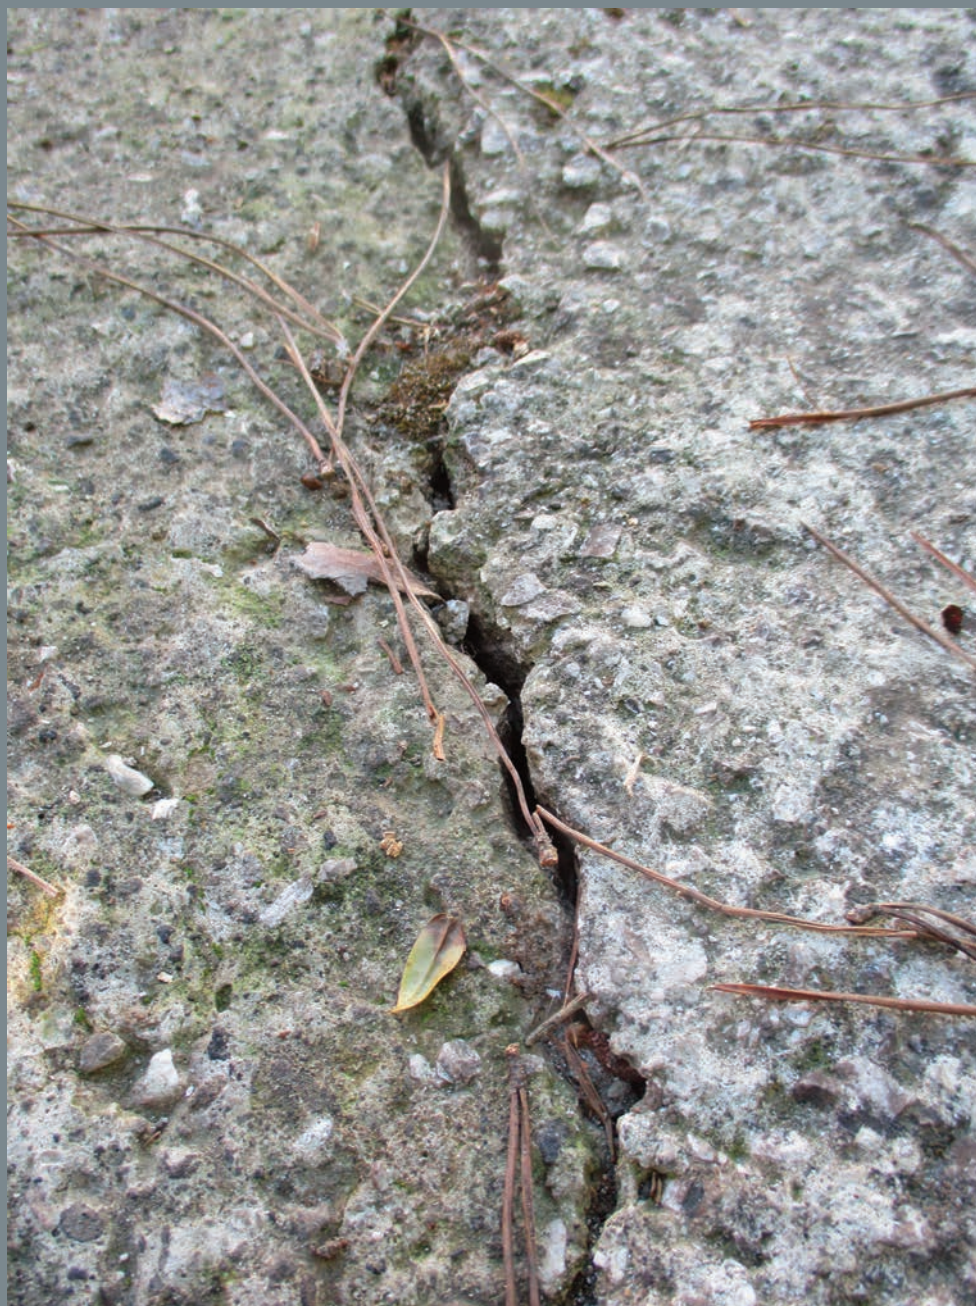
Photo 33

Detail of the coseismic rupture on paved road shown in photo 32.

It is appreciable a vertical offset of almost 2 cm.

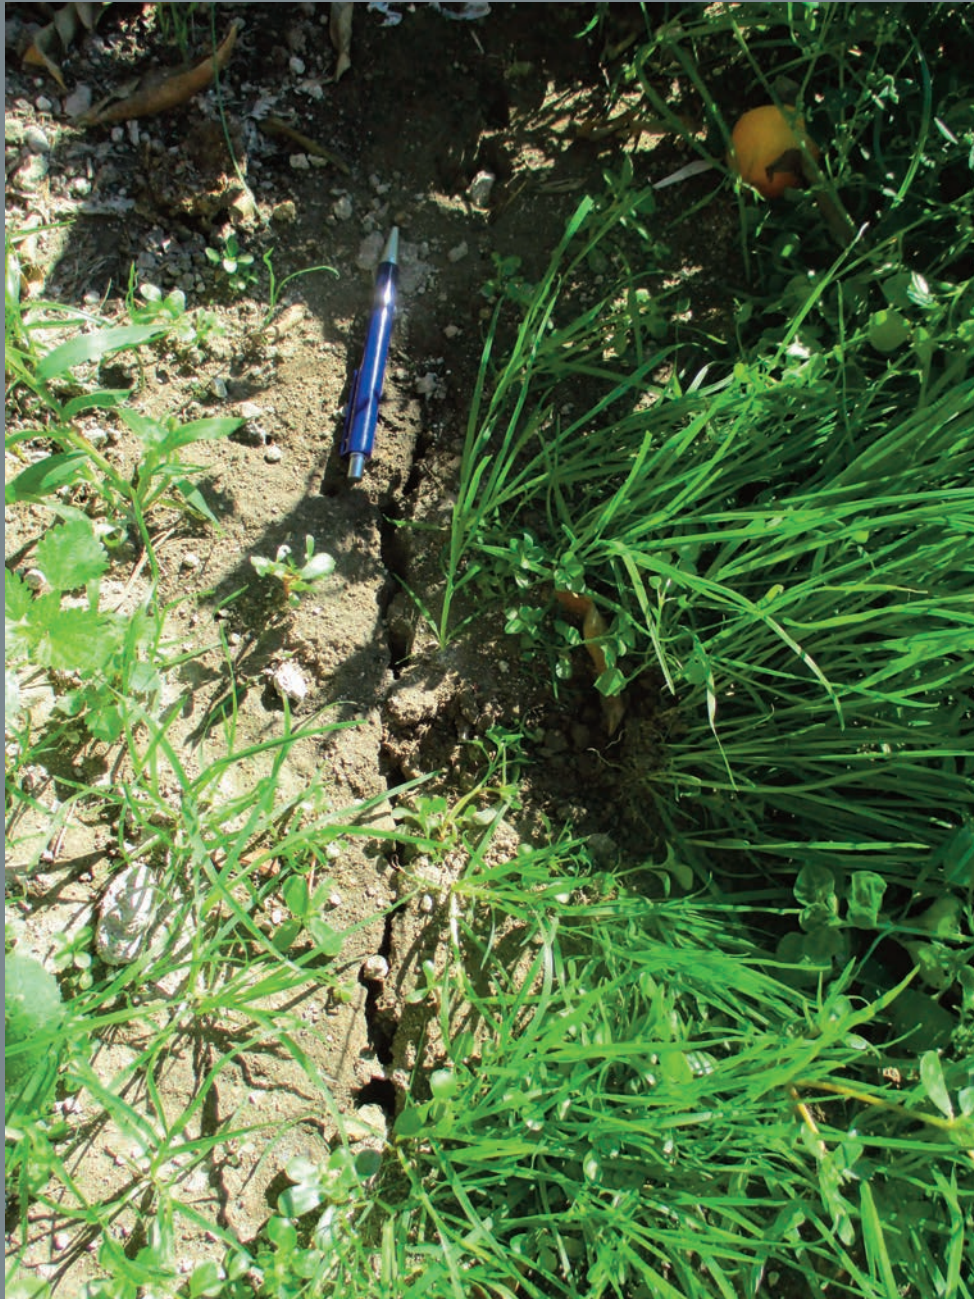
Photo 34

Coseismic rupture in soil in a garden at Via D'Aloisio with direction N80E and horizontal opening of a few cm, along the E-W striking dip-slip system fault of the Mt. Epomeo northern flank.

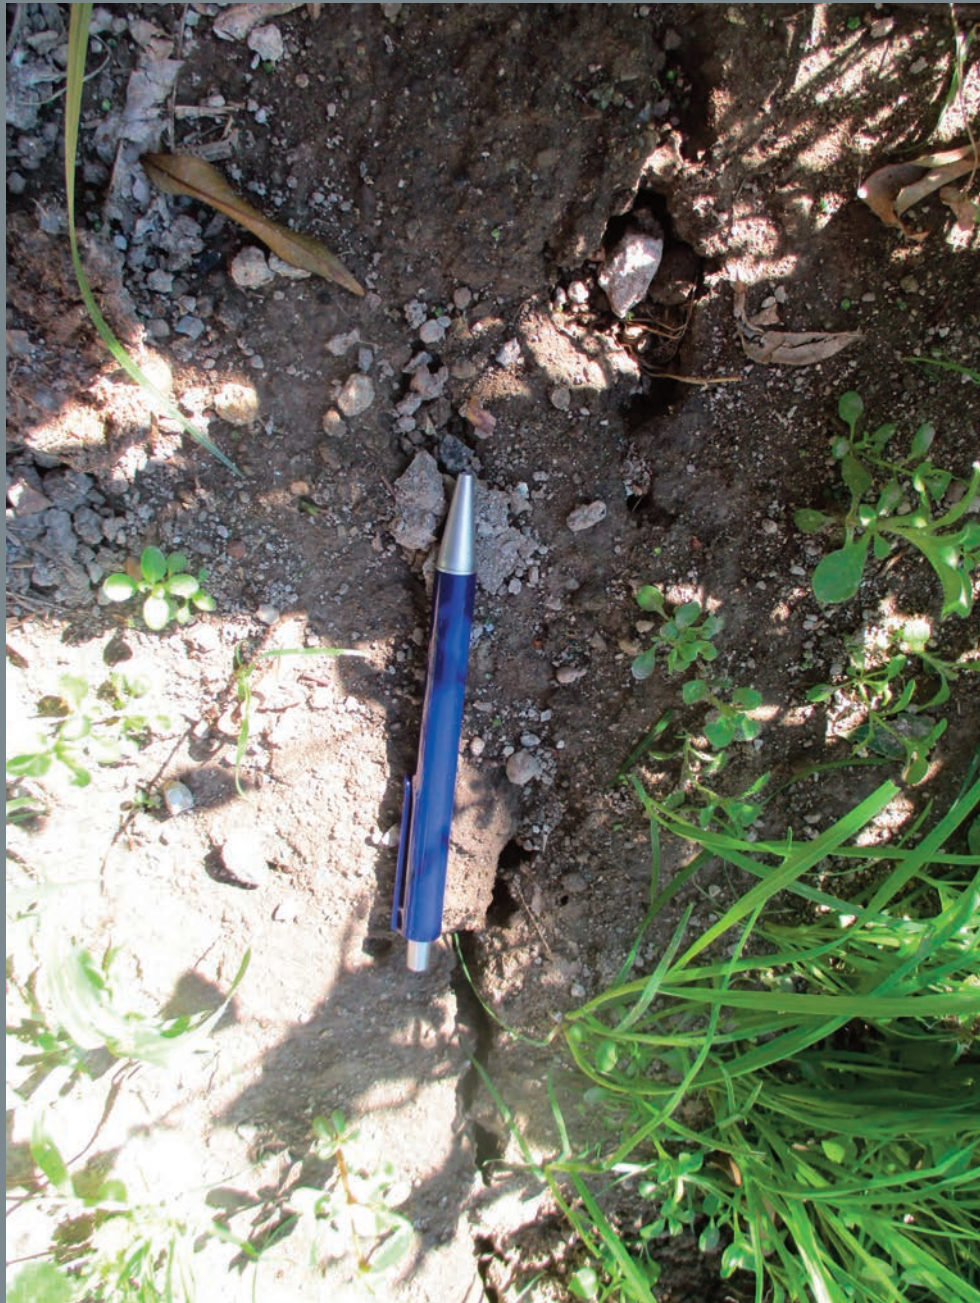
Photo 35

Coseismic rupture in soil in a garden at Via D'Aloisio with direction N80E and horizontal opening of a few cm, along the E-W striking dip-slip system fault of the Mt. Epomeo northern flank.

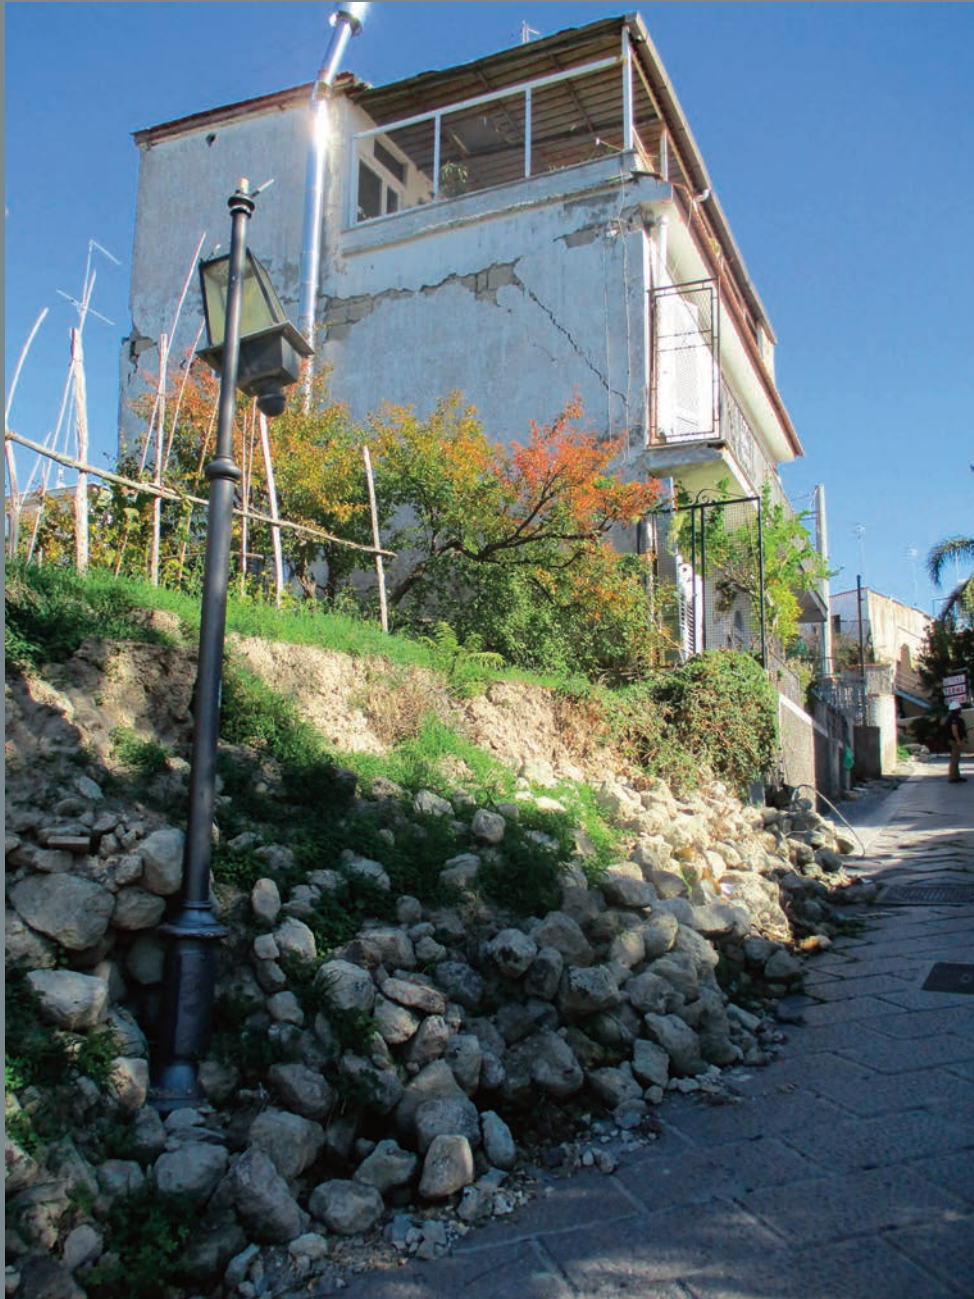
Photo 36

Collapse of drywall in Via D'Aloisio known locally as "parracine", from south to north along the E-W striking dip-slip system fault of the Mt. Epomeo northern flank. Lamppost and chimney of the house lowered towards North.

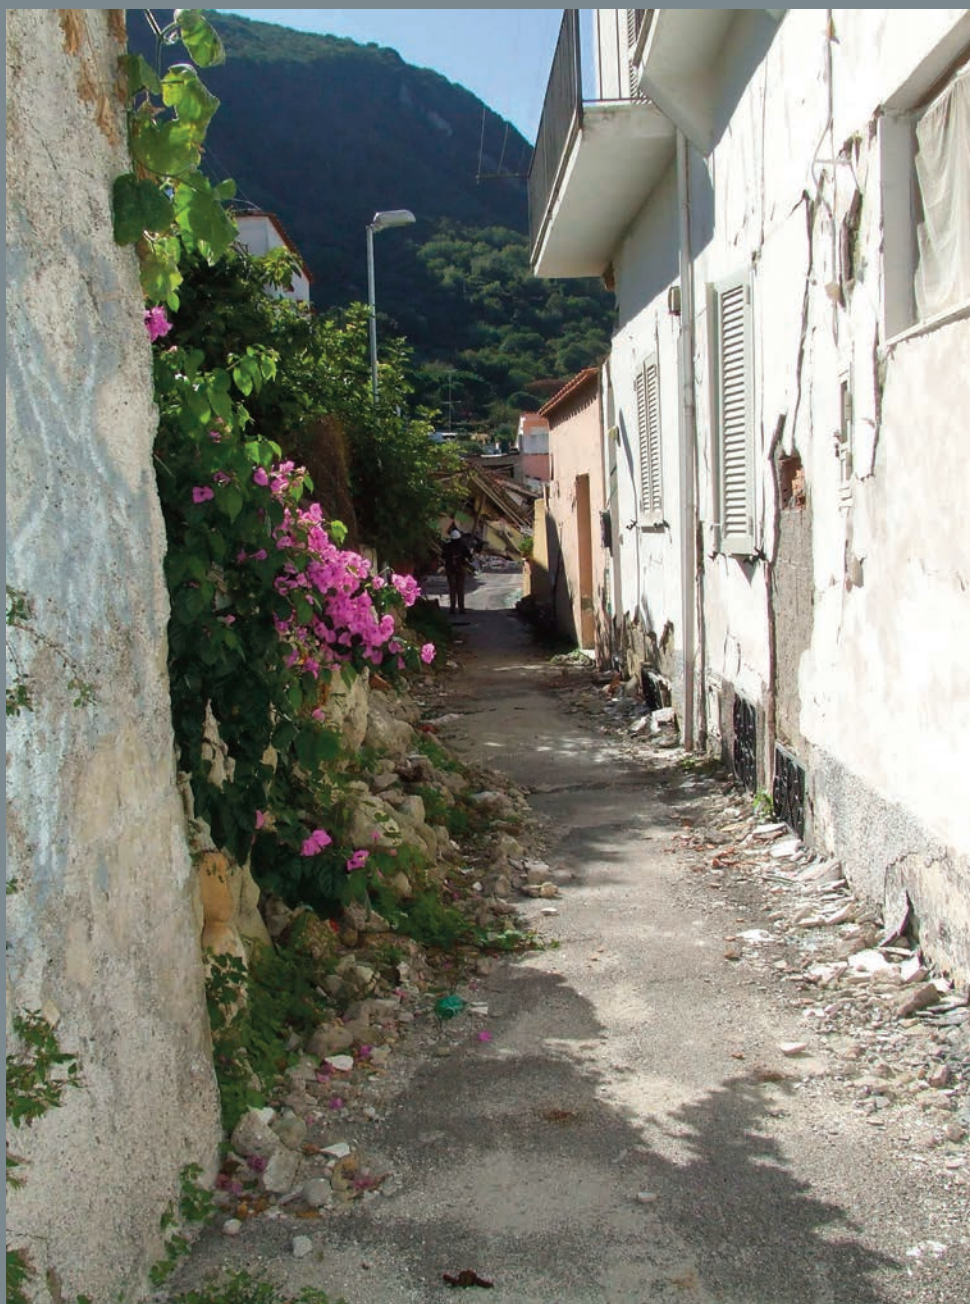
Photo 38

Collapse of drywall in a side street of Via D'Aloisio with E-W trending. In the background of the picture it is visible the collapse of the house shown in the previous photo 37.

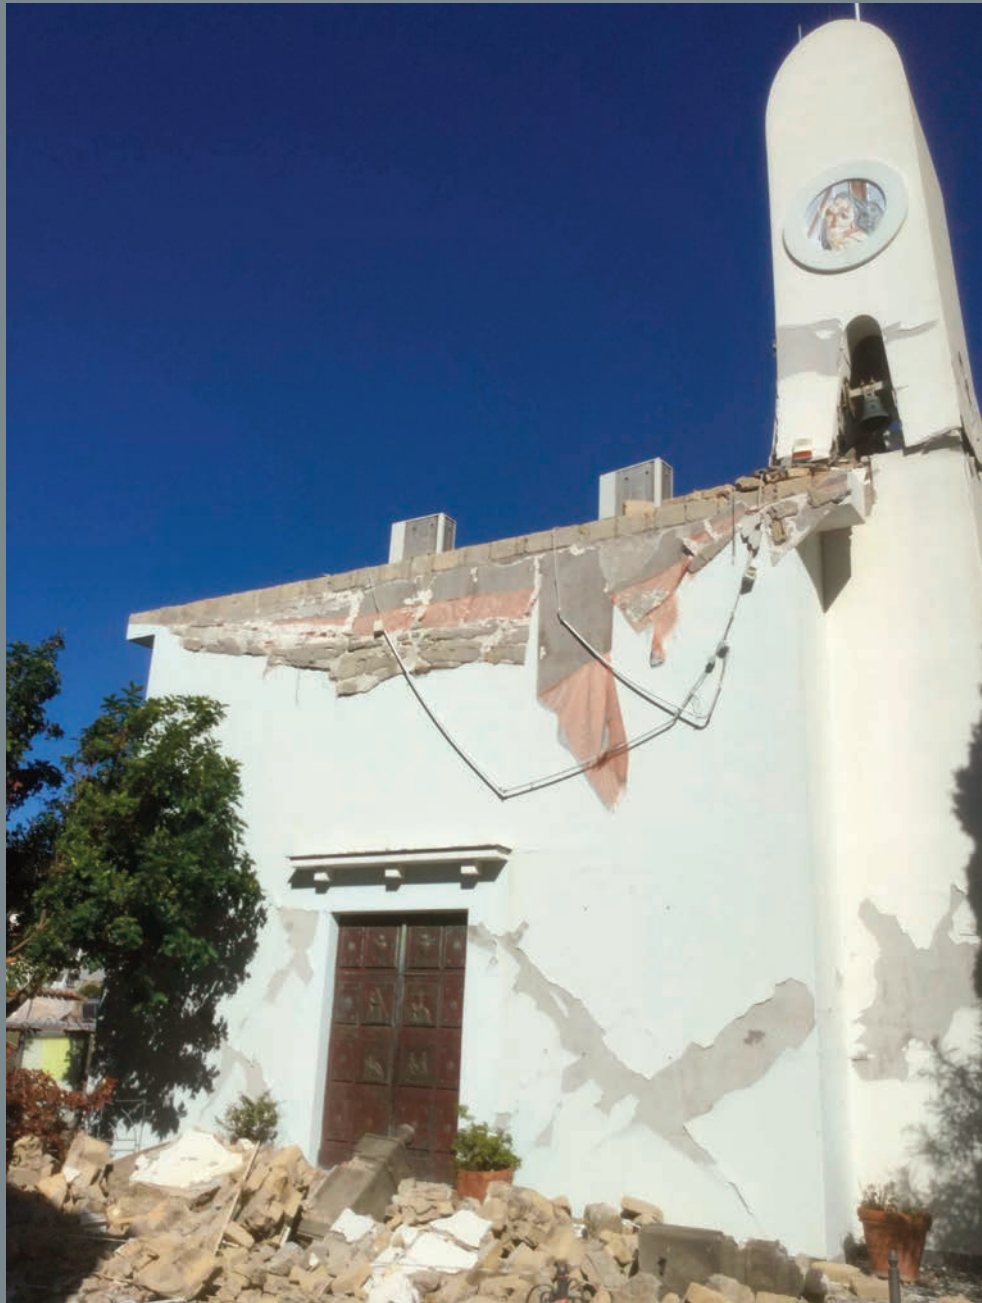
Photo 39
(40.743094° 13.898618°)
Severe damages and collapse of the Suffragio church bell tower which caused the death of a woman, along Via D'Aloisio.

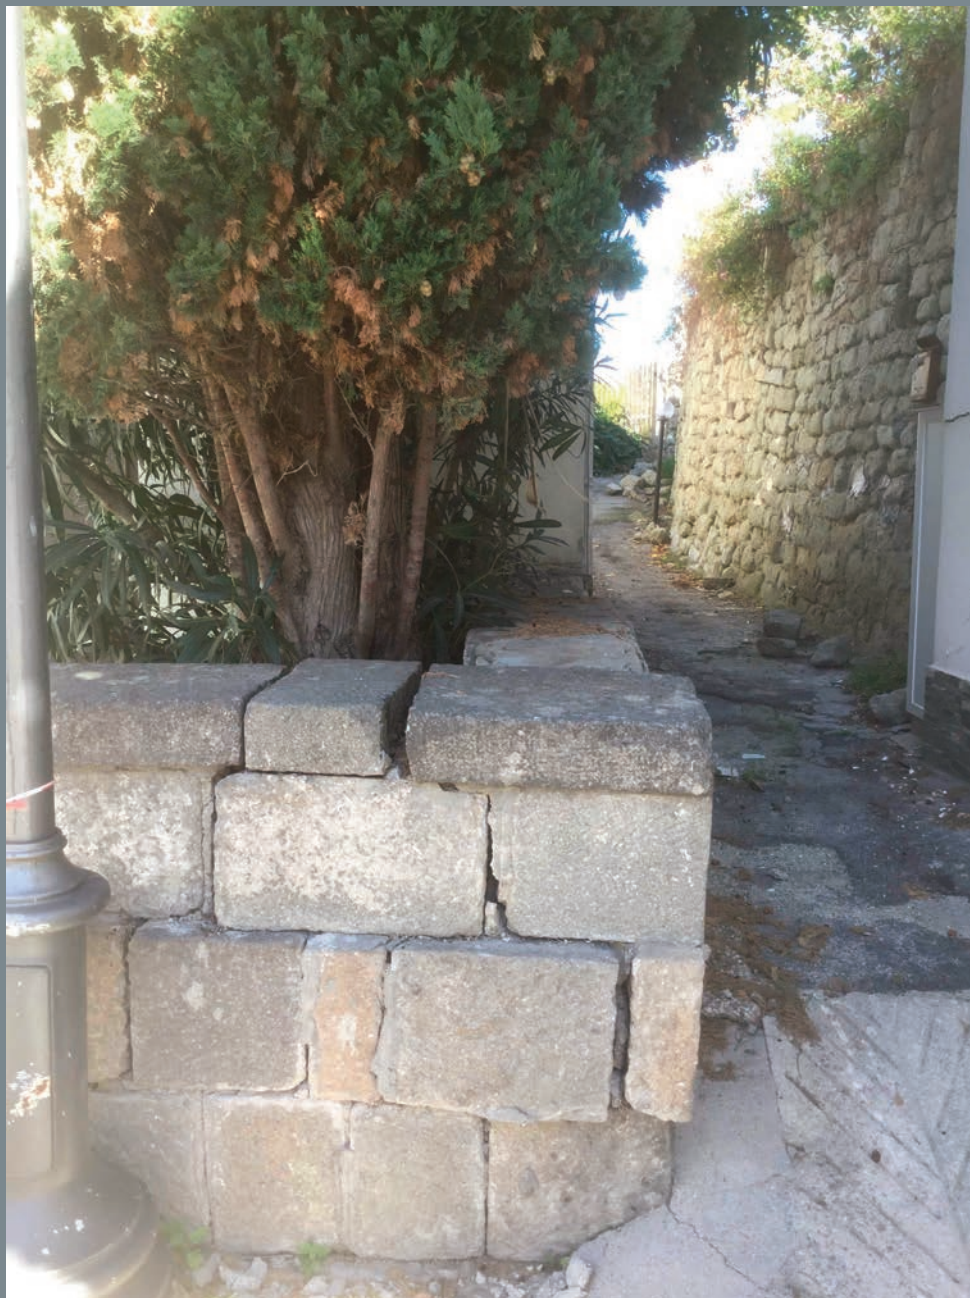
Photo 40

Coseismic fracture affecting both paved road and man-made structures, near the Suffragio church along Via D'Aloisio.

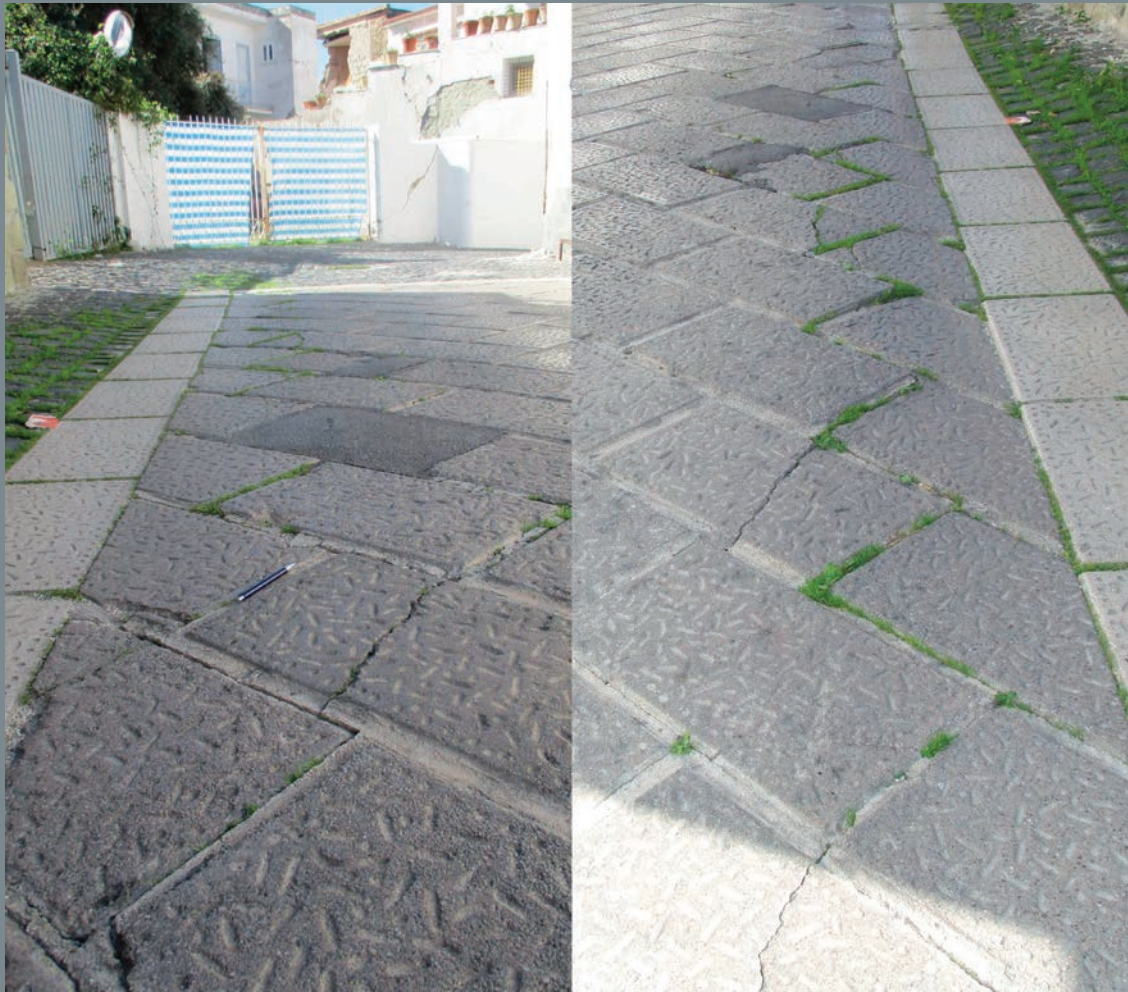
Photo 41

Fracture in paved road along Via D'Aloisio, which extends on the wall of a house.

The house is severely damaged.

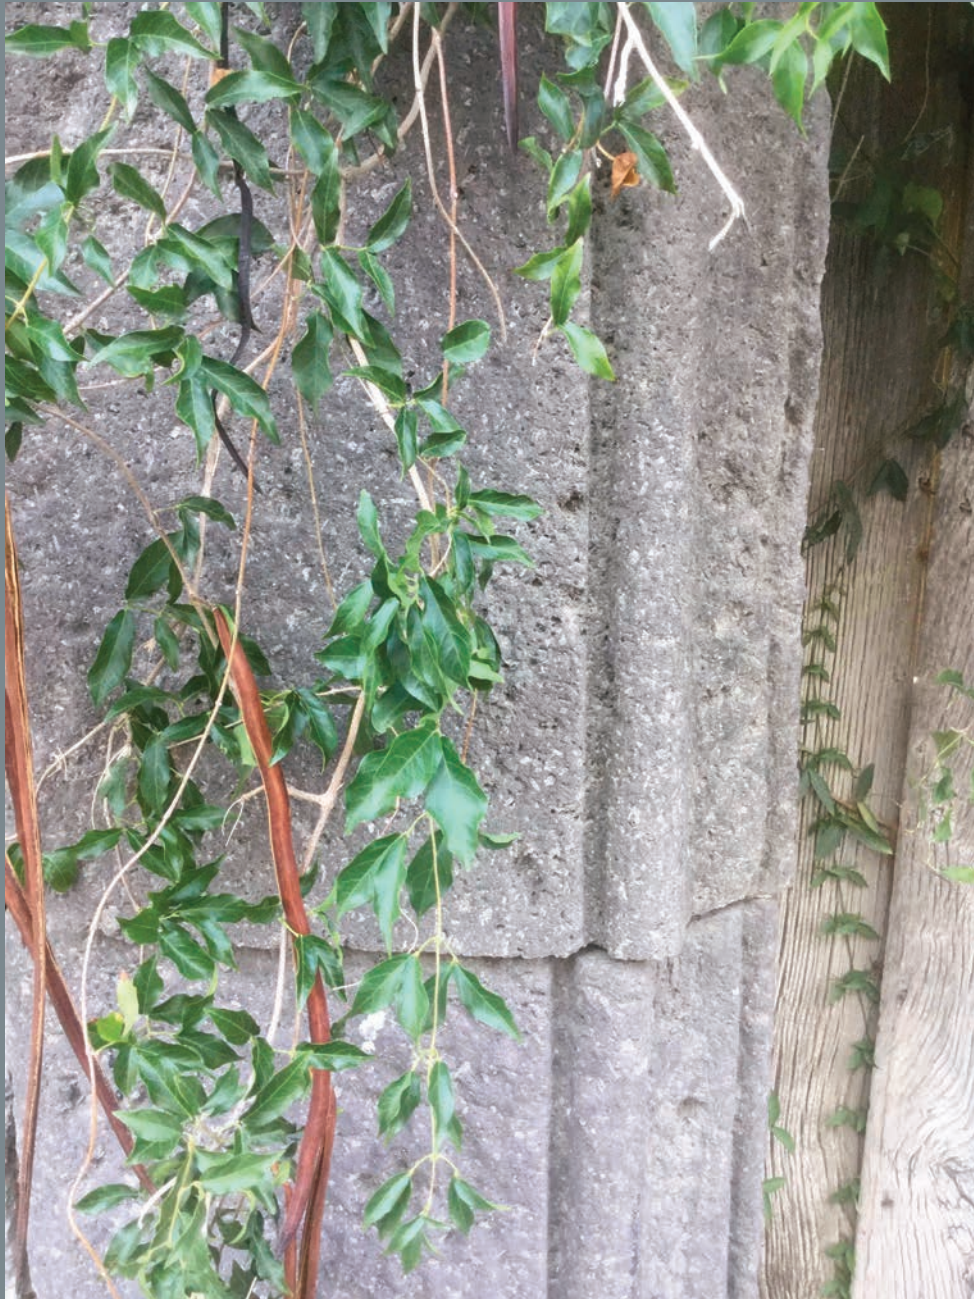
Photo 42

Column of doorway of an house along Via D'aloisio, showing a fracture with right movement.

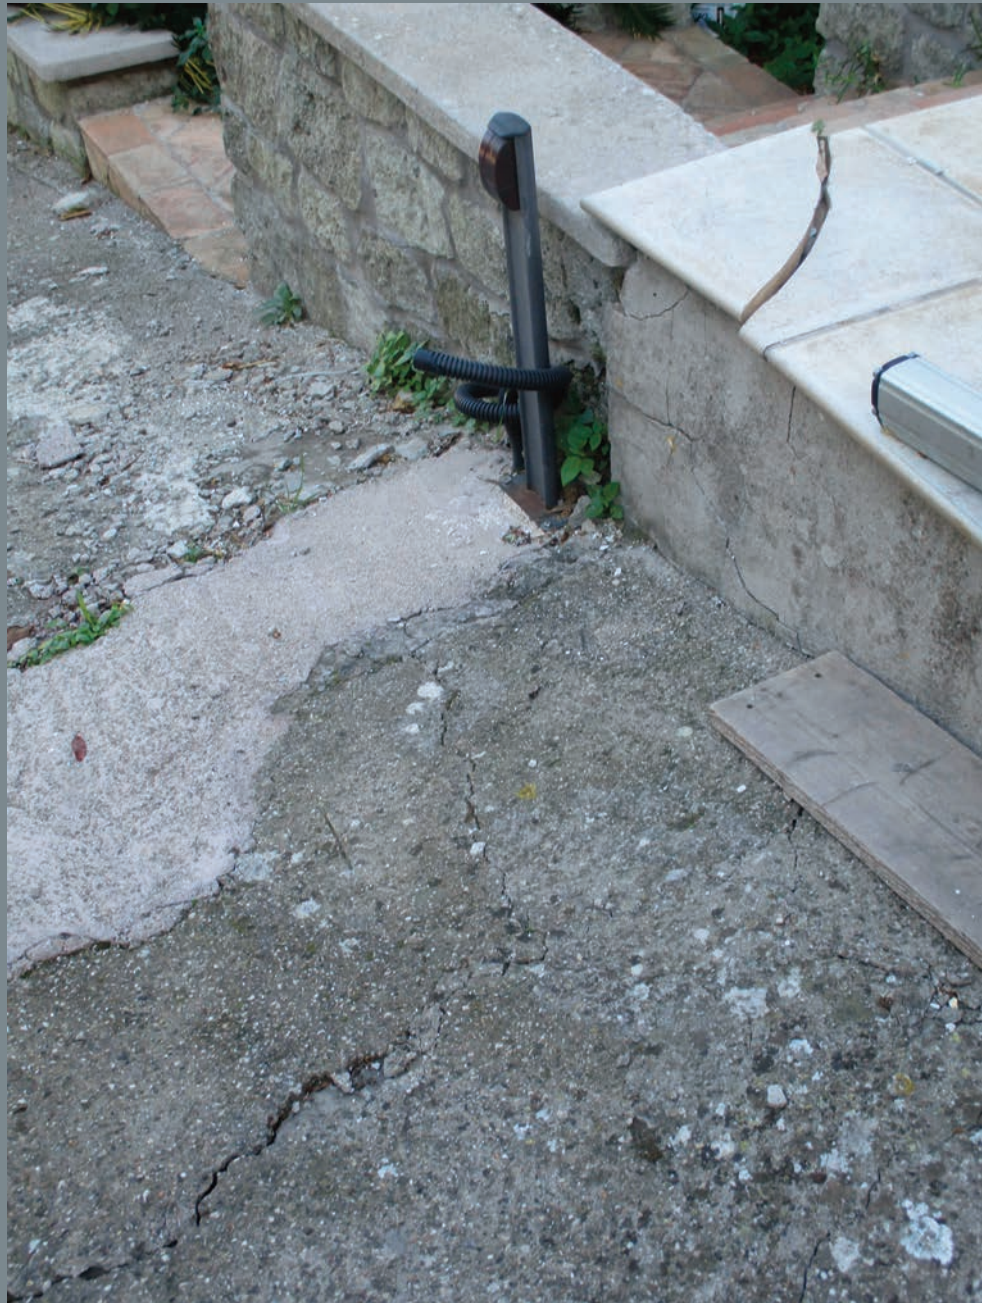
Photo 43

Coseismic fracture affecting both paved road and man-made structures, along Via D'Aloisio.

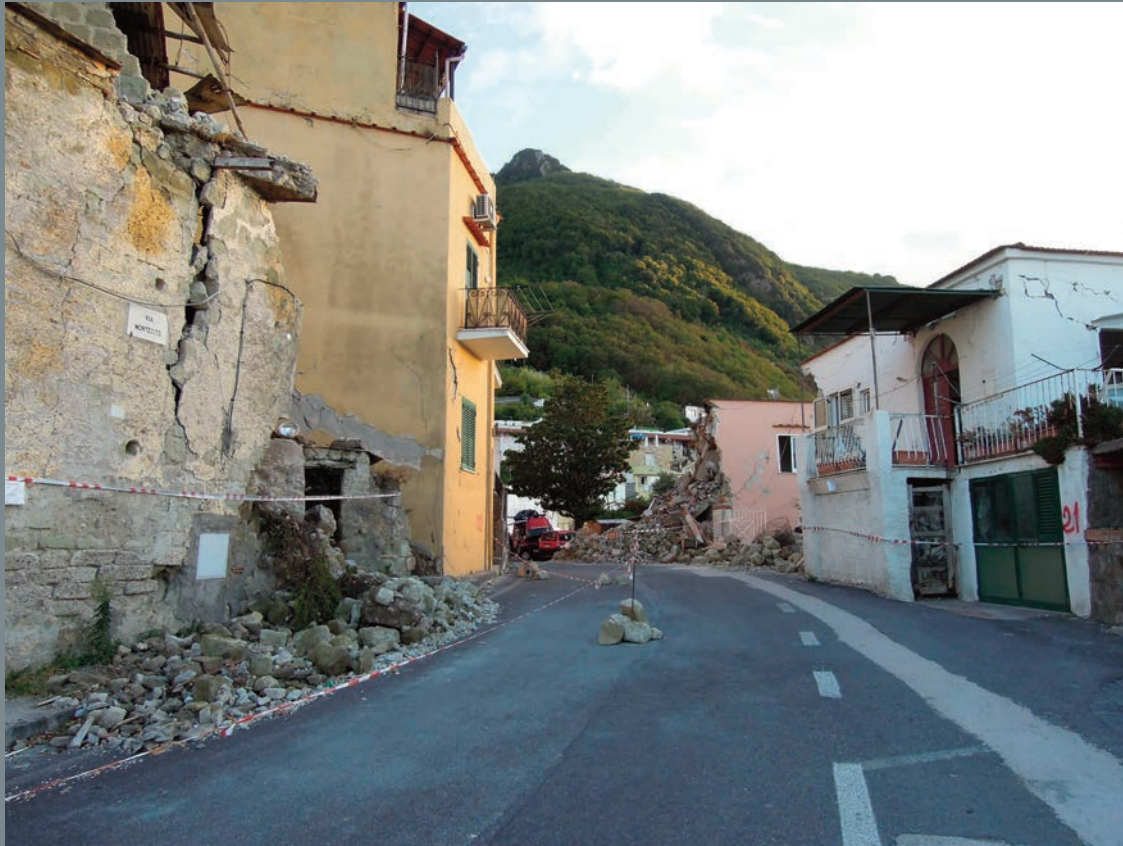
Photo 44

Fracture affecting the tarred Via Montecito along the E-W striking dip-slip system fault of the Mt. Epomeo northern flank. Houses along the road are collapsed or heavily damaged.

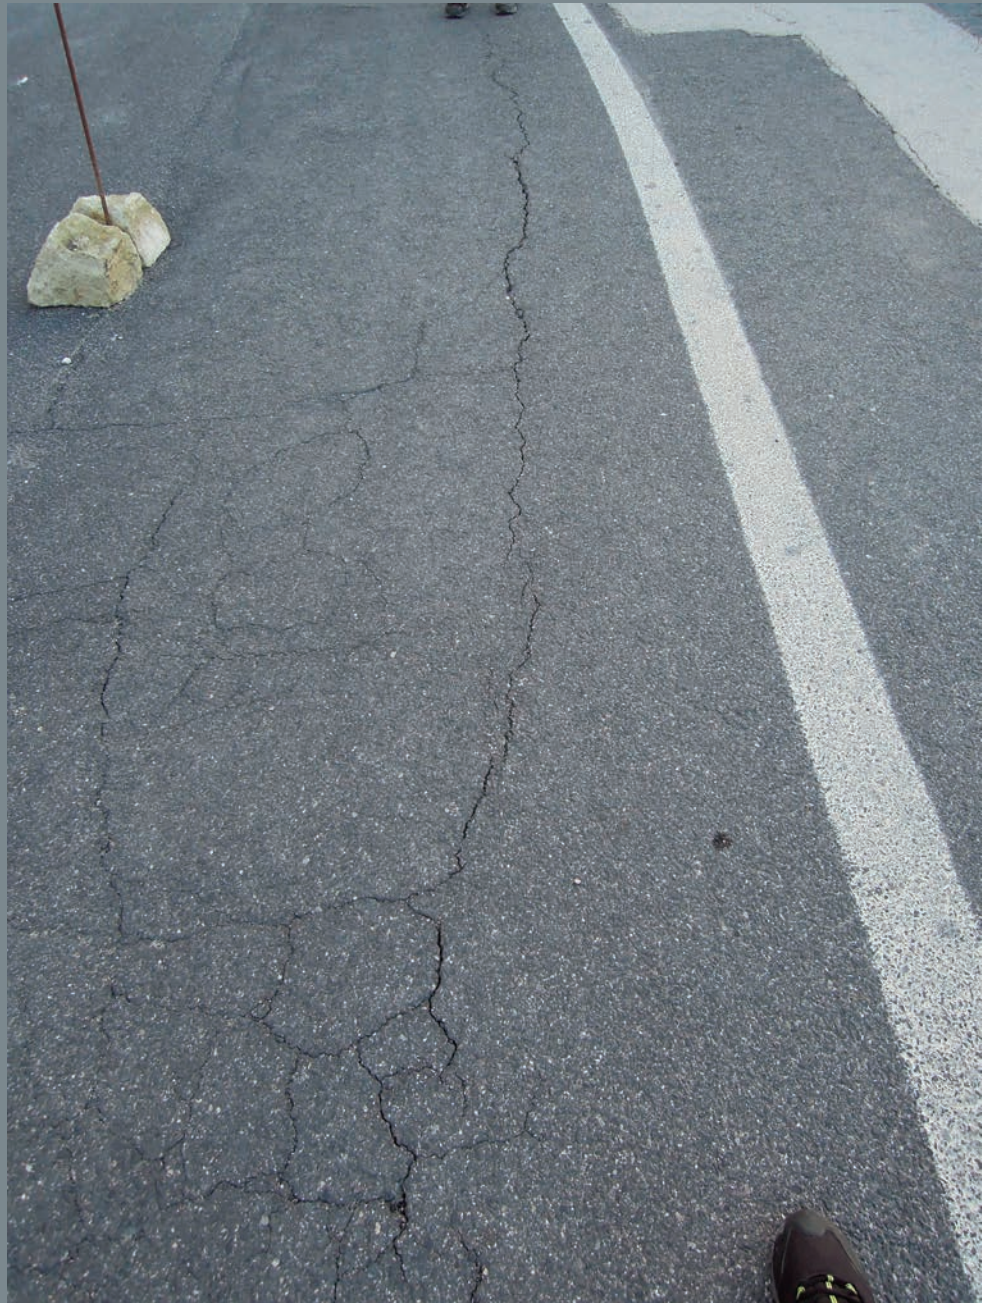
Photo 45
(40.742054° 13.899618°)
The fracture in tarred Via Montecito.

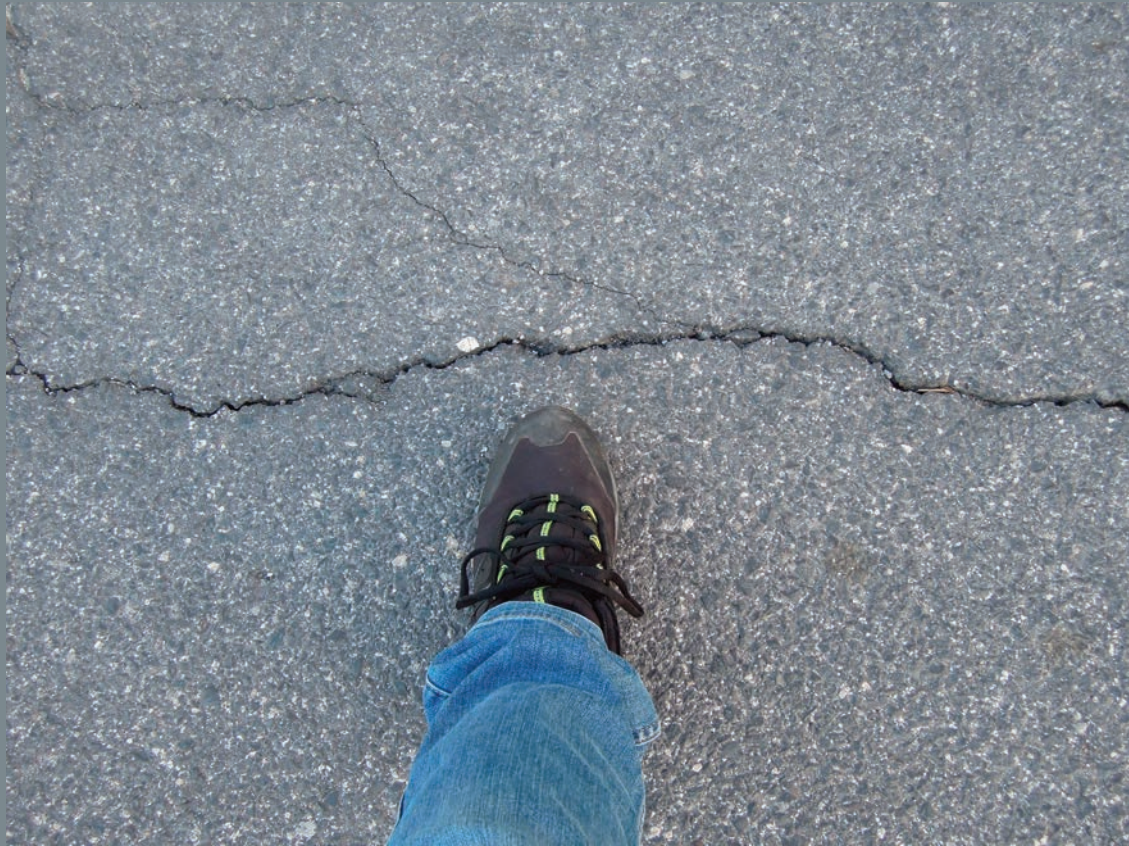
Photo 46

Detail of fracture showed in photo 45.

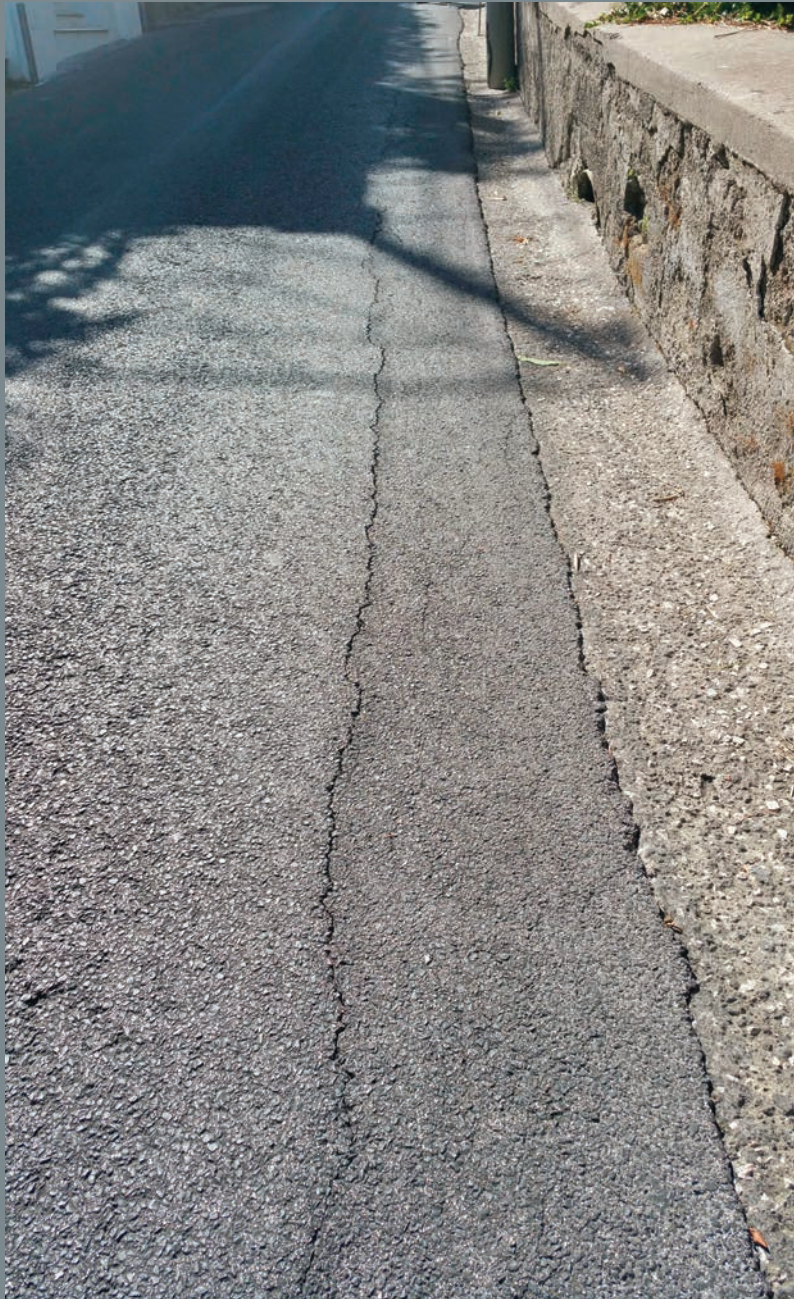
Photo 47

Coseismic fracture on paved road in Via Castanito, Casamicciola Terme.

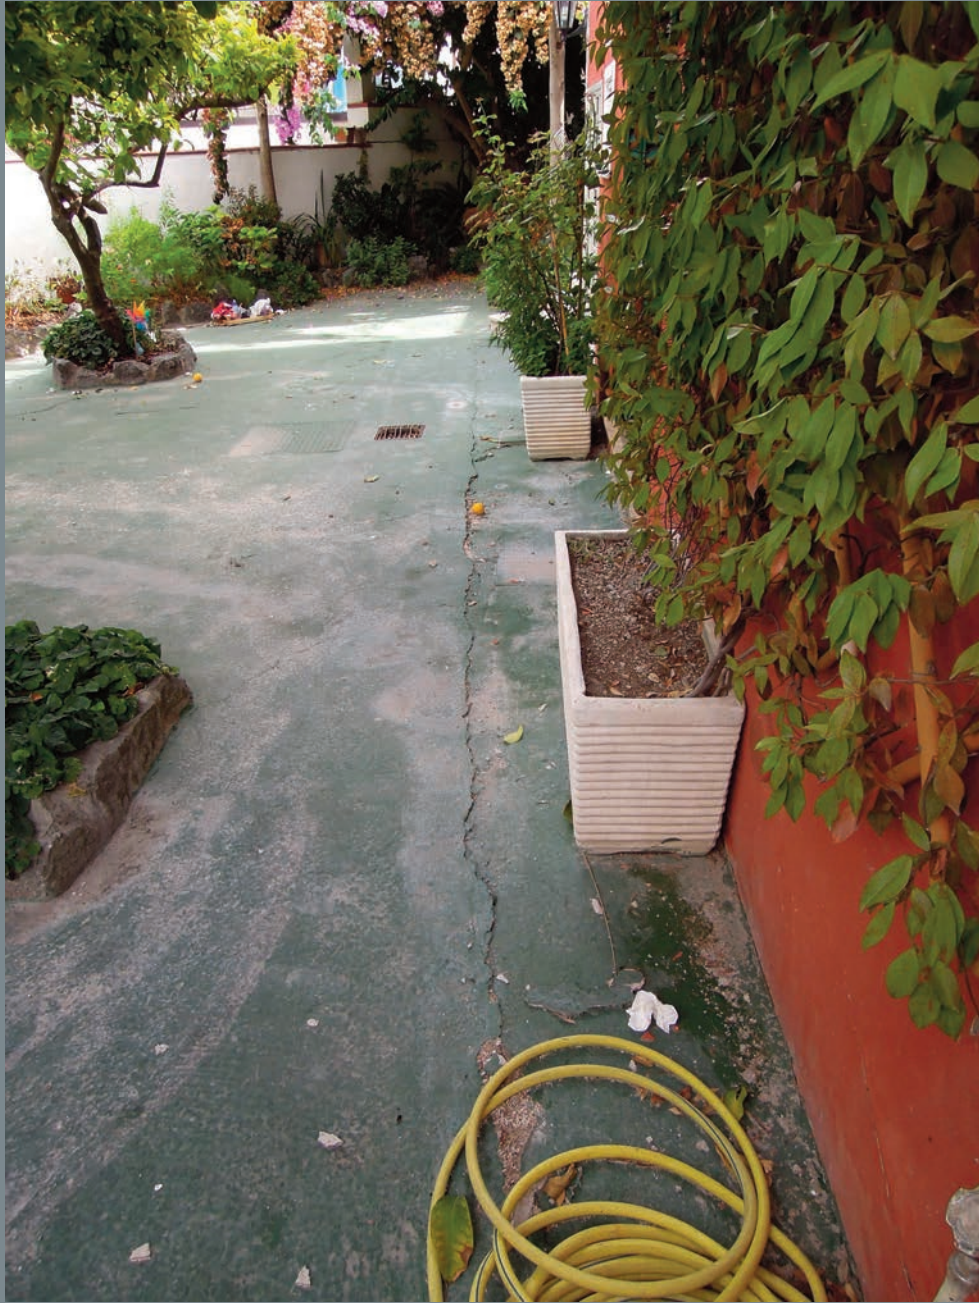
Photo 48

Fracture in the courtyard of a house in Via Sassolo, Casamicciola Terme.

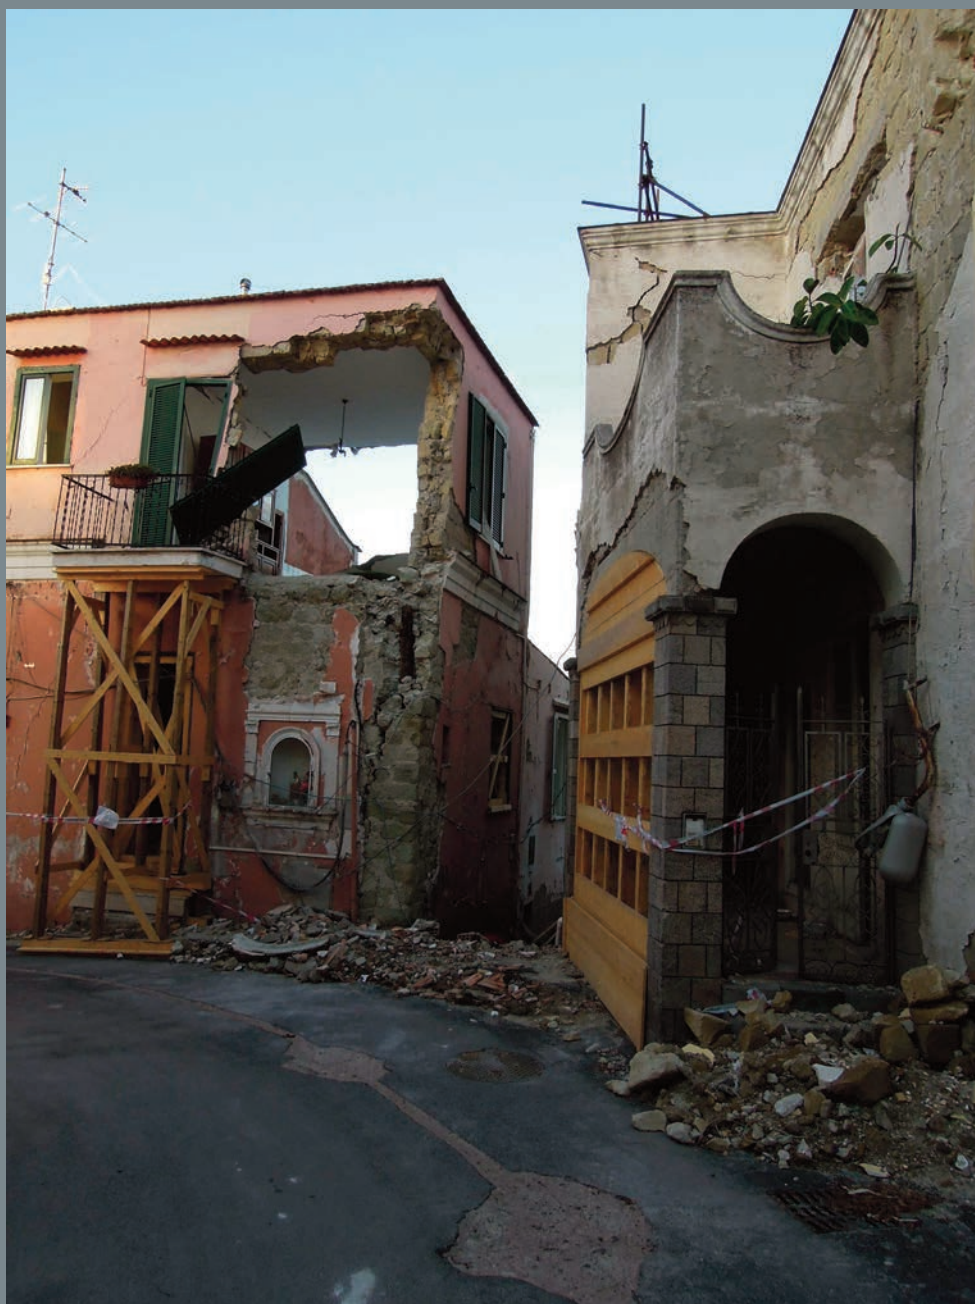
Photo 49

Houses heavily damaged along Via Ottringolo in the hilly historical centre of Casamicciola Terme.
