A photographic collection of the coseismic geological effects induced by the 21 August 2017, M=4, Casamicciola earthquake (Ischia island, Italy)

Emergeo Working Group*

Accepted 19th July 2019 | *Accettato il 19 luglio 2019*

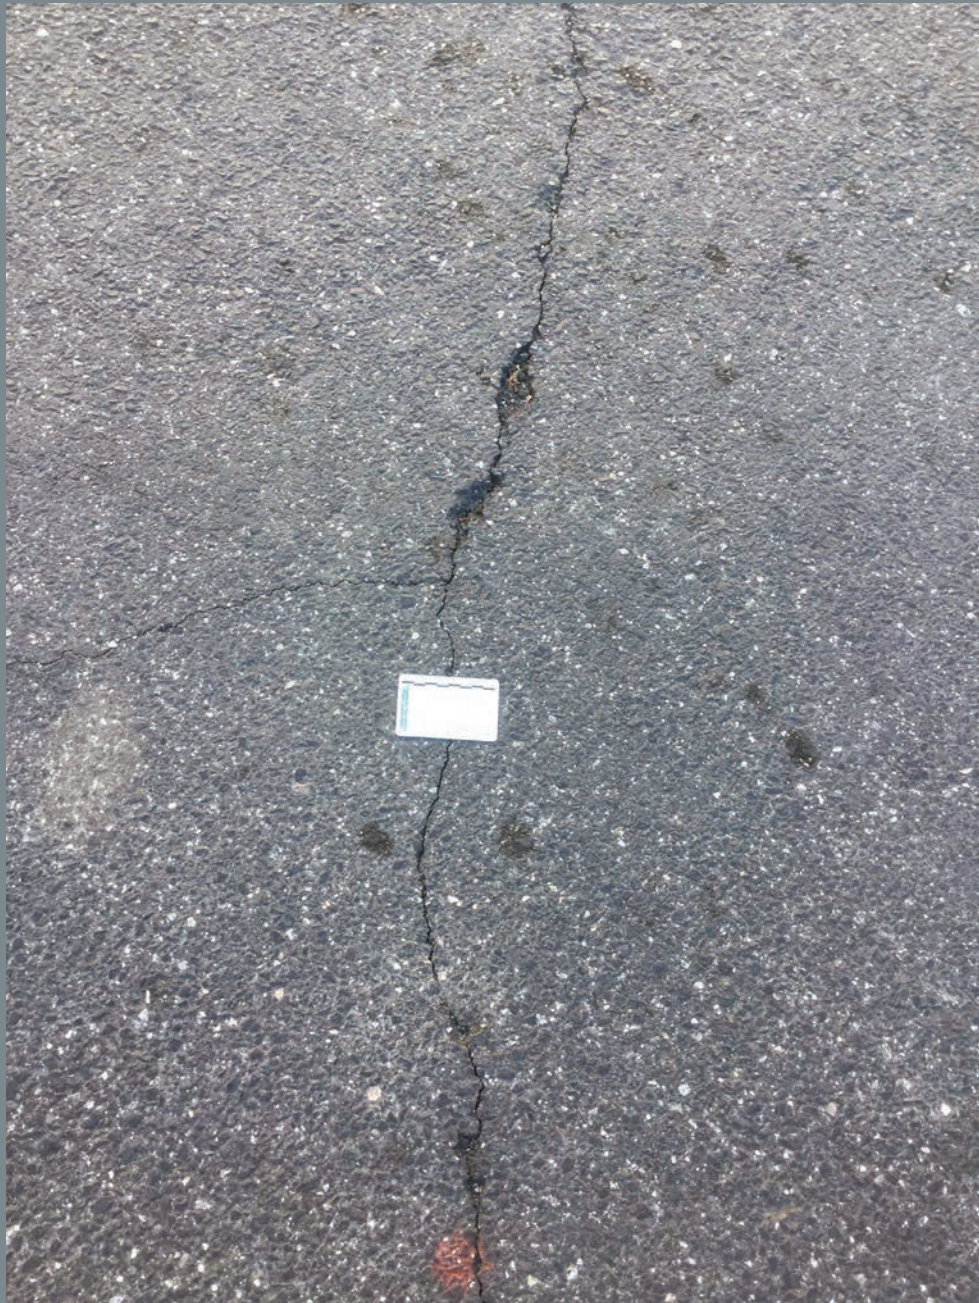
Photo 50

Coseismic fracture on tarred Via Ottringolo, Casamicciola Terme.

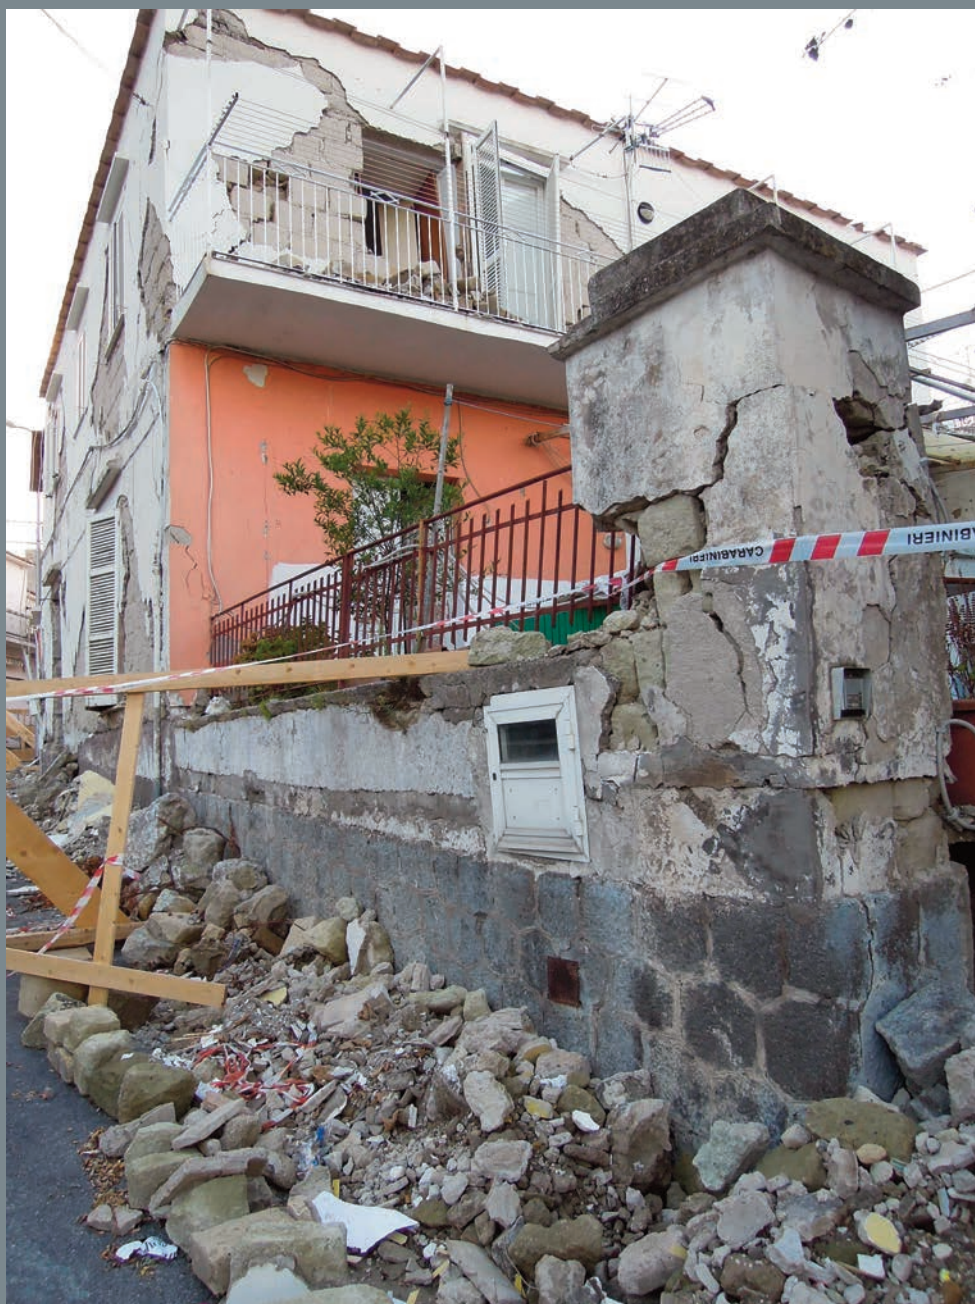
Photo 51

Collapses of the wall of a house damaged along Via Ottringolo.

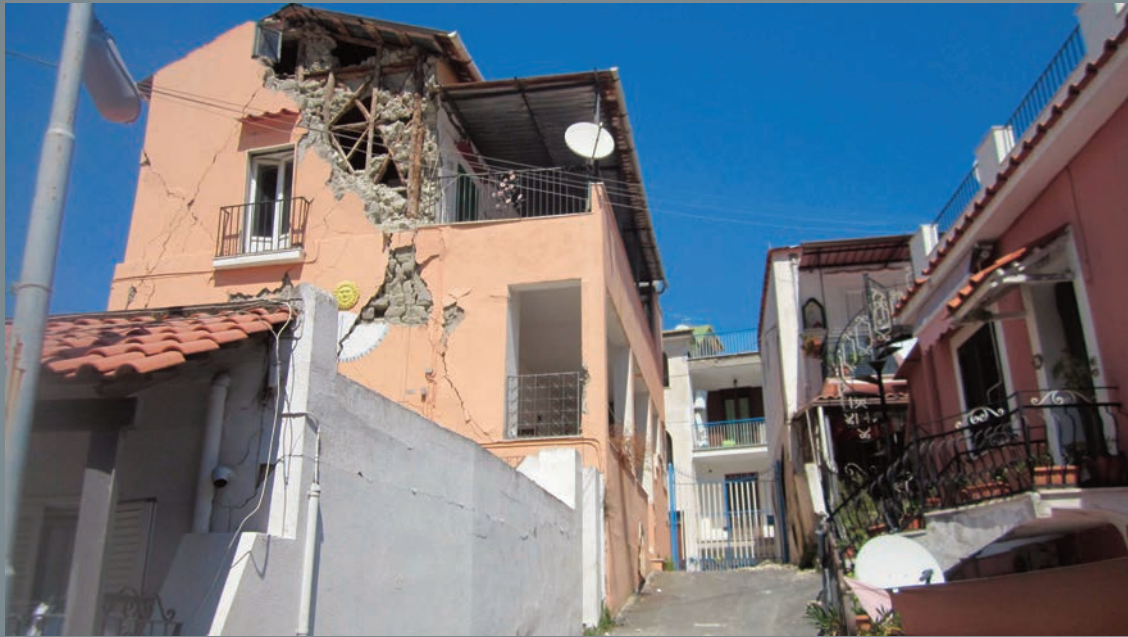
Photo 52
(40.742486° 13.901391°)
House heavily damaged along Via Speziera.

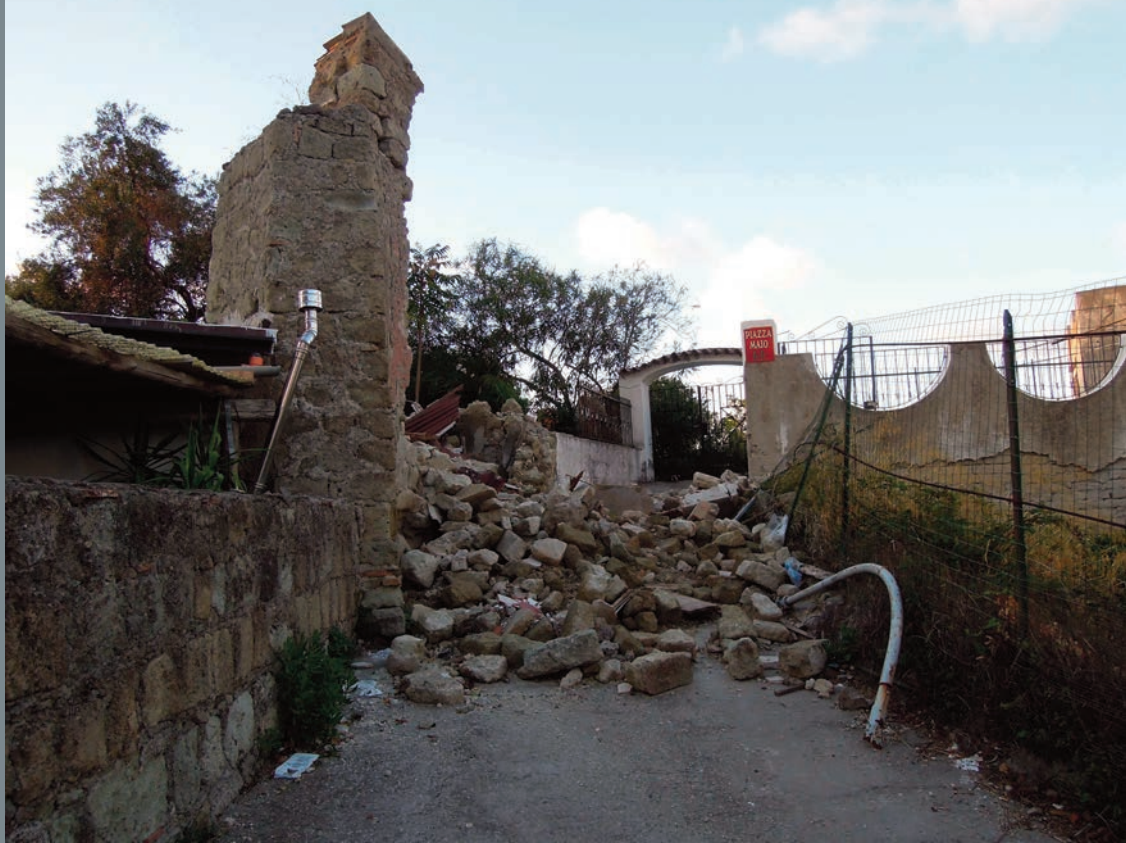
Photo 53

Collapses of walls at Piazza Maio.

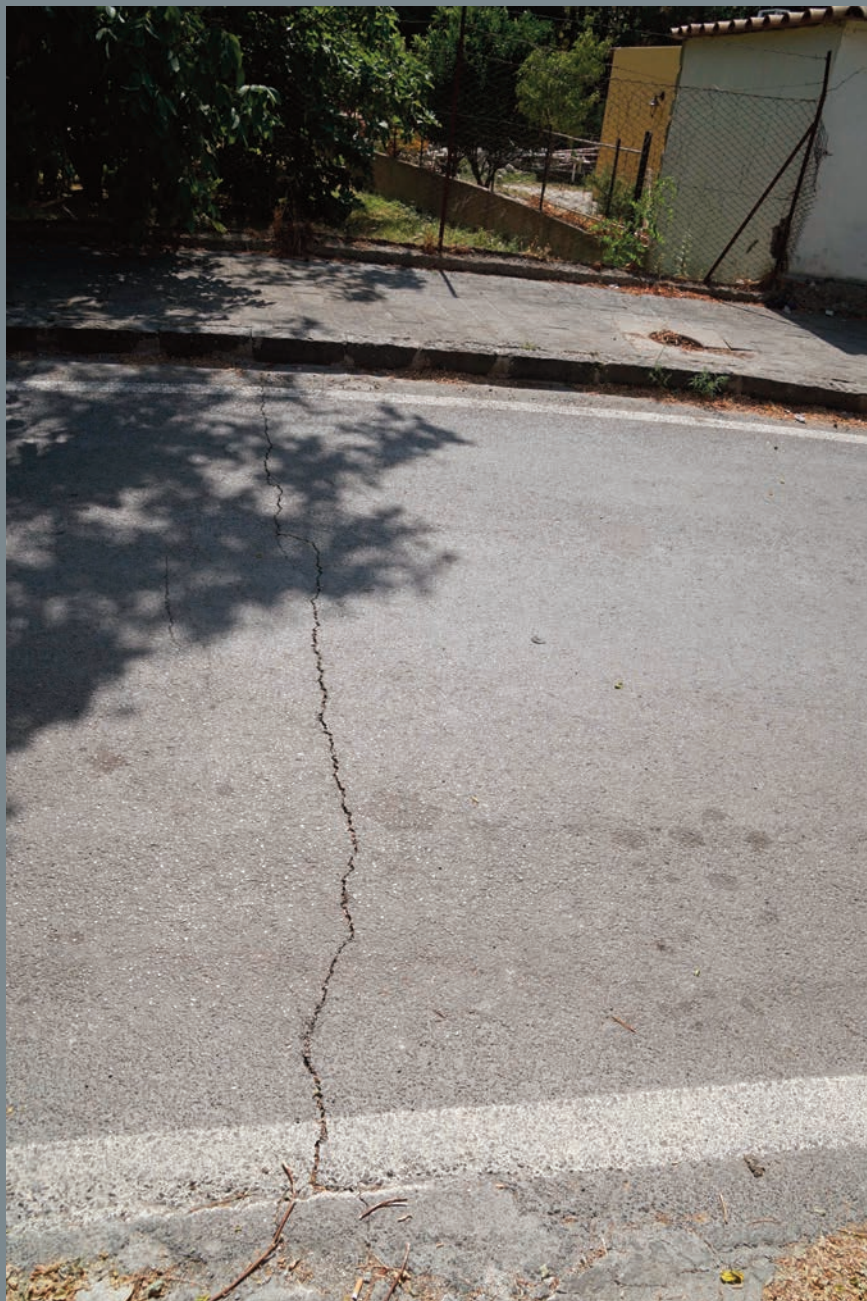
Photo 55

Fracture in the asphalt at the beginning of Via Santa Barbara, which extends to the sidewalk.

The fracture has direction N10/20E, crosses the entire road surface and has a length of about 5m.

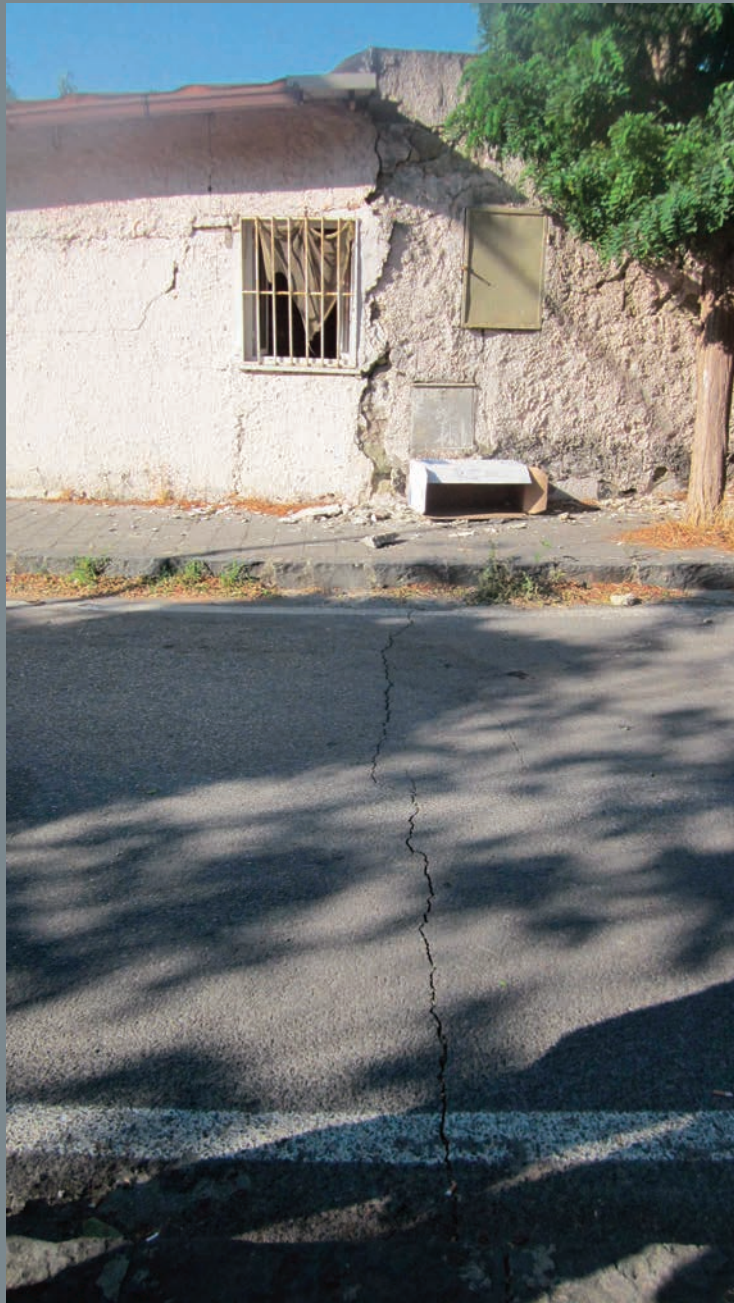
Photo 56

The same fracture of photo n.55 in Via Santa Barbara, but seen from the opposite side of the road; it is evident that it extends to the wall of a house.

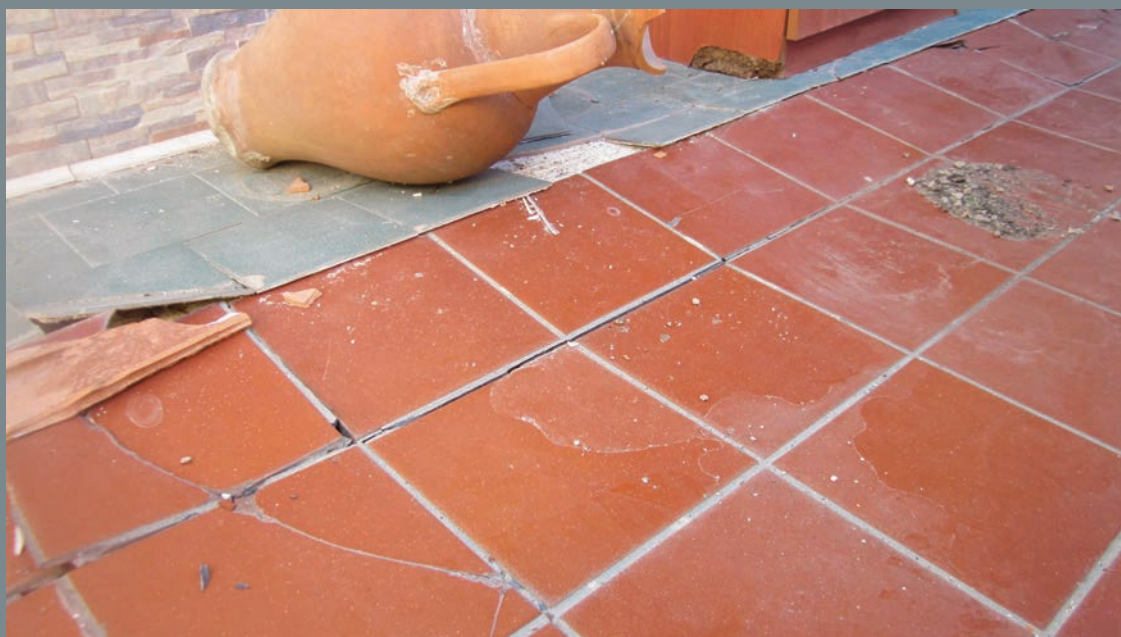
Photo 57

Fracture with lowering into the tile flooring of the terrace outside the house at n.16 Via Santa Barbara.

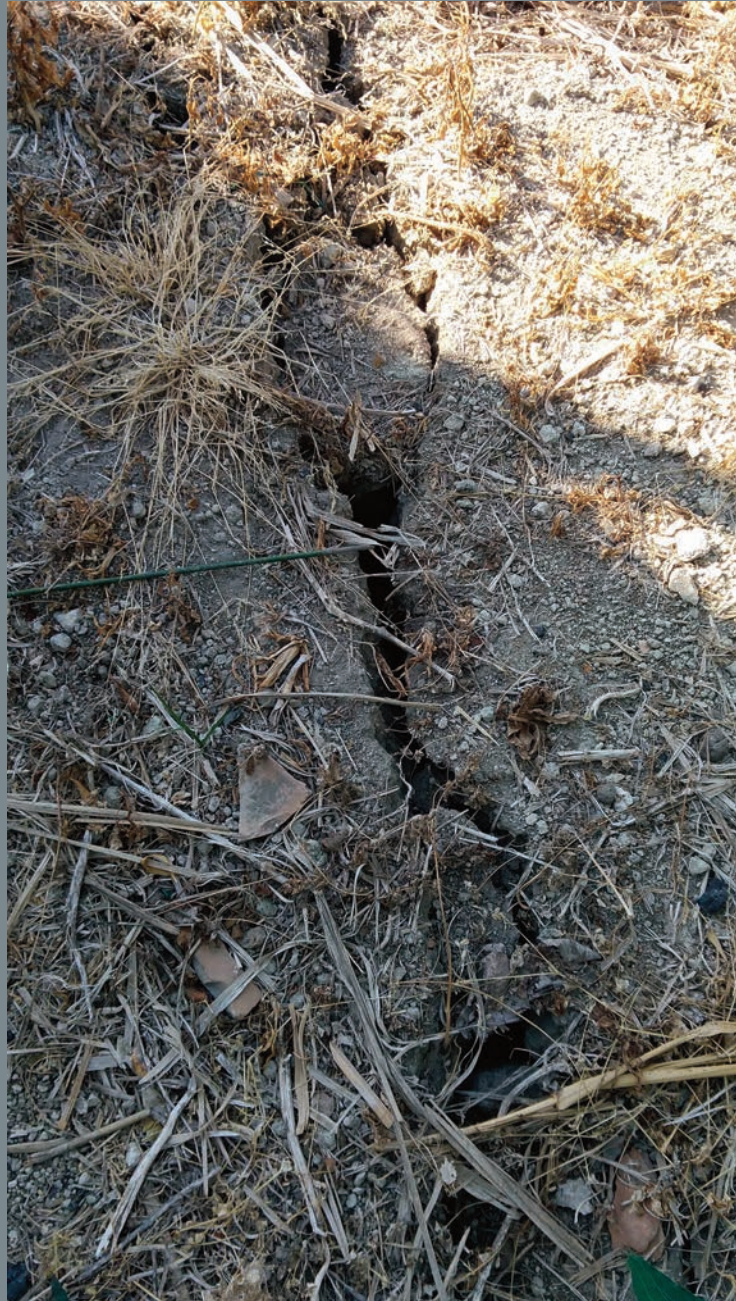
Photo 58

Rupture in the house garden at n. 16 Via Santa Barbara; it begins along the edge of this street, and extends for about 20 m towards Northeast. There is also evidence of ground sinking with direction N110E - N120E and horizontal opening of some cm.

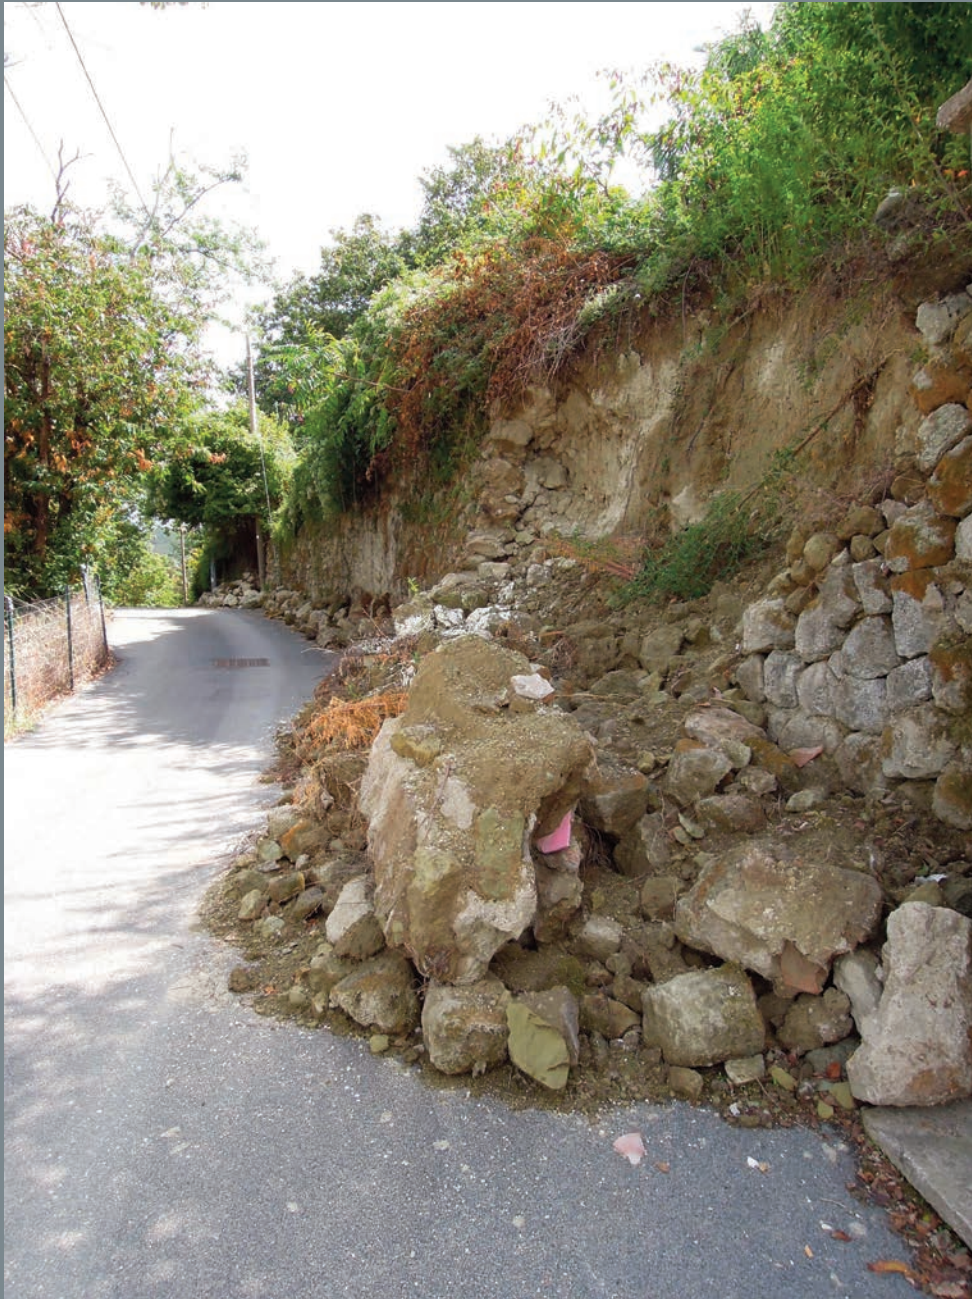
Photo 59

Collapse phenomena of drywalls in Via Nizzola, Casamicciola Terme.

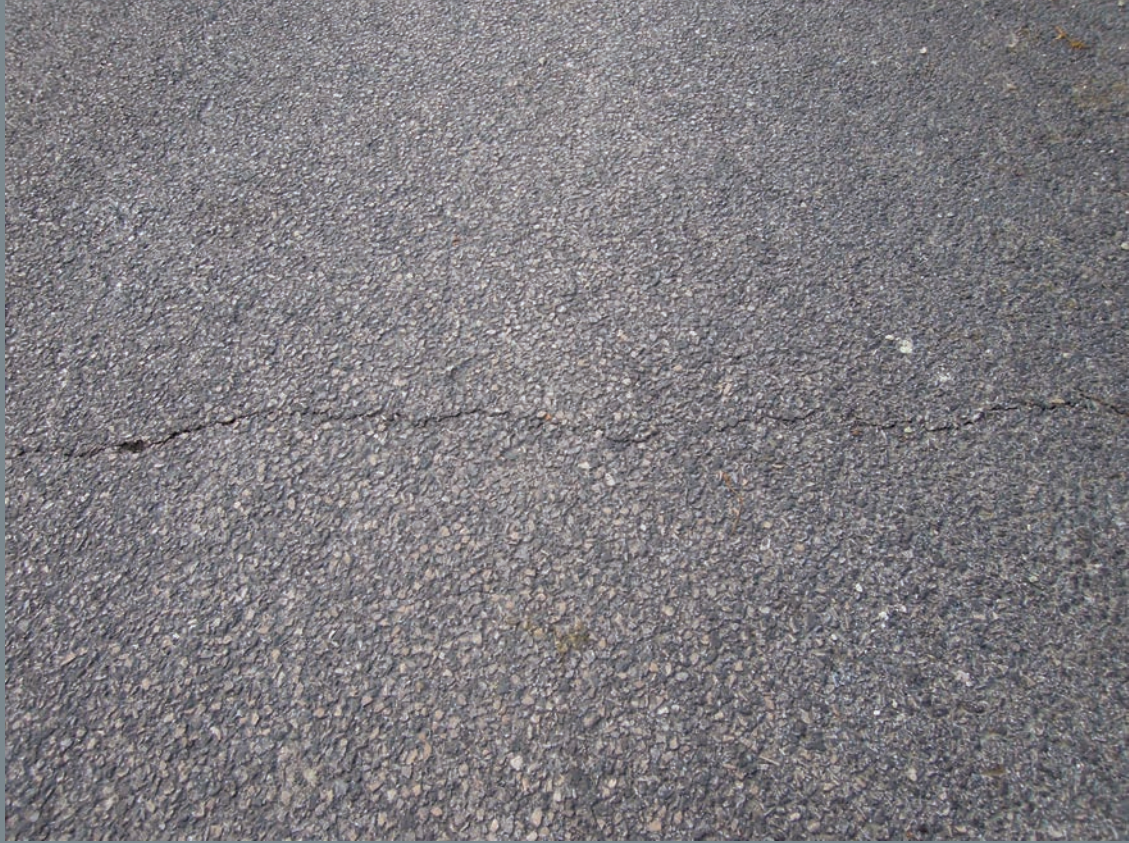
Photo 60
(40.742459° 13.904303°)
Fracture on paved road in Via Nizzola, Casamicciola Terme.

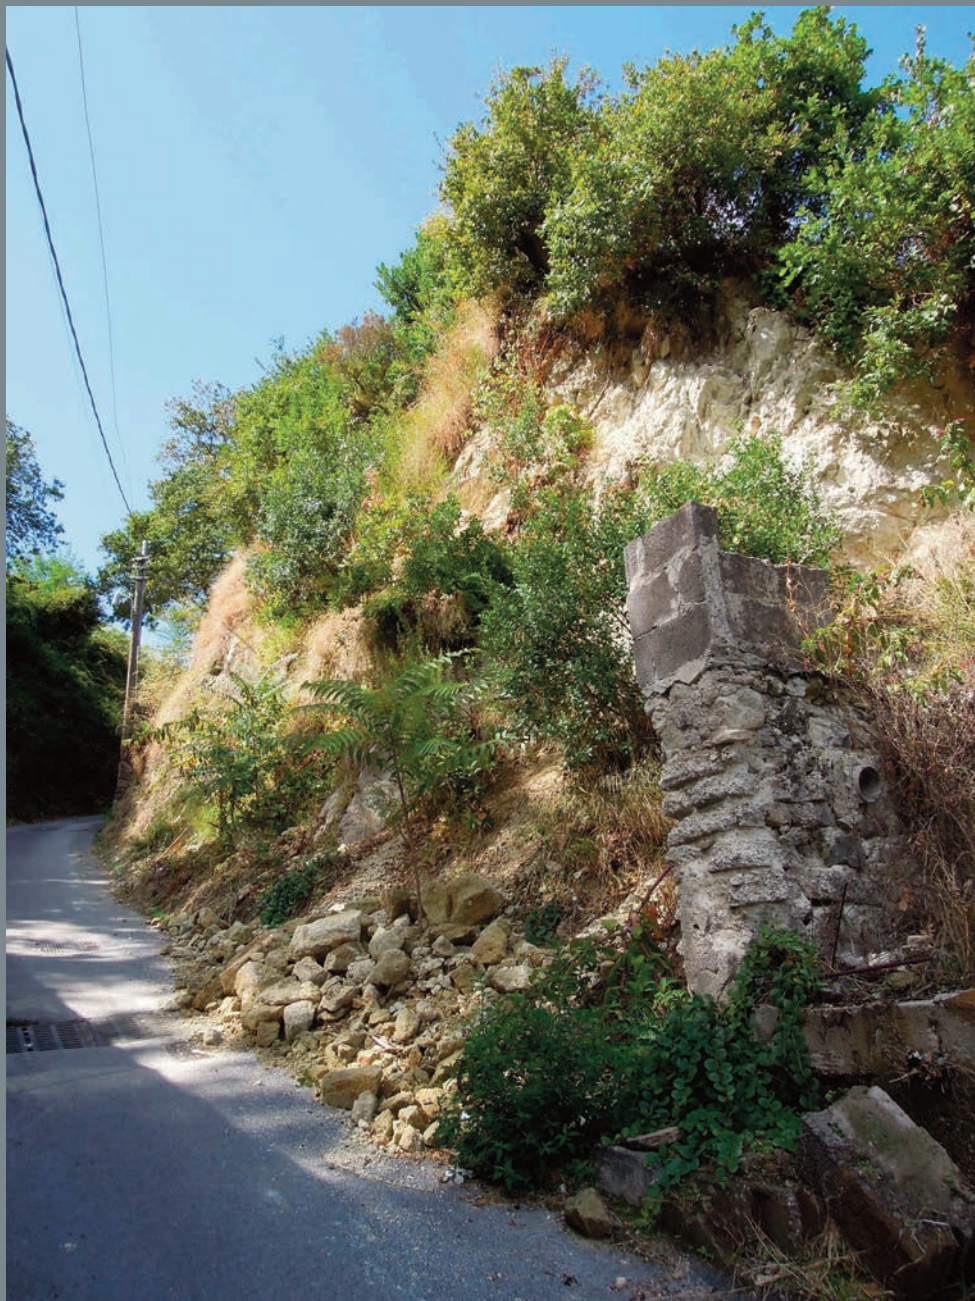
Photo 61

Collapse phenomena of tuff blocks in Via Nizzola, Casamicciola Terme.

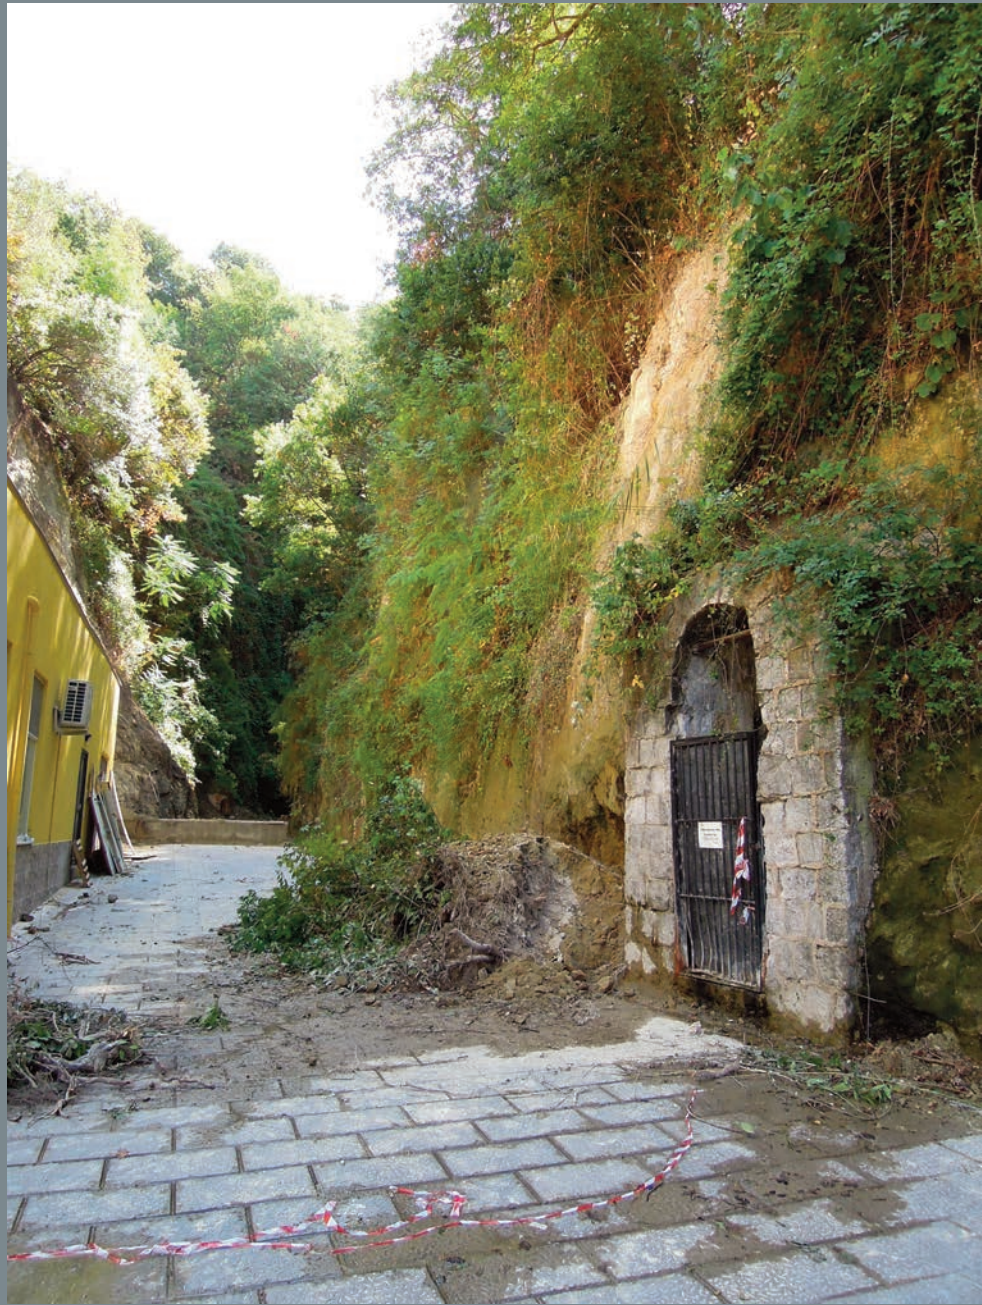
Photo 62

Small landslides in volcanoclastic deposits in Via Nizzola, Casamicciola Terme.

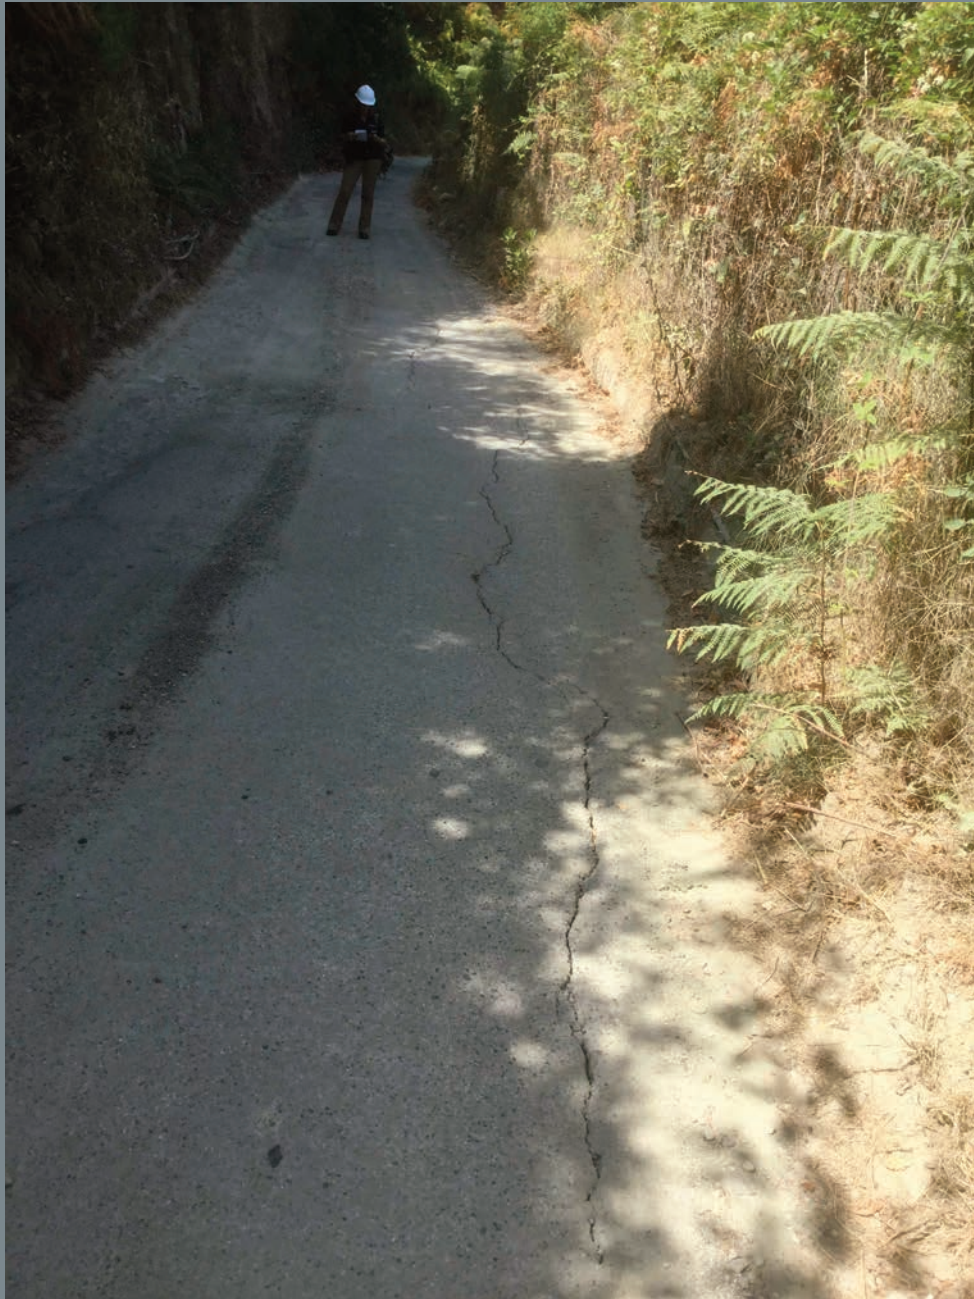
Photo 63

Rupture in tarred road along Via Campomanno. The total length of the fracture system is of the order of hundred of meters.

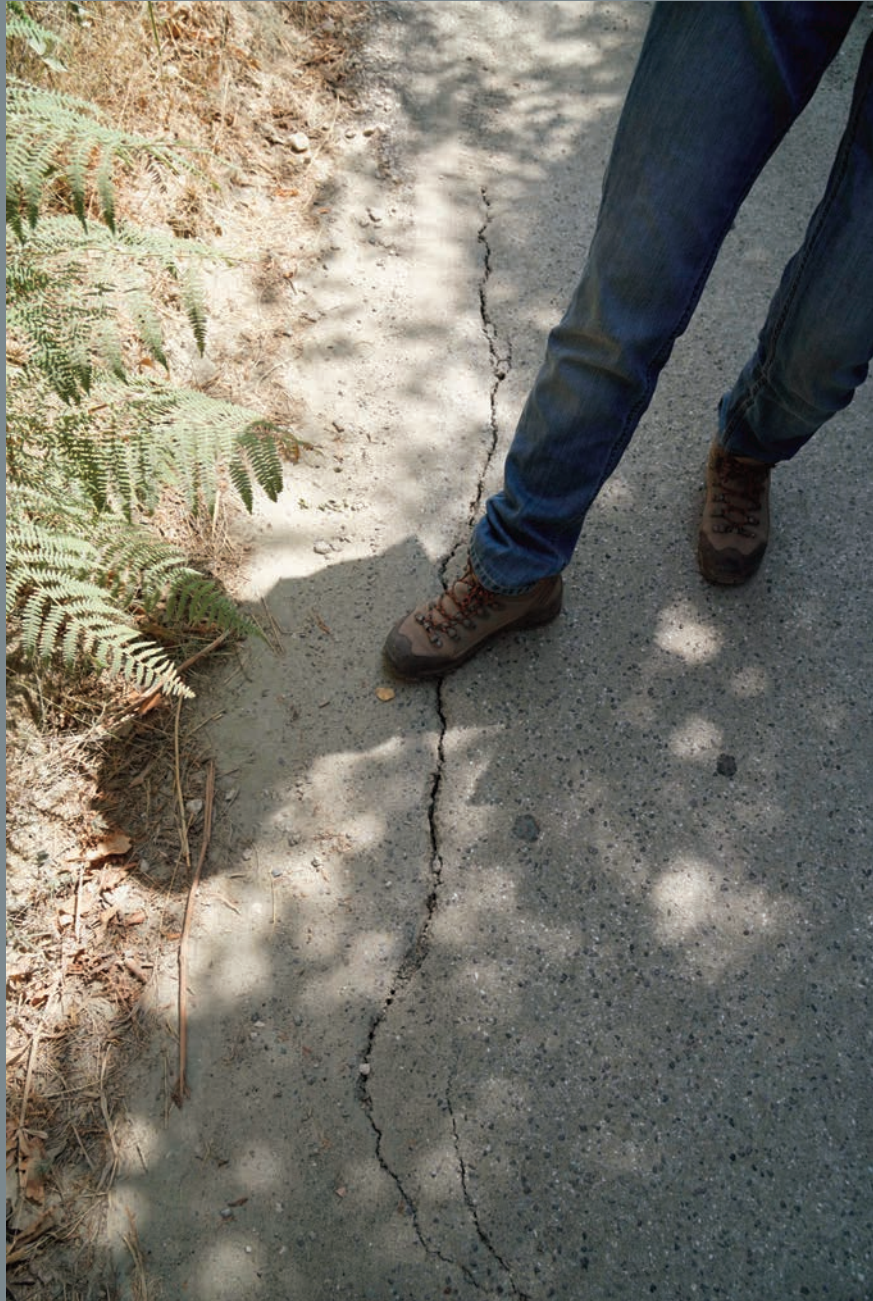
Photo 64

The rupture extends along Via Campomanno. An opening of 1 cm is appreciable.

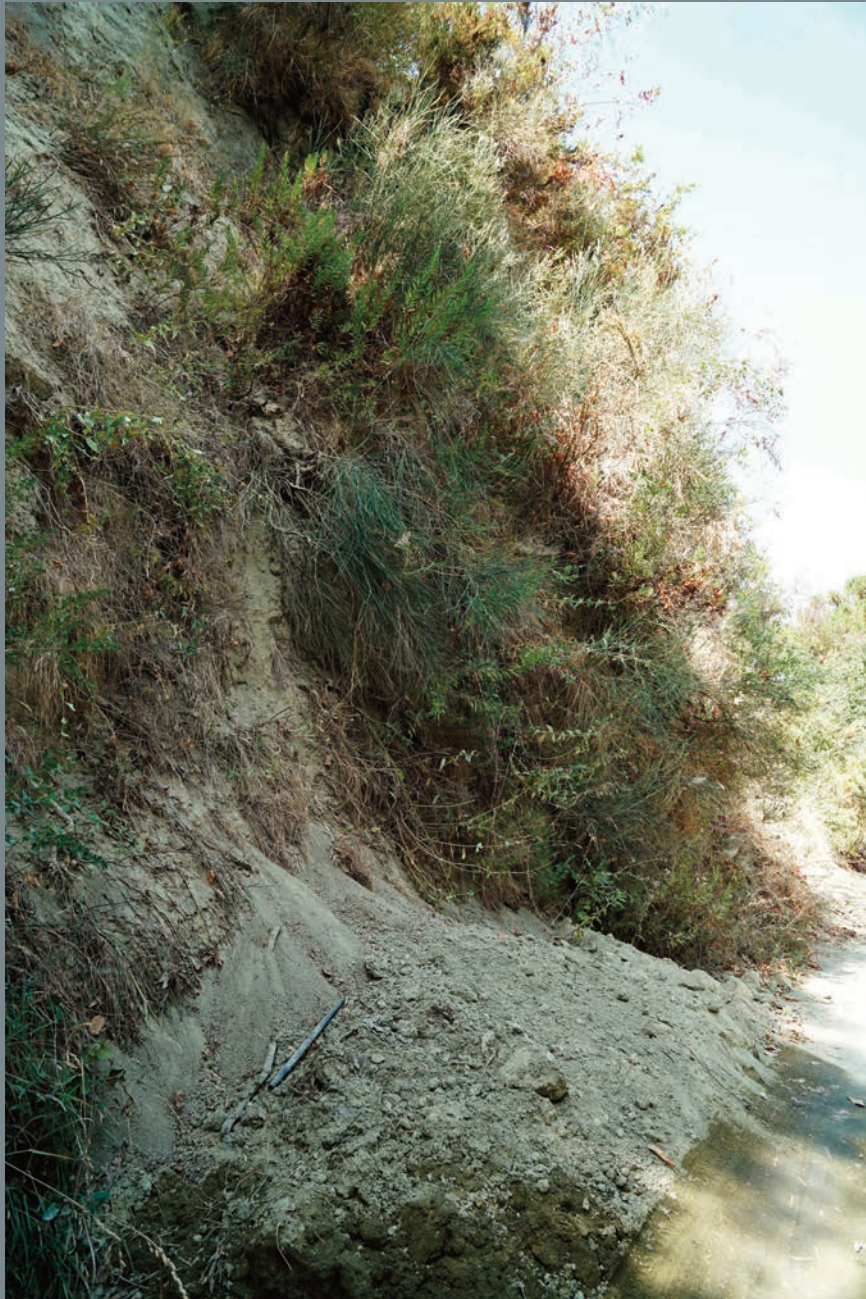
Photo 65

Small debris flow in volcanoclastic deposits along Via Campomanno.

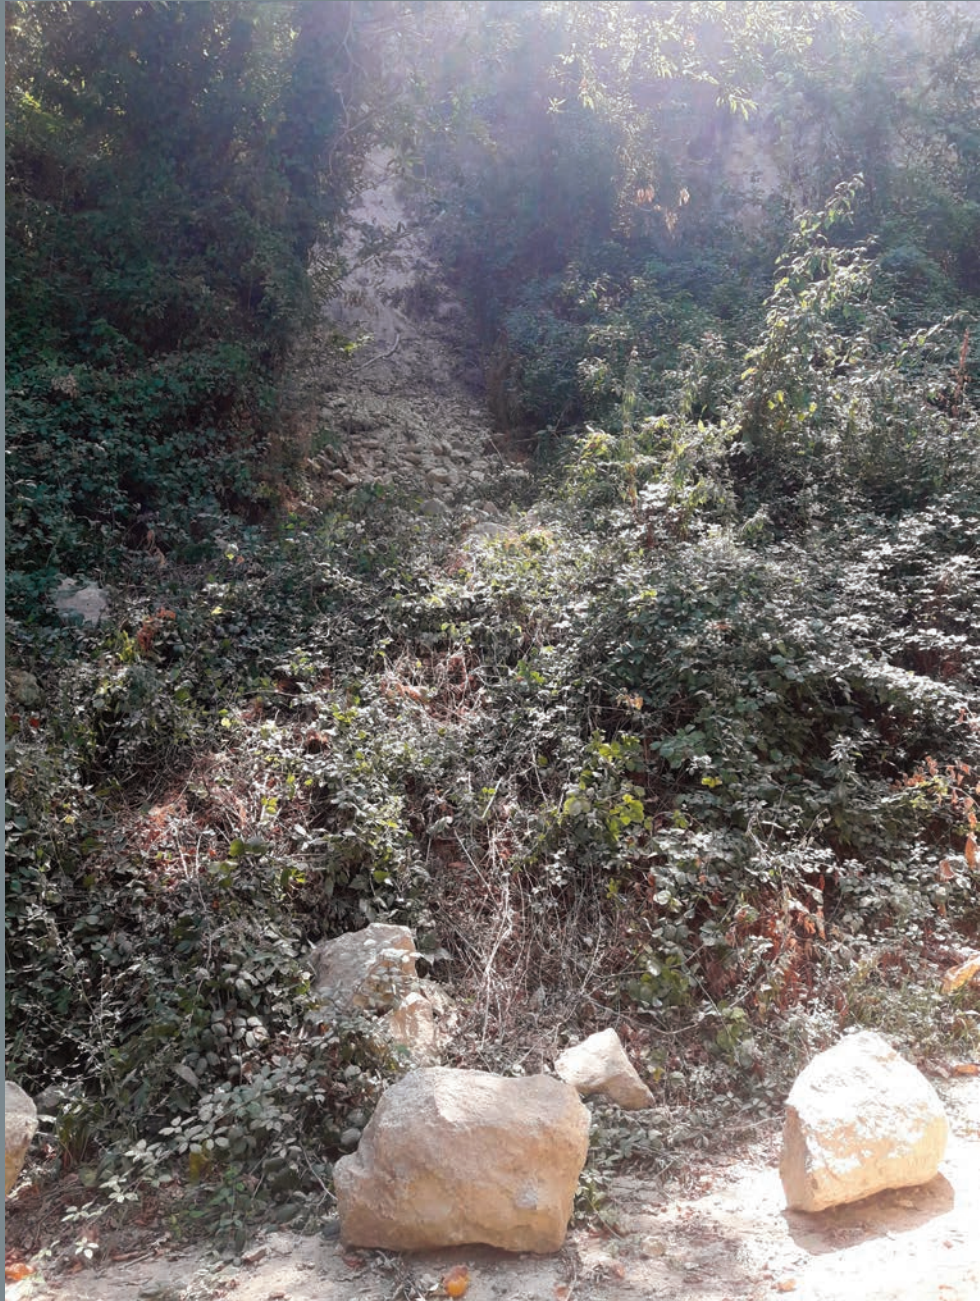
Photo 66

Coseismic rockfall in volcanoclastic deposits as secondary coseismic effect,
along Via Campomanno.

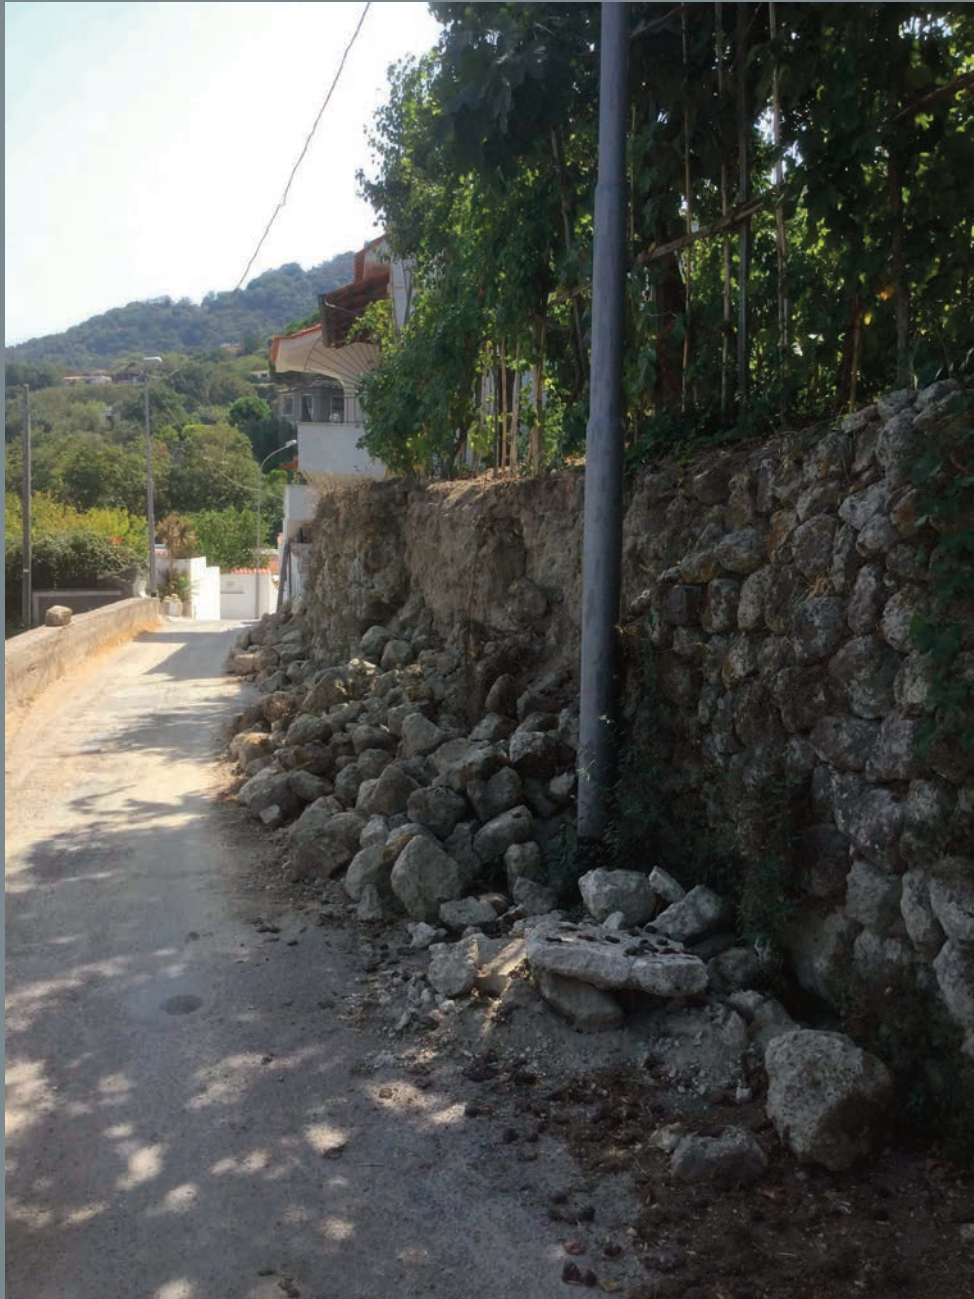
Photo 67

Collapse of drywalls as secondary coseismic effect, along Via Campomanno.

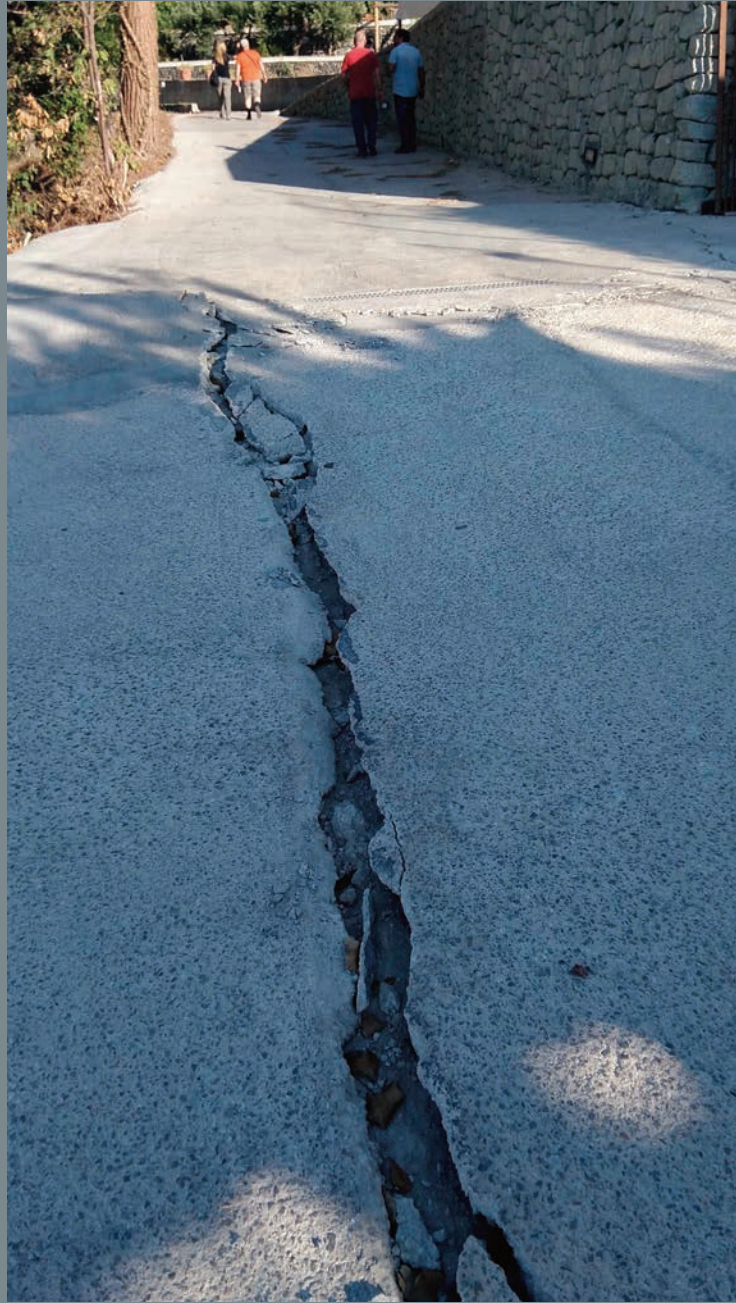
Photo 68

Long ruptures observed in the concrete floor of the entrance avenue of a villa in n. 29 Via Santa Barbara. The average direction of the ruptures is about N110E (in detail the segments vary from N80E to N120E) and the maximum observed opening is about 4 cm.

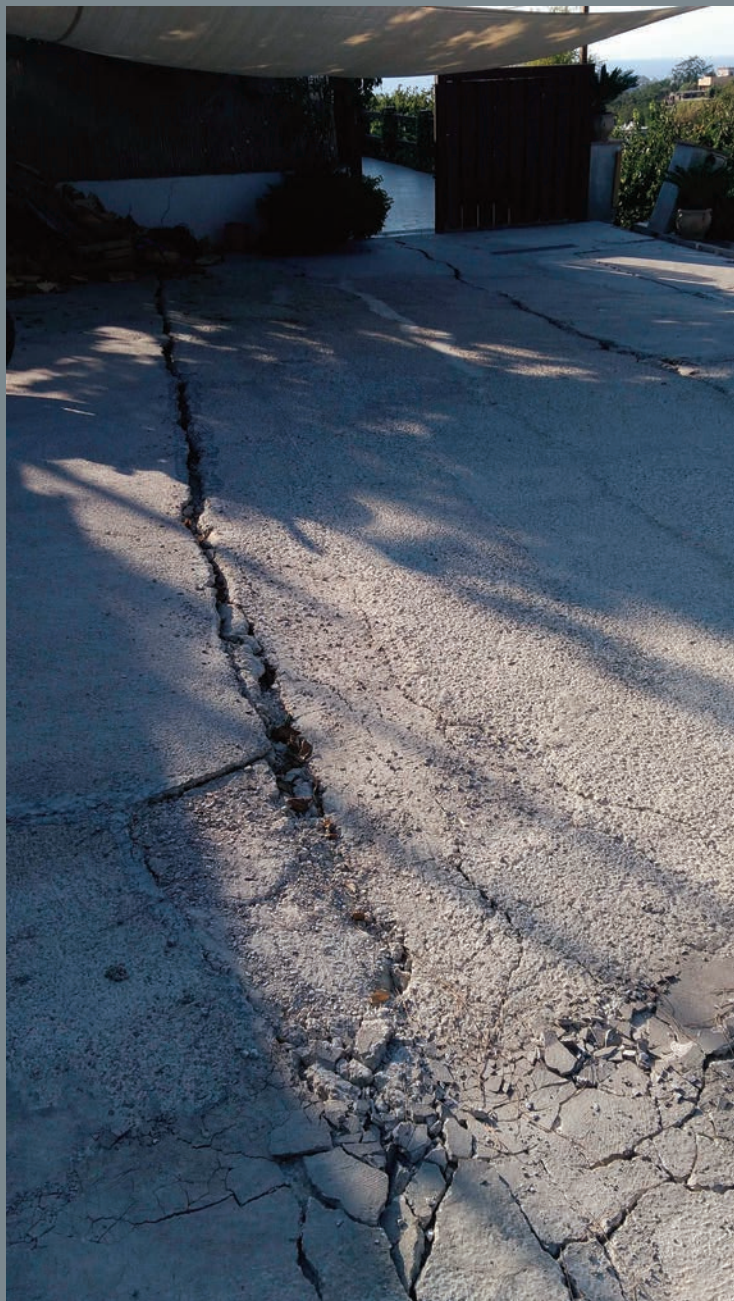
Photo 69

The ruptures shown in photo 68 extend along a cemented embankment, and on a lateral containment wall, in the same villa.

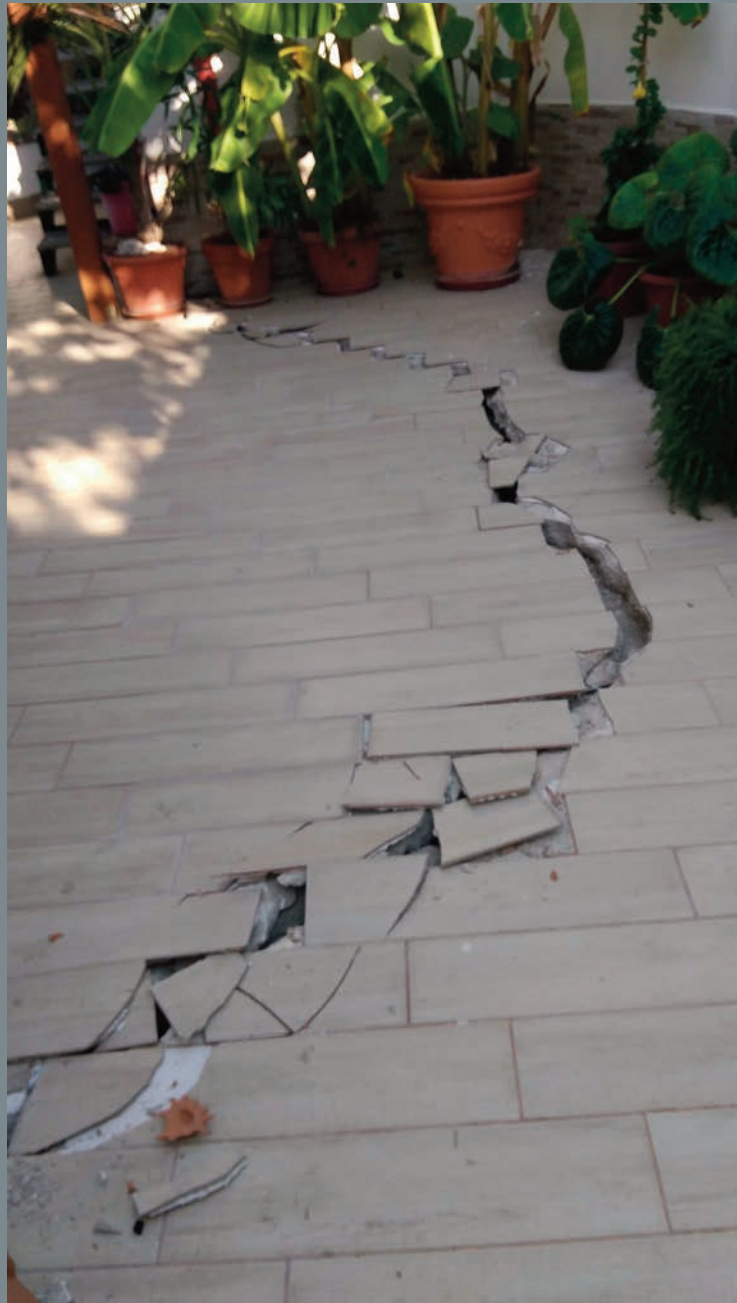
Photo 70

The ruptures of the previous photos extends to the terrace outside.

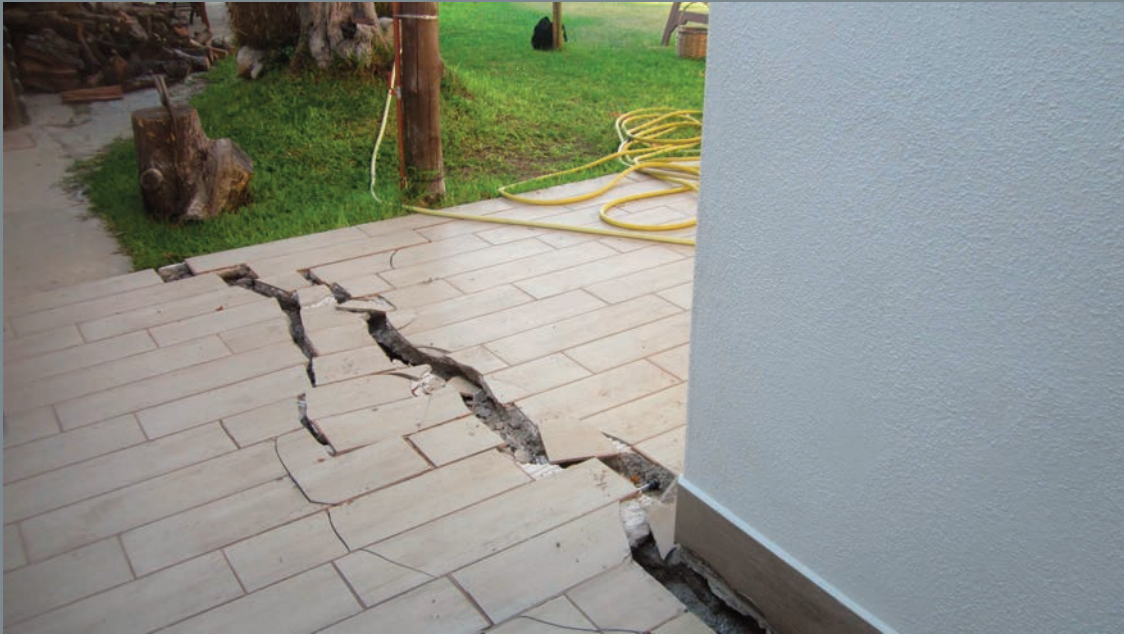
**Photo 71**

The rupture of the previous photos also extends to the back of the house and affects the skirting board and ground. The overall length of the fracture system in Photo 68, 69, 70, 71 is of the order of hundred of meters.
