A photographic collection of the coseismic geological effects induced by the 21 August 2017, M=4, Casamicciola earthquake (Ischia island, Italy)

Emergeo Working Group*

Accepted 19th July 2019 | *Accettato il 19 luglio 2019*

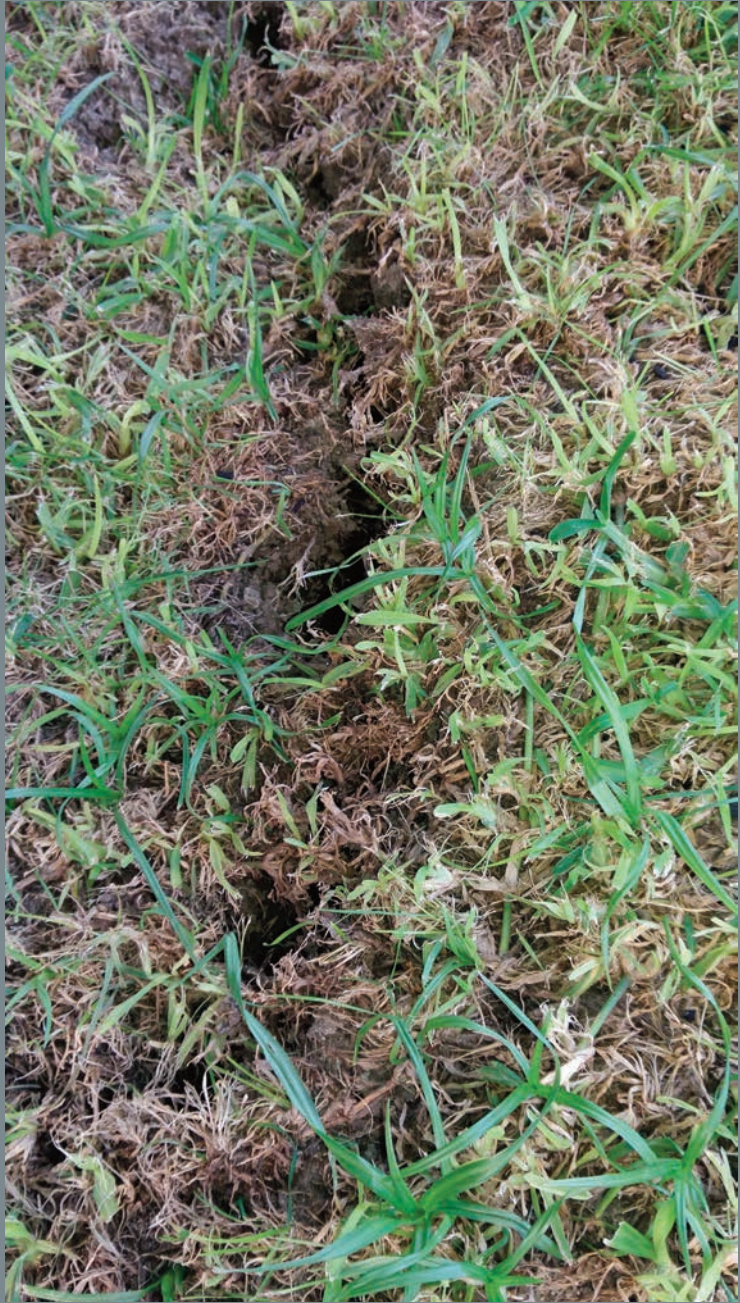
Photo 72

Rupture in ground a few meters long, open at some points, in the garden at the back of the same villa (previous photos) with mean direction of N100/110E and a lowering towards Northeast.
