In field data to correctly characterize the seismic response of buildings and bridges

Abstract

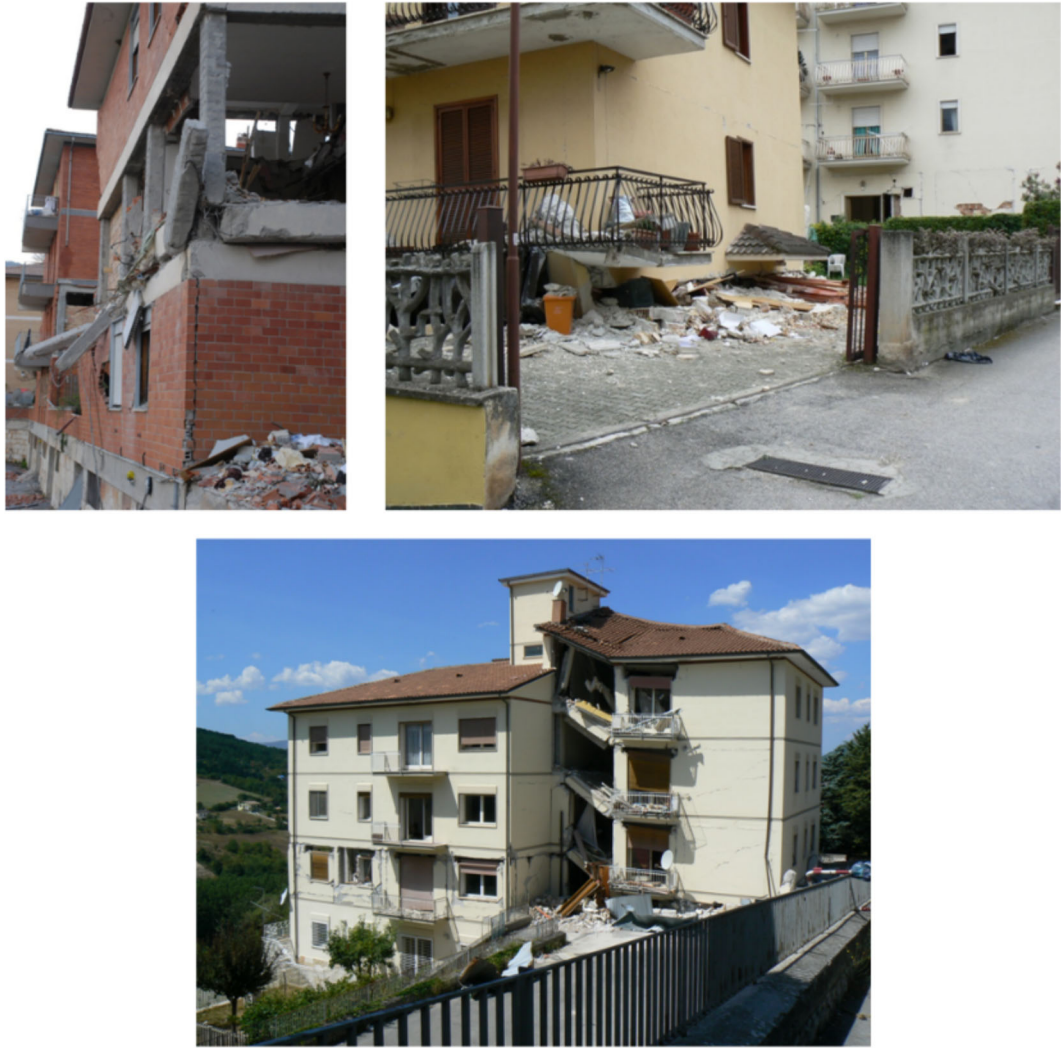
Figure 1: Soft story collapses observed after the 6 April 2009 L'Aquila earthquake

The soft storey mechanism has been observed in many cases after the 6 April earthquake in L'Aquila (Celebi *et al.*, 2010). In Figure 1, some significant images of (partially) collapsed buildings observable in L'Aquila are reported. It is possible to verify that the *soft storey mechanism* usually affected the first floor,

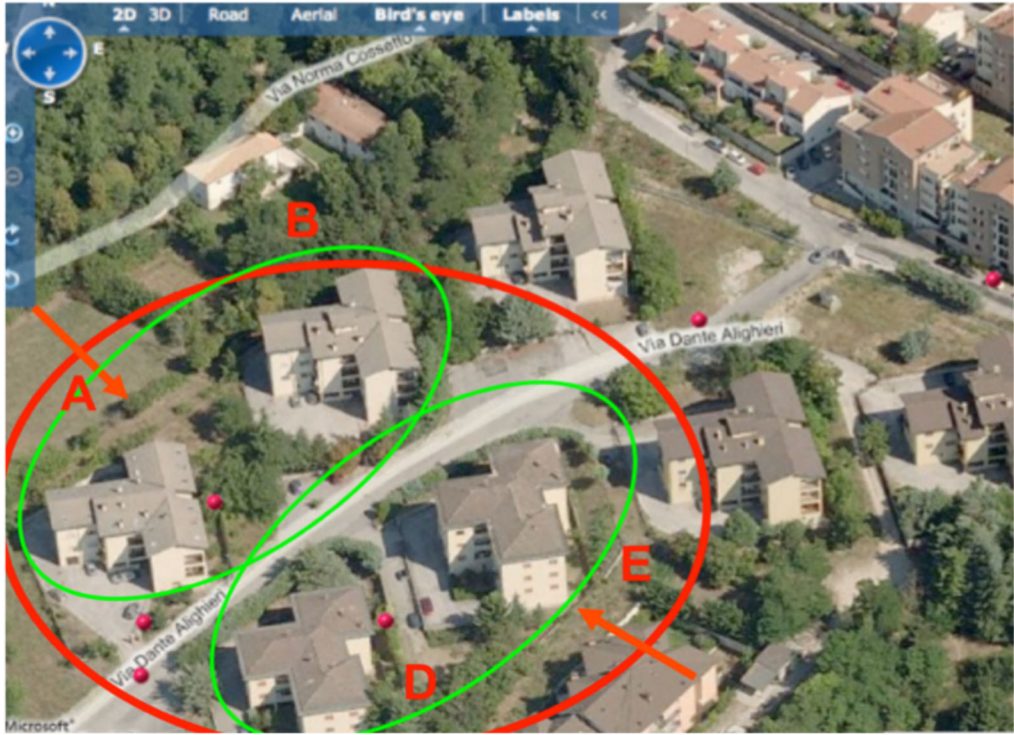
Figure 2: Aerial view of the area with the investigated buildings. Red arrows point to buildings collapsed (A and E) due to soft storey mechanism.

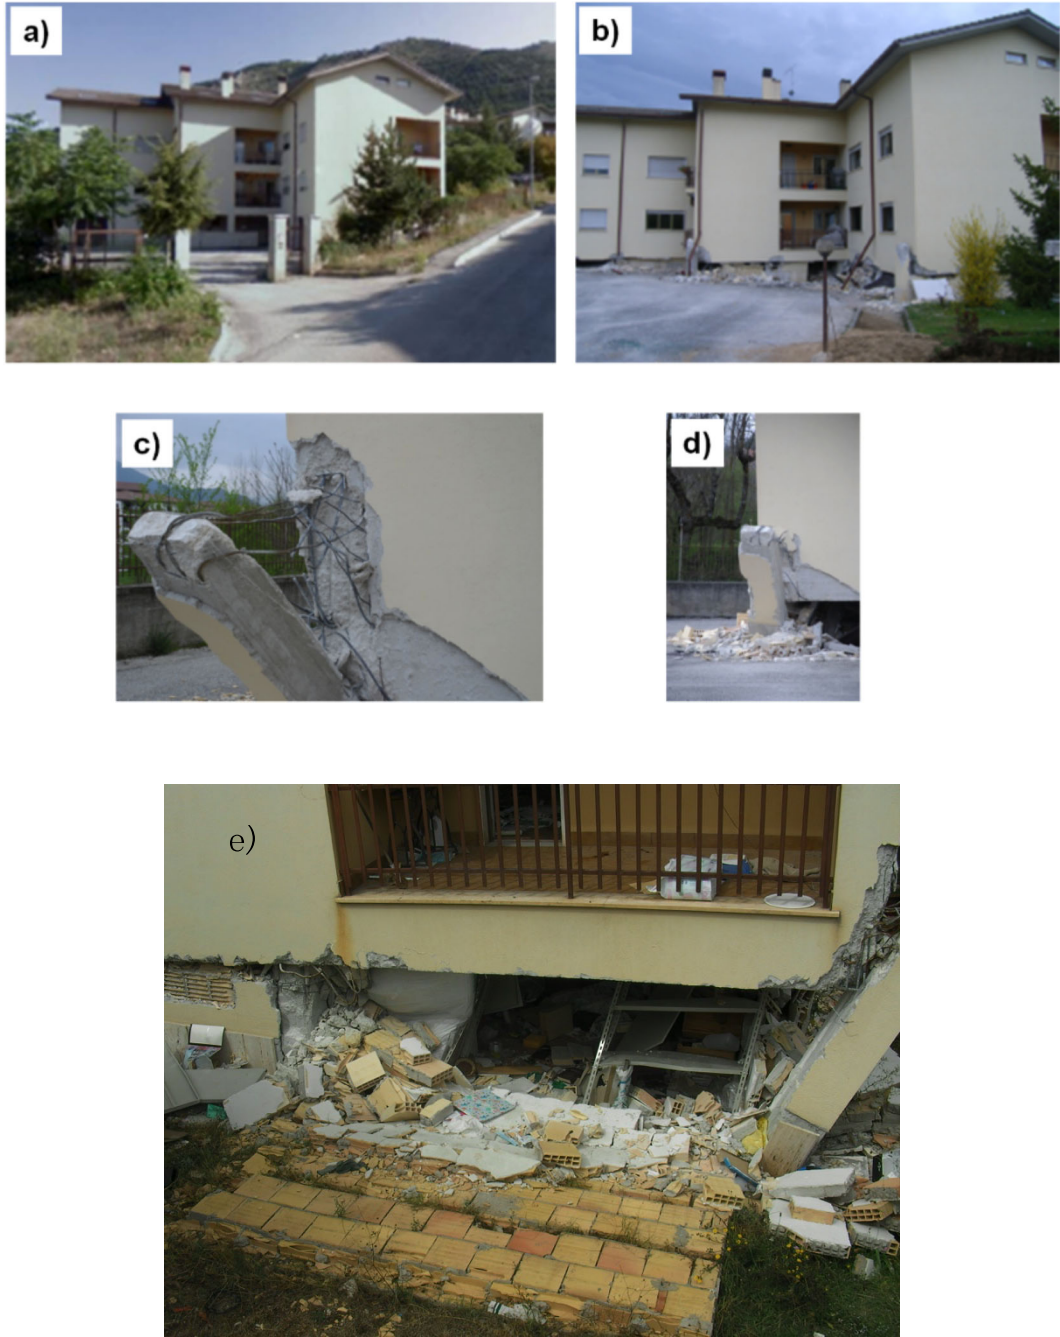
Figure 3: Building A before (a) and after (b, c, d, e) the seismic event

Figure 3 presents some view of building A (3 storey) before and after the seismic event. The view after the earthquake shows the collapse of the first storey.

During the response of the buildings to the 6 April 2009 earthquake a key role, was played by the infilled masonry walls. The two collapsed buildings were characterized by the expulsion of infill walls at the first level, with an overturning local mechanism. After such a sudden expulsion, most likely occurred during the first phases of the earthquake, the walls were not able to contribute any more both to the lateral stiffness of the buildings (stiffening effect) and to the dissipation of the energy injected by the seismic action. This interpretation is strengthened by the observation that one of the overturned infills was observed lying on the ground without showing diagonal cracks (Fig. 3e). Such a circumstance was

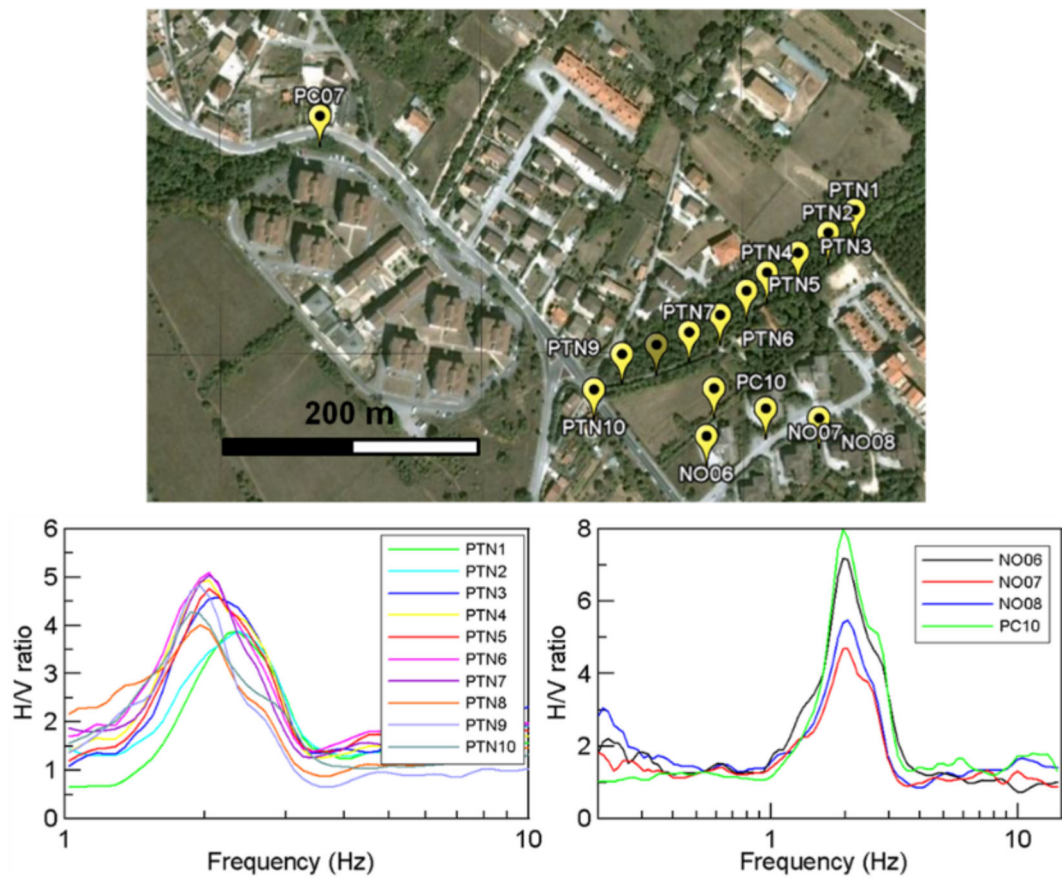
Figure 7: Location of seismic measuring points (top panel) along with HVNSR results (bottom panels). Building A is located between measuring points NO06 and PC10.

To check for the spatial stability of the amplification function in the area we performed a wide series of microtremor measurements in the sites shown in Figure 7. The microtremor data were collected during a short time window (40-60 minutes). Signals were cut into short duration (40 seconds) windows and processed through a dettrigger algorithm (SESAME, 2004) to remove the ones affected by strong transient disturbs. Fourier spectra were evaluated and smoothed using the method proposed by Konno-Omachi (2004). Finally the average spectral ratio, along with the standard deviation, was evaluated for the geometrical mean of horizontal components. The results of the analysis are shown in Figure 7 along with the positions of the measuring points. It is clear that an H/V peak centered at about 2-3 Hz characterizes all the investigated area. The frequency of the peak tends to change moving along a profile oriented in NE-SW direction. All the area surrounding the buildings shows a quite stable H/V values both in frequency and

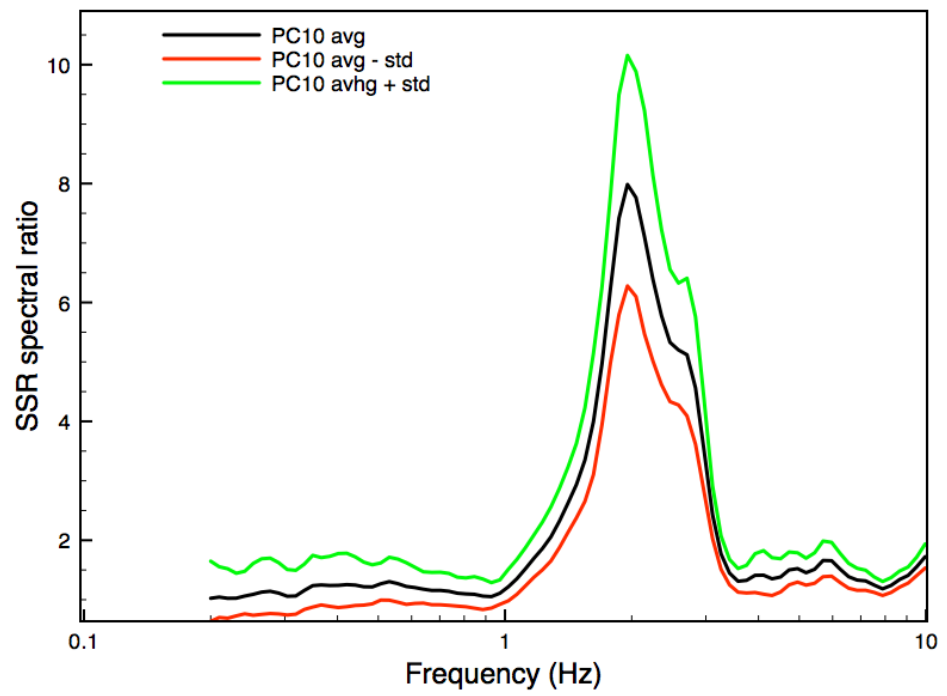
Figure 9: SSR spectral ratio for PC10 station. Middle line (black curve) represents the mean value; standard deviation is also shown (upper and bottom lines).

Starting from the selected earthquakes we cut a short time window (10 seconds) starting about 1 second before the S wave arrival. The Fourier spectra were evaluated on the selected time windows along with the geometrical mean of the spectral ratio for the horizontal components. Finally the average on all the evaluated spectral ratios allowed calculating the mean value of the amplification function along with its standard deviation. The results of SSR analysis for PC10 site are shown in Figure 9. It is clear an evident amplification peak centered between 2 and 3 Hz with amplitude values of about 8. The amplification factor found at the site is quite important and indicates the presence of strong local site effects for the area.

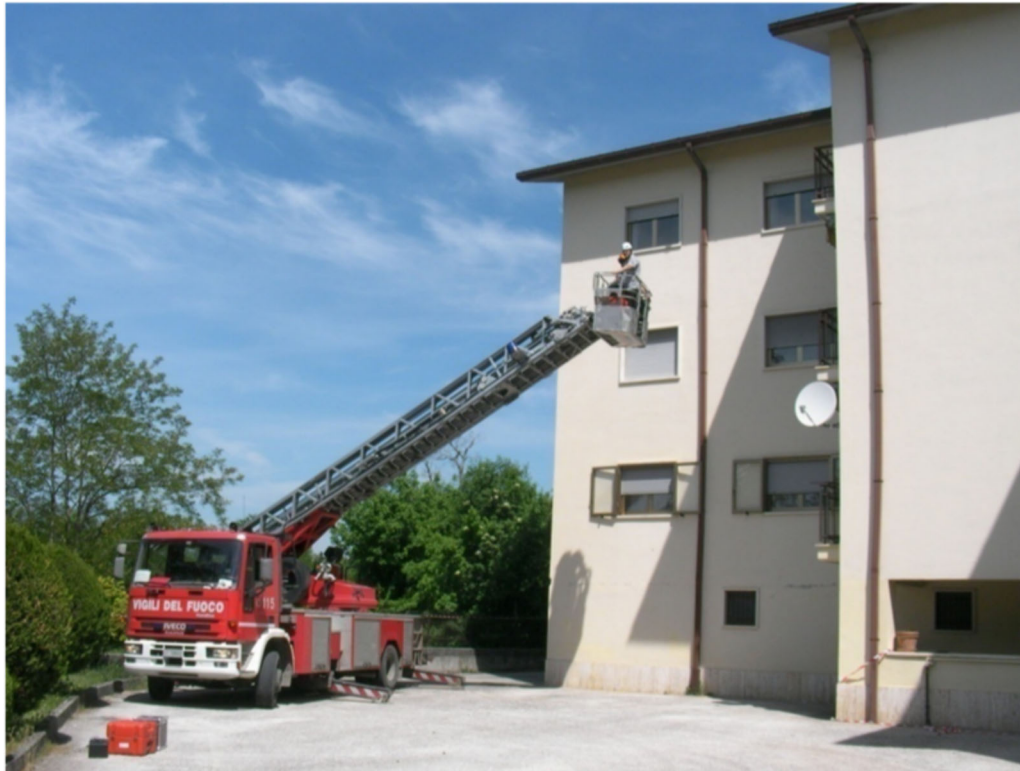
Figure 11: a phase of the installation of the instruments from outside of the buildings using a Fire Brigades truck

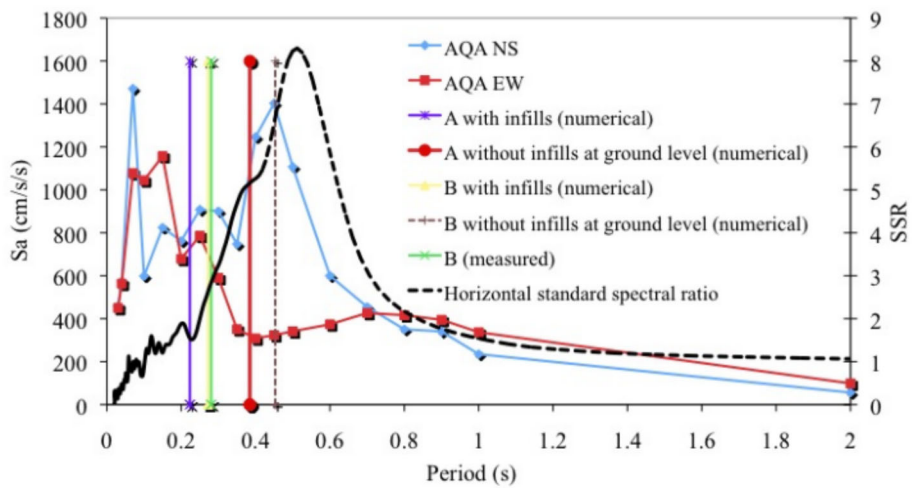
Figure 15: Acceleration response spectra relevant for the analysis and fundamental periods of buildings A and B with different structural configurations of the infill walls.

The same analysis can be conducted on the second couple of buildings A (3 stories) and B (4 stories). In this case the results are reported in Figure 15. It is possible to observe how the measured frequency on the survived building (B 4-stories) corresponds to the numerical frequency with intact infills at the first level

and is located in a frequency zone of the response spectrum characterized by relatively low acceleration amplitudes. On the contrary, on the building A (3-stories) the absence of infills at ground level was responsible of a frequency shift toward the range characterized by strong earthquake shaking. It is worth noticing that the survived building B, in absence of infills at the ground floor, probably could have experienced a collapse similar to that of building A. This observation leads to the consideration of the importance of the workmanship in the execution of apparently not so important details, like the connection of the infills to the r.c. frame, and especially, to the upper beam.

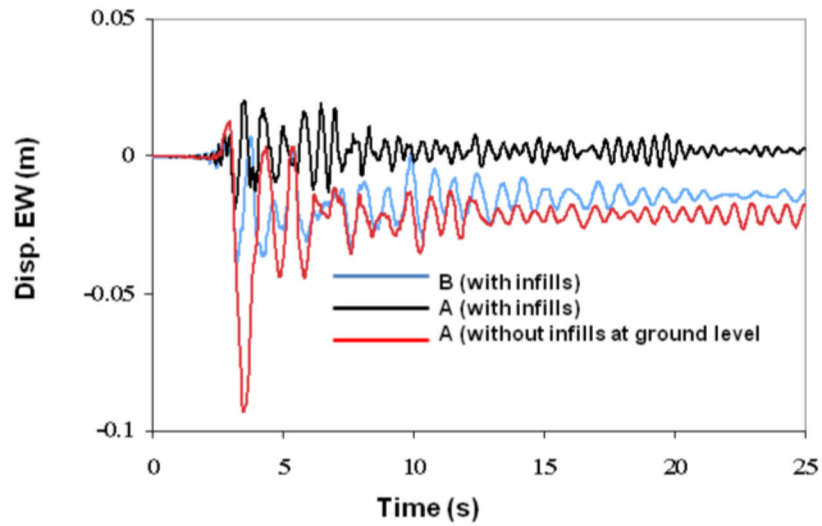
Figure 18: Displacement time histories obtained with the nonlinear model on the top of buildings A and B with different configurations of the infill walls

Figure 18 shows a comparison of time histories (as forecasted by the FE code) for both building A (3-stories, working and not working infill walls at the first level) and building B (4-stories). Again the strong displacement demand, characterizing the time history of the 3-storey building when the *soft storey mechanism* is triggered, is quite evident.

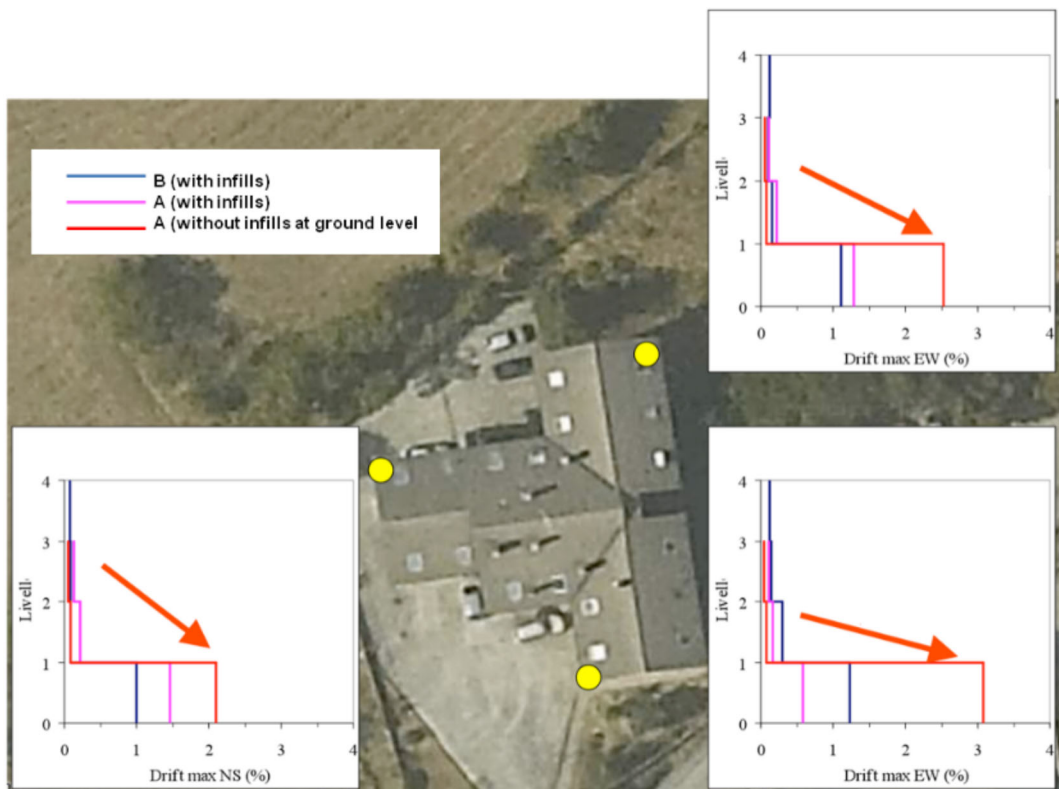
Figure 19: Maximum interstorey drifts obtained with the nonlinear analysis of buildings A and B with different configurations of the infill walls.

As known, a very meaningful parameter able to synthetically quantify the damage occurred during an earthquake is the inter-storey drift. In Figure 19 the drift demand of the three considered cases (building B with working **infilled masonry walls** and building A in the two different condition of working and **deactivated infilled masonry walls**) is reported: while in the two cases with working **infilled masonry walls**, the drift demand is bounded by 1.5% (acceptable value corresponding to a medium level of damage), for building A with *deactivated* infills the drift demand jumps to 3%. This value certainly exceeds the drift

capacity and corresponds to a collapse condition.

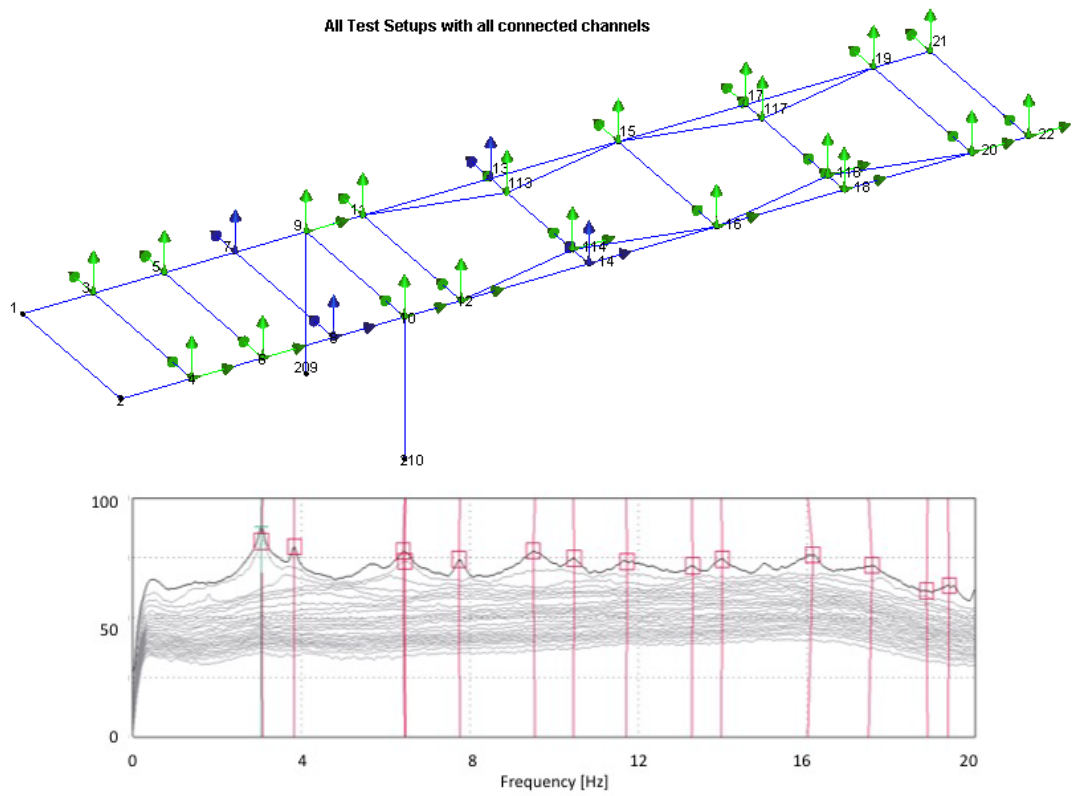
Figure 23: The 2014 instrumentation setup (up) and the identified modes (down).

For the sake of completeness additional dynamical tests were accomplished in 2013 and 2014, using a more sophisticated instrumental setup (see Fig. 23 – year 2014).
