Application of an integrated monitoring system for rock failures in the Coroglio tuff cliff (Naples, Italy)

ABSTRACT: In high risk, coastal, urban areas, cliff stability monitoring is an essential task for human activities. This paper presents the implementation of an integrated monitoring system at the Coroglio tuff cliff, located in the highly urbanized coastal area of Naples (Italy) on the border of the active volcanic caldera of Campi Flegrei. The system consists of standard geotechnical monitoring instruments (crackmeters and clinometers) coupled with a modern deformation monitoring technique based on Brillouin Optical Time-Domain Analysis (BOTDA) optical fiber network, integrated by a velocimetry sensor and a weather station. Remote sensing equipment like UAV digital photogrammetry (UAV-DP) and terrestrial laser scanning (TLS) have been also used for obtaining detailed multitemporal DTM of the cliff, as well as geostructural analysis and classification of the slope, supported by structural fieldwork. In the first phase of the study, we integrated the results of long-range TLS surveys with structural field mapping. The accurate and rapid detection of structural discontinuitie

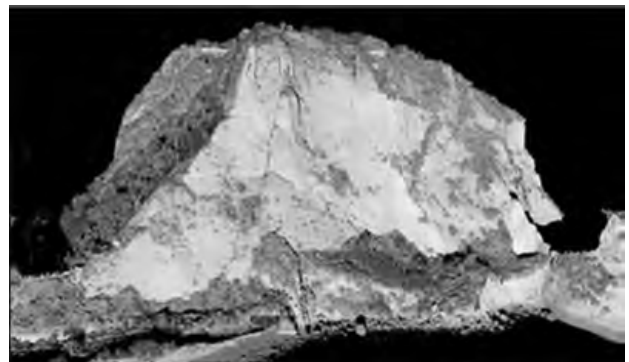
Figure 4. Point cloud derived by TLS survey of Coroglio cliff.

During the first phase of the study, we integrated the results of long-range TLS surveys (Fig. 4) with structural field mapping. The accurate detection of structural discontinuities of rock plays an important role for kinematic analysis of unstable blocks along the cliff surface and the understanding of the failure mechanism, and for the failure susceptibility definition. The geostructural survey allowed to obtain several results.
