Diagnostic Process of an Ancient Colonnade Using 3D High-Resolution Models with Non-Invasive Multi Techniques

Giuseppe Casula, Silvana Fais, Francesco Cuccuru, Maria Giovanna Bianchi and Paola Ligas

Abstract: Here, an avant-garde study of three ancient Doric columns of the precious, ancient Romanesque church of Saints Lorenzo and Pancrazio in the historical town center of Cagliari (Italy) is presented based on the integrated application of different non-destructive testing methods. The limitations of each methodology are overcome by the synergistic application of these methods, affording an accurate, complete 3D image of the studied elements. Our procedure begins with a macroscopic in situ analysis to provide a preliminary diagnosis of the conditions of the building materials. The next step is laboratory tests, in which the porosity and other textural characteristics of the carbonate building materials are studied by optical and scanning electron microscopy. After this, a survey with a terrestrial laser scanner and close-range photogrammetry is planned and executed to produce accurate high-resolution 3D digital models of the entire church and the ancient columns inside. This was

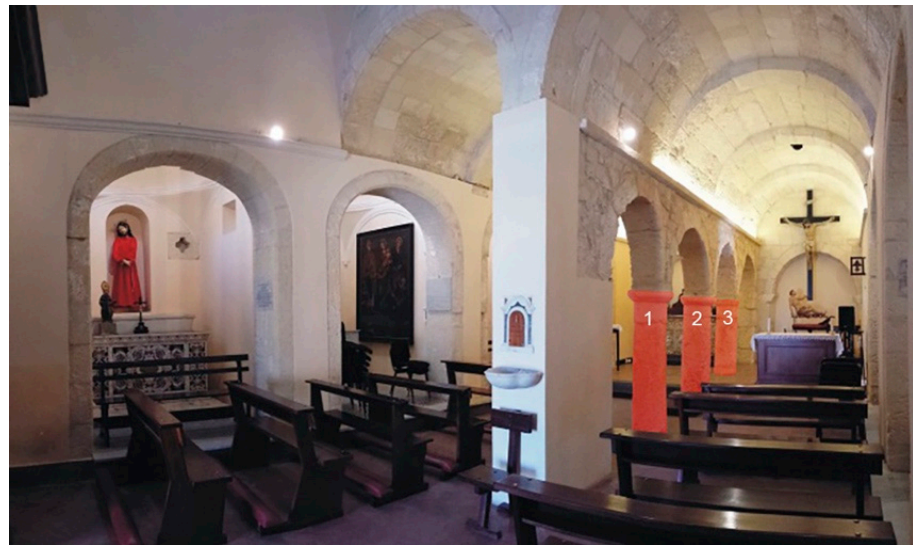
Figure 2. The three studied columns inside the church are highlighted in red and numbered as column 1, column 2, and column 3.

This work describes the integrated application of the diagnostic methods presented above for the study of the ancient Romanesque church of Saints Lorenzo and Pancrazio (Figure 1), which dates from the second half of the 13th century and is located in the historical part of Cagliari (Italy). The analysis focused especially on the three carbonate supporting columns (Figure 2) inside the church.

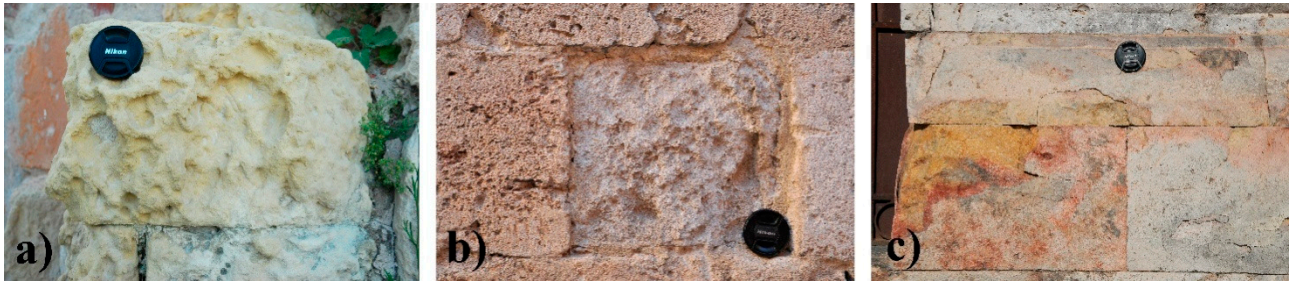
Figure 3. Degradation forms of the Calcari di Cagliari used as building materials: (a) Alveolization of an ashlar of Pietra Cantone; (b) loss of material due to pulverization and detachment in an ashlar of Tramezzario; (c) fractures, oxidation, and detachments in a wall built with Pietra Forte ashlars.

to its high content of carbonate mud. The degree of poor cementation of granules causes significant degradation forms, mostly when the rock is water-saturated. This condition, combined with the presence of salts, causes alveolization and pulverization on both the outcrops and the monument built with this lithotype (Figure 3a).

The Tramezzario is usually a hard, compact stone, although in several cases, it can be characterized by the combination of weak cementation and high secondary porosity values that contribute to the development of severe degradation forms such as detachment and pulverization phenomena (Figure 3b).

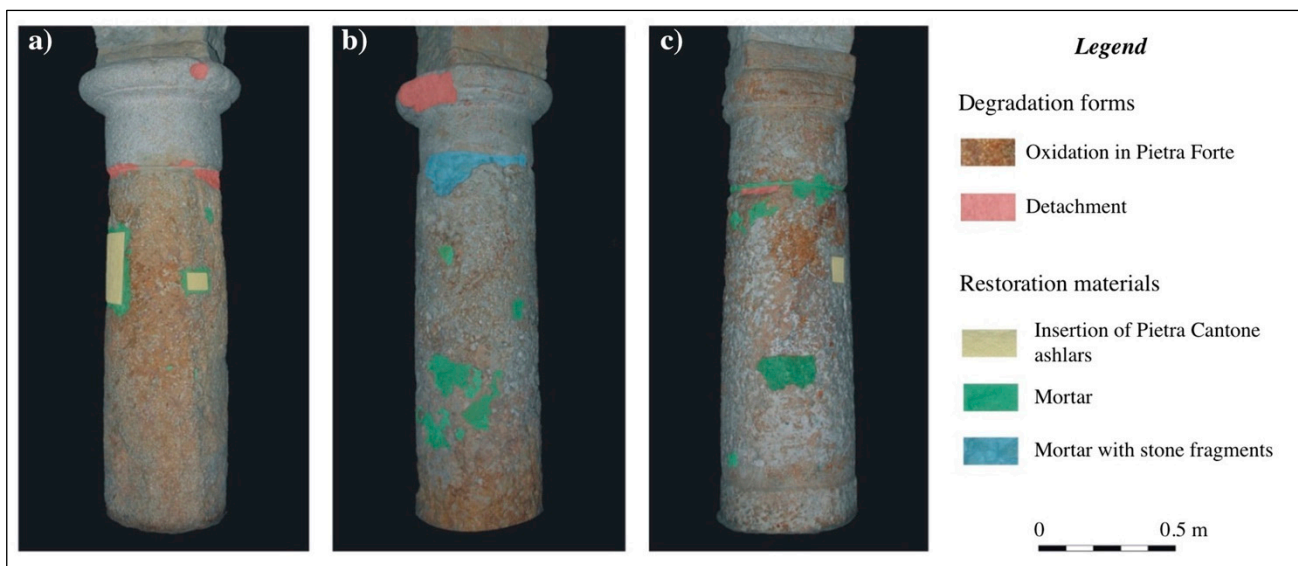
At the preliminary macroscopic observation (Figure 4a–c) the columns were characterized by shallow alteration, such as oxidation, causing the lithotype to be red in several sectors. In different parts of the capitals and in the joint between the stem and the capital, a few material detachments can be seen due to physical causes. Previous restoration works are clearly visible in all three columns. The most common form of restoration is mortar applications, sometimes combined with stone fragments of Pietra Cantone and Tramezzario as filling materials (Figure 4b). In columns 1 and 3, restoration works characterized by prismatic additions of Pietra Cantone are clearly visible (Figure 4a–c). Additions of such a lithotype with very different petrophysical and textural properties to the column building material (Pietra Forte) may not be appropriate and could even be harmful, especially if they develop deep into the inner parts of the columns.

Figure 4. Macroscopic characteristics of the studied columns: (a) Column 1; (b) Column 2; (c) Column 3.

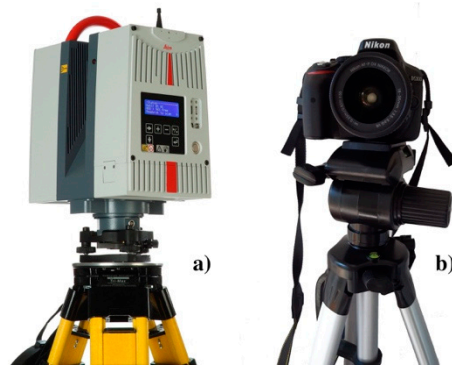
In this work, we performed a TLS survey by installing a Leica HDS-6200 (Figure 5a) phase-shift scanner on about 60 survey stations distributed along the plan and inside the church of Saints Lorenzo and Pancrazio, covering the entire perimeter. The resulting filtered, registered, aggregated, unstructured point cloud consisted of about 1.3 Tb of points.

Figure 5. (a) The Leica HDS-6200 TLS; (b) The Nikon D5300 digital reflex camera.

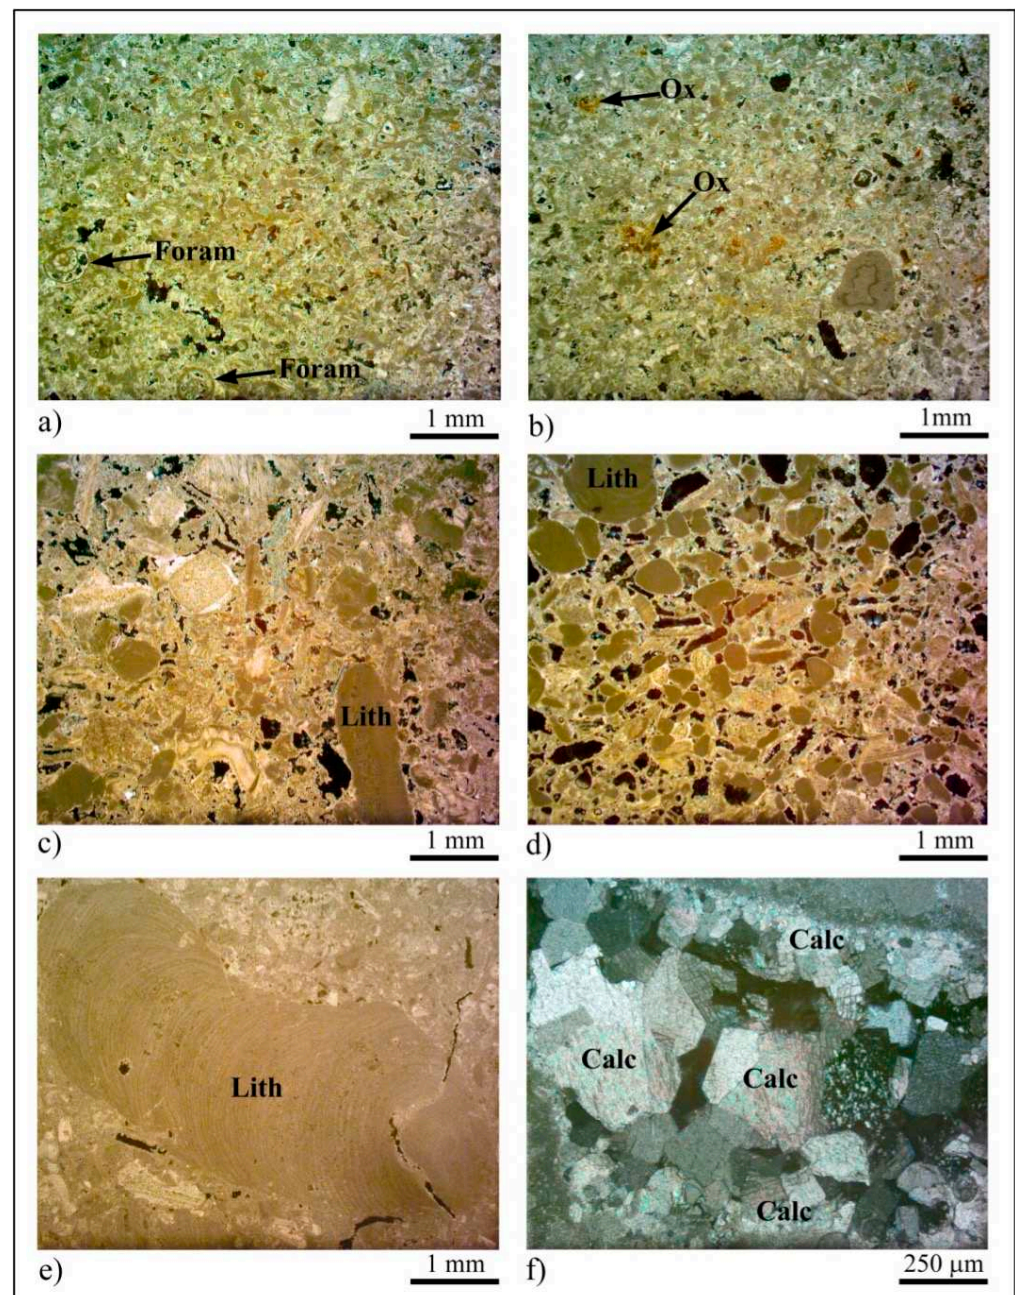
Figure 7. Textural characteristics of Calcari di Cagliari Auct. (a) Foraminifera (Foram) in mud-supported Pietra Cantone, OM plane polarized light; (b) iron oxide (Ox) specks in Pietra Cantone, OM plane polarized light; (c) bioclasts cemented by sparry calcite in Tramezzario. Lith (Lithothamnium algae), OM plane polarized light; (d) sector rich in Lithothamnium (Lith) algae fragments in Tramezzario, OM plane polarized light; (e) Lithothamnium (Lith) algae in Pietra Forte, OM plane polarized light; (f) Sparry calcite (Calc) crystals in the Pietra Forte cement, OM cross polarized light.

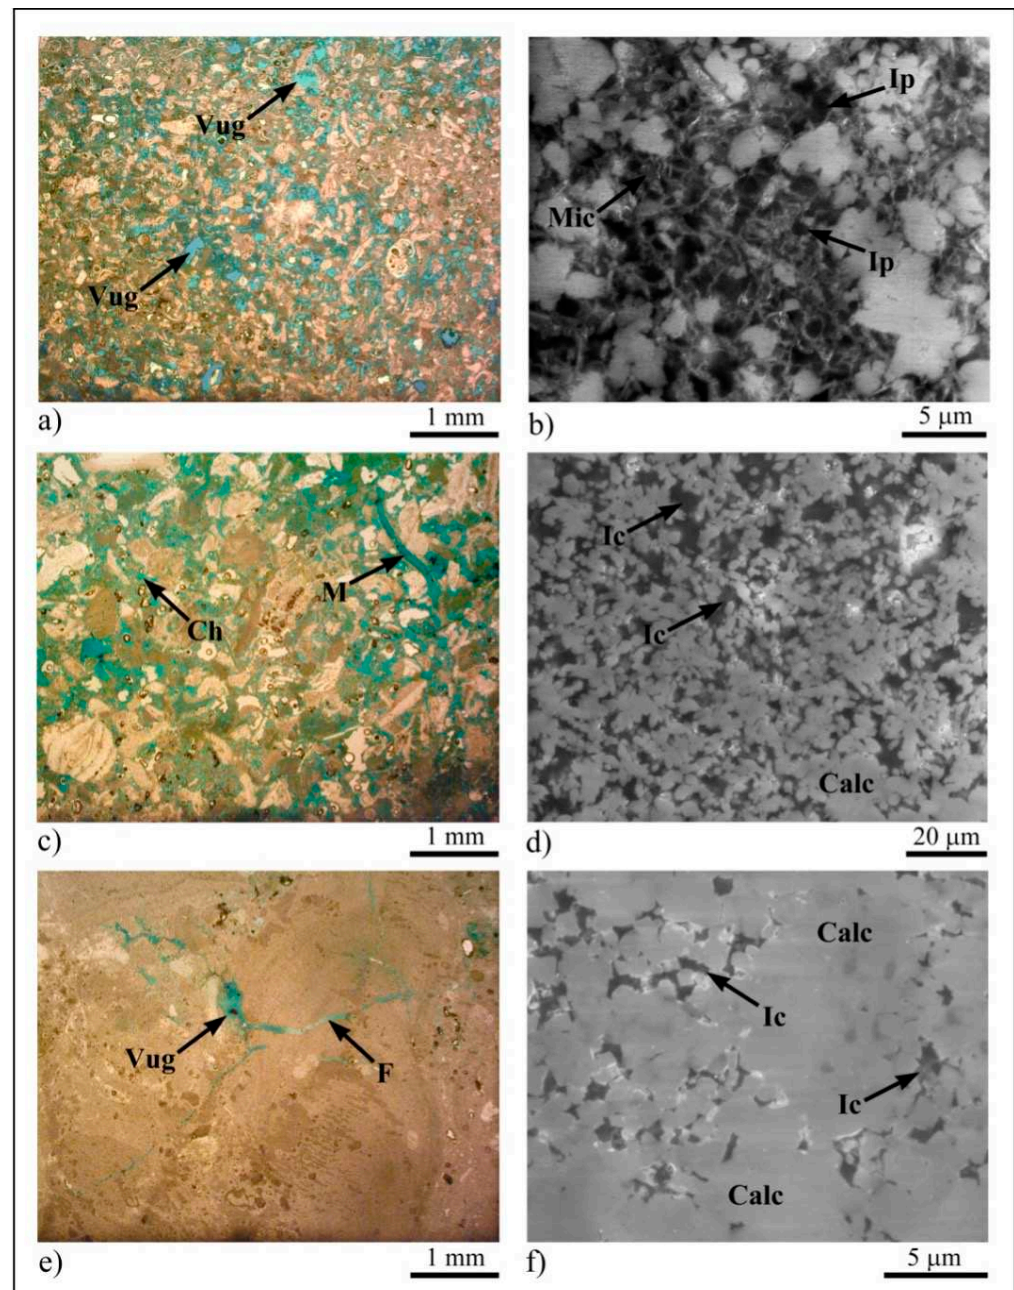
Figure 8. Porosity of Calcari di Cagliari Auct. (a) Vug porosity (Vug) in Pietra Cantone, OM plane polarized light; (b) interparticle porosity (Ip) in micrite mud (Mic) of Pietra Cantone, SEM backscattered-electron (BSE) image, EHT = 20 kV, WD = 10 mm; (c) moldic (M) and channel (Ch) porosities in Tramezzario, OM plane polarized light; (d) intercrystal (Ic) porosity in Tramezzario calcite (Calc) cement, SEM BSE image, EHT = 20 kV, WD = 10 mm; (e) Vug and fracture (F) porosities in Pietra Forte, OM plane polarized light; (f) intercrystal (Ic) porosity in Pietra Forte sparry calcite (Calc) cement, SEM BSE image, EHT = 20 kV, WD = 10 mm.

In Tramezzario, the porosity is 10% on average, but it can reach 20%, depending on the dissolution degree of the rock. The mesoporosity is of the secondary type [65] and is mainly of the channel, moldic (Figure 8c), intraparticle, and fracture types. These pores, except for the fractures, occur due to dissolution processes and appear to be well connected. In the SEM, the Tramezzario appeared to be made from single subhedral–anhedral calcite microcrystals (sizes 2–3 μm) or characterized by polyhedral aggregates of the same mineral. Intercrystal pores [65] with sizes between 4 μm and 5 μm (Figure 8d) represent the main microporosity of the Tramezzario. These pores, located within the sparry calcite cement,

are generally interconnected (Figure 8d). The values of effective porosity measured by MIP on five representative samples of Tramezzario were generally high. They were within the range of 13.40–40.85% (Table 1) with a mean value of $27.02 \pm 9.02\%$.

In Pietra Forte, the porosity is about 1–4% and is mainly of the secondary type [65], including intraparticle, vug and fracture pores (Figure 8e). However, pores of the primary type, such as growth frameworks due to the growth of Lithothamnium algae, are present in a few cases. Pietra Forte is exclusively made up of calcite, characterized by single subhedral microcrystals (sizes 2–3 μm) or polyhedral aggregates of calcite. In the SEM analysis,

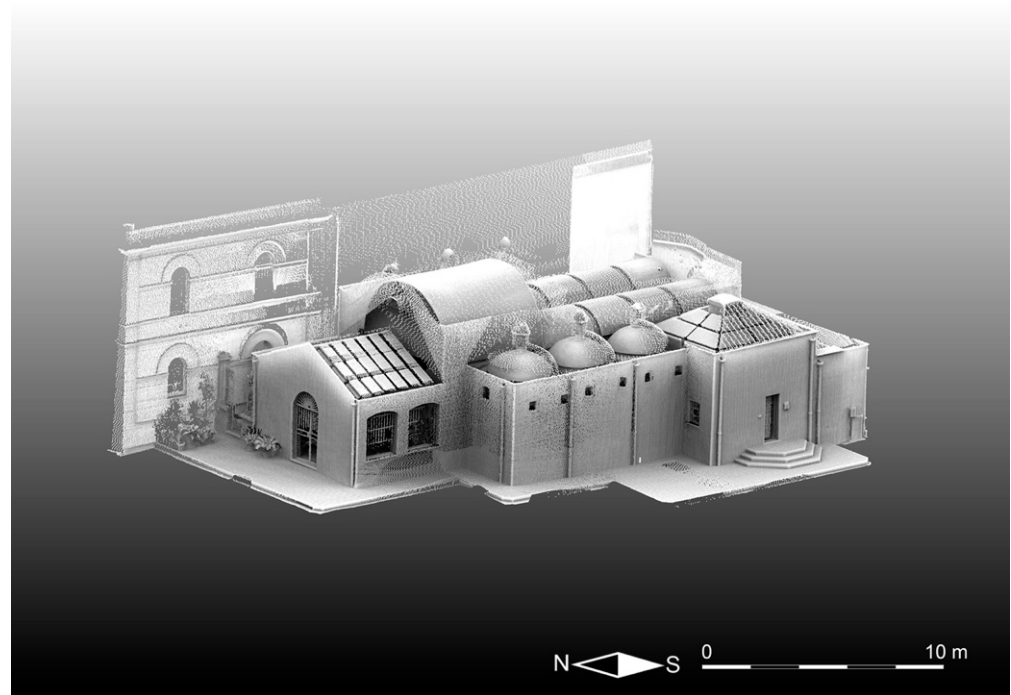
Notably, the first results obtained with the TLS methodology were the high-resolution 3D models (i.e., aggregated, unstructured point clouds) texturized with an intensity parameter that can be considered practically proportional to the reflecting power of the targeted surface materials and comparable with the velocity patterns of the ultrasonic tomography. The first aggregated, filtered, and registered cloud represents the entire Saints Lorenzo and Pancrazio church building, containing approximately 1.3 billion points (Figure 9). Subsequently, using TLS data, we formed 3D models of the three studied columns, each one containing approximately tens of millions of points, as presented in Figure 10, and immediately comparable with the corresponding models obtained with the application of CRP.

Figure 9. Unified, filtered, registered, unstructured point cloud texturized with the intensity that represents the high-resolution 3D model of the church of Saints Lorenzo and Pancrazio computed after TLS data processing.

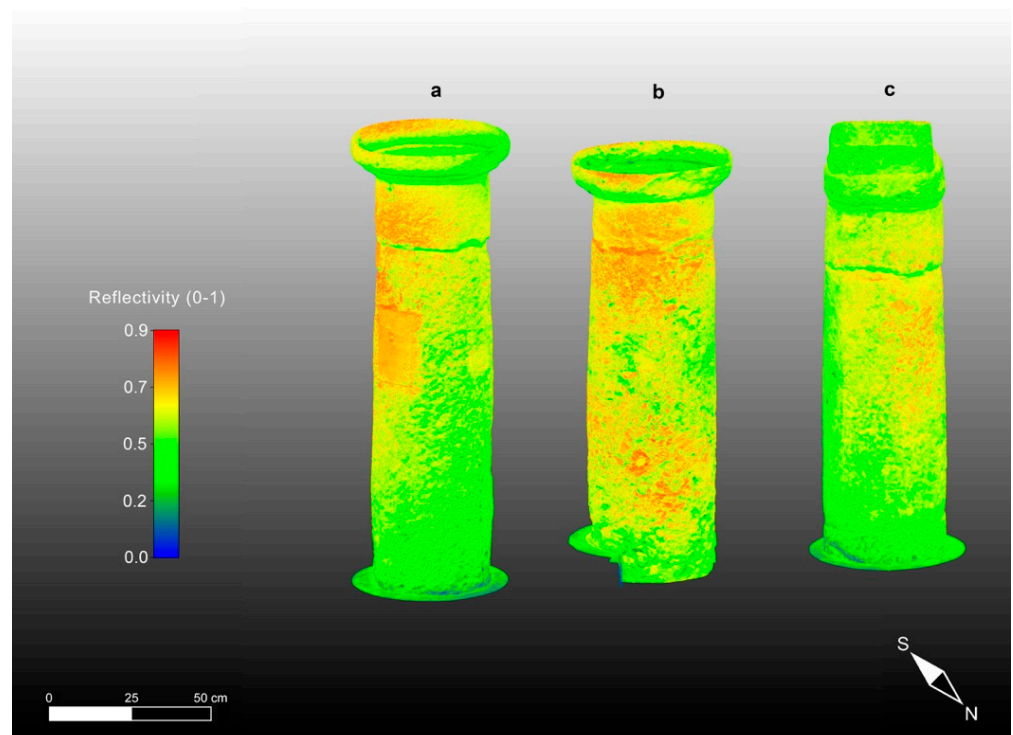
Figure 10. High-resolution 3D models of the studied columns from the Saints Lorenzo and Pancrazio church texturized with the intensity obtained after TLS data processing: (a) Column 1; (b) Column 2; (c) Column 3.

Regarding the CRP methodology, we computed similar high-resolution 3D models texturized with the natural colors of the building materials that make up the studied columns and subsequently calibrated adjusting scales and coordinates for direct comparison with the corresponding TLS models; the latter models are presented in Figure 11.

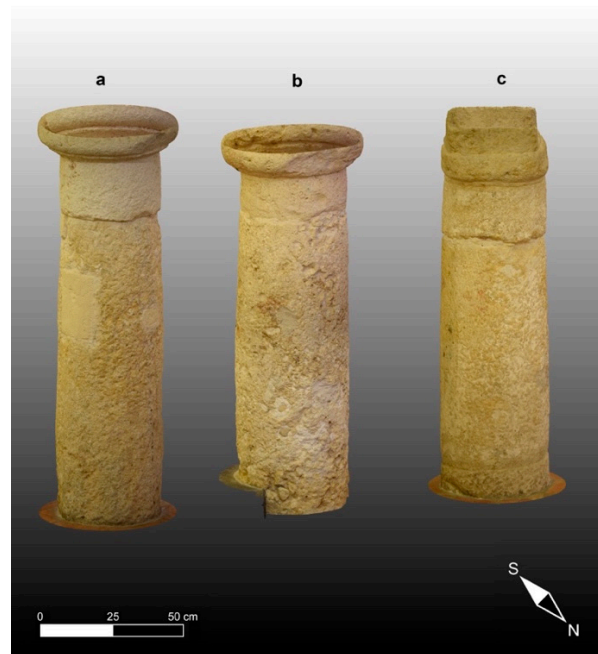
Figure 11. High-resolution 3D models of the three studied columns computed with CRP photogrammetry data processing and texturized with the natural colors of the high-quality 2D images: (a) Column 1; (b) Column 2; (c) Column 3.

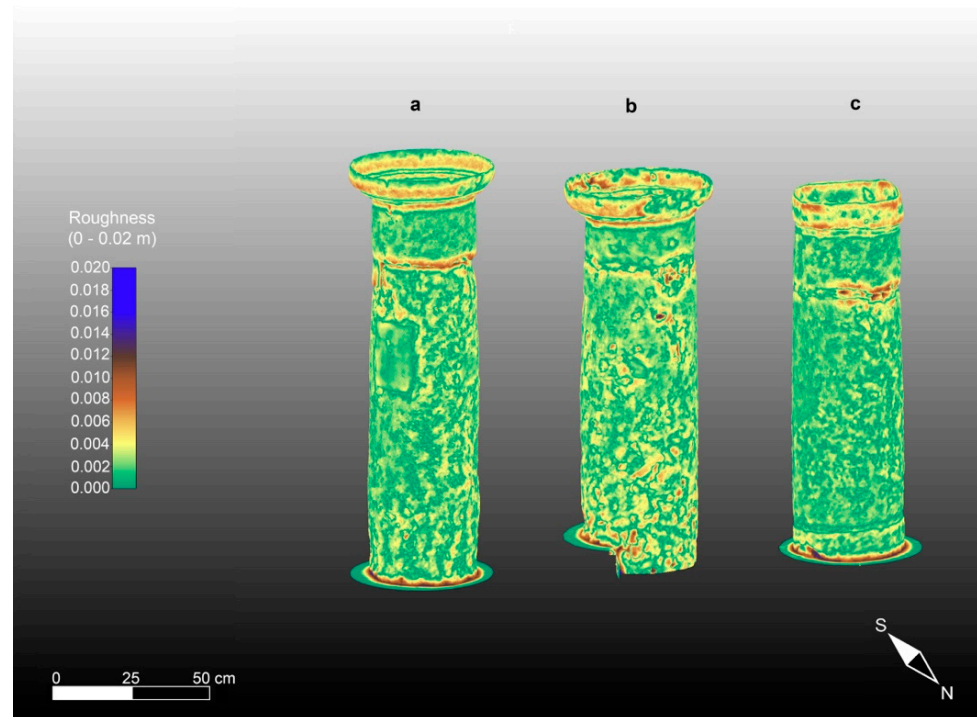
Figure 13. Roughness patterns of the three studied columns superimposed onto the 3D high resolution CRP models: (a) Column 1; (b) Column 2; (c) Column 3.

Regarding the roughness (see Figure 13), column 2 appears to be the most damaged. As a matter of fact, the roughness pattern shows greater residuals varying in the 0–2 cm range, particularly at the base of the column shaft and in its upper part, just below the capital, and in an area close to the joint. Column 3 is less damaged than column 1. They both show a pattern of geometrical and roughness anomalies with little variation (0–1.5 cm). In fact, looking at Figure 13, the roughness patterns of the three studied columns can be seen to range between low values (0–2 mm), represented by green hues, and higher anomalies (about 2 cm or greater in the case of column 2), represented by red and blue hues. This condition is also confirmed by the TLS intensity patterns and macroscopical analyses and is mainly due to the natural macropores caused by the dissolution phenomena of the calcite. In particular, this occurs in the areas of the artifacts in which the concentration of fossils is greater. In the resulting morphological maps, regarding the geometrical anomalies presented in Figure 12 corresponding to the studied columns, it is noteworthy that the color scale used for the maps ranges between a negative residual of -2.5 cm, presented

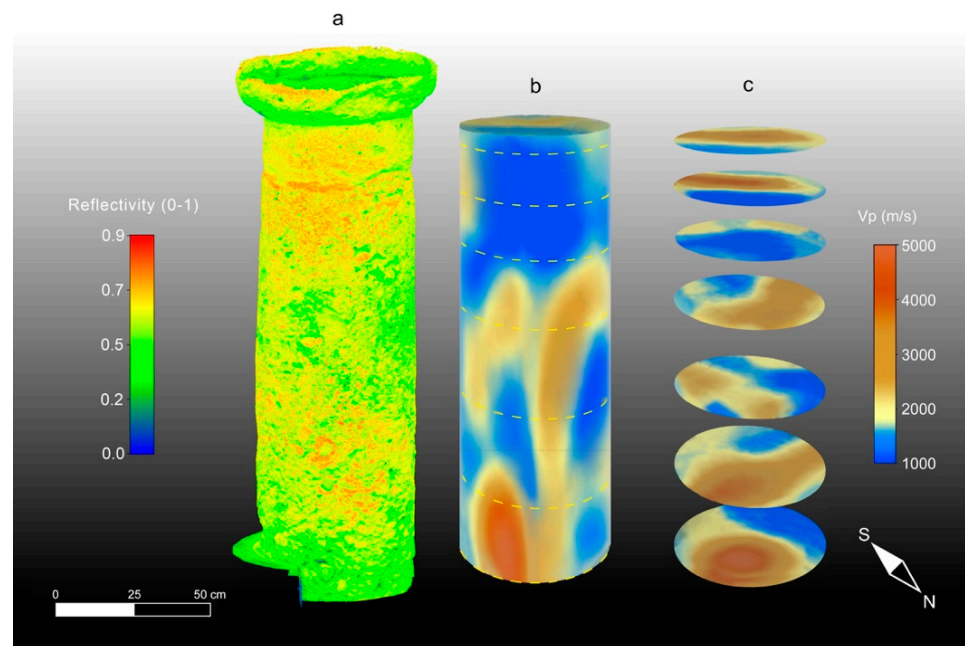
Figure 15. High-resolution 3D models of column 2. (a) TLS reflectivity model; (b) ultrasonic tomography; (c) tomographic slices.

From the analysis of the 3D tomography on each column, it is clear that column 2 (Figure 15b,c) is characterized by a higher variability in the longitudinal velocity value compared with the other two columns (1 and 3) (Figures 14b,c and 16b,c). In column 2, the elastic characteristics of the Pietra Forte are generally poor for different reasons: (1) deformation along the longitudinal axis of the column shaft, as observed in the high-resolution 3D digital models derived with the CRP and TLS methodologies; (2) the presence of macropores (e.g., small karst cavities) and microfractures that result in a significant de-

crease in the longitudinal velocity; and (3) textural variations of the carbonate material, especially the different types of porosity, and the presence of discontinuities among the bioclasts [16,17]. In particular, points 2 and 3 increase the roughness of the shallow part of the column shaft which, in turn, affects the TLS reflectivity, as can be observed in Figure 15a. The comparison between the 3D TLS reflectivity model and the 3D ultrasonic tomography (Figure 15a,b) clearly highlights that the low-velocity sectors (shown in blue) are almost in correspondence with the high-reflectivity ones (red), where the roughness caused by the degradation of the shallow materials is greater. This is especially evident in the upper part of the column shaft, where reflectivity values in the range of 0.7–0.9 correspond to velocity values in the range of 1000–1800 m/s, which is typical of quite intensively altered Pietra Forte. In this particular case, the longitudinal velocity decreases, probably due to a worsening of the mechanical properties of the material, related to a deformation, as is well-evidenced by the high-resolution 3D CRP and TLS models, and the presence of a joint. This deformation is probably due to an inappropriate load distribution on the supporting structure.

Horizontal slices through the longitudinal development of the 3D tomographic volume (Figure 15c) provided high-resolution images of the inside column, allowing us to better understand the three-dimensional development of the low-velocity zones (colored blue) associated with Pietra Forte degradation as well as to detect their geometry and size.

In sectors with higher velocities (colored brown) corresponding to lower TLS reflectivity values (Figure 15a,b), the elastic characteristics were improved due to a greater compactness and a higher degree of cementation, which reduced the porosity and discontinuities inside the material. In Figure 17a–d, a possible correlation between the velocity distribution inside column 2 and the textural characteristics of the investigated carbonate materials is presented, together with the CRP model.

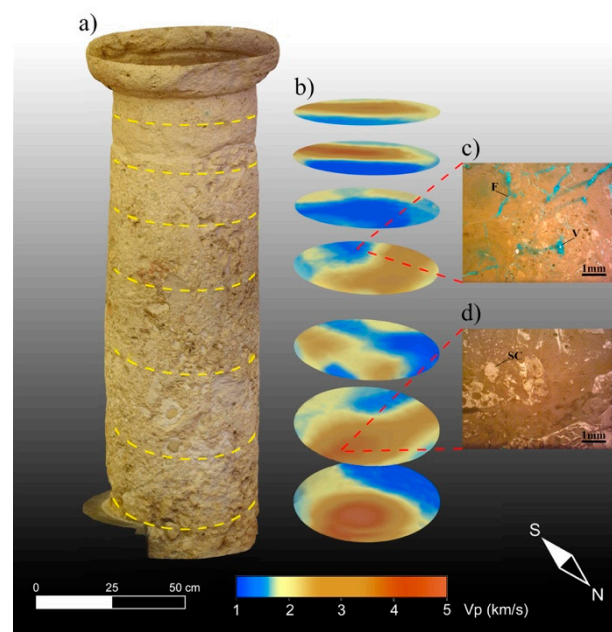
Figure 17. Integrated analysis of the ultrasonic tomography and thin sections for column 2. (a) CRP model; (b) tomographic slices; (c) thin section of the Pietra Forte in a sound sector of the shaft; (d) thin section of the Pietra Forte in a degraded sector of the shaft. F = fracture, V = vug, SC = sparry calcite cement.
