Seismological and geotechnical aspects of the $M_w=6.3$ L'Aquila earthquake in central Italy on 6 April 2009

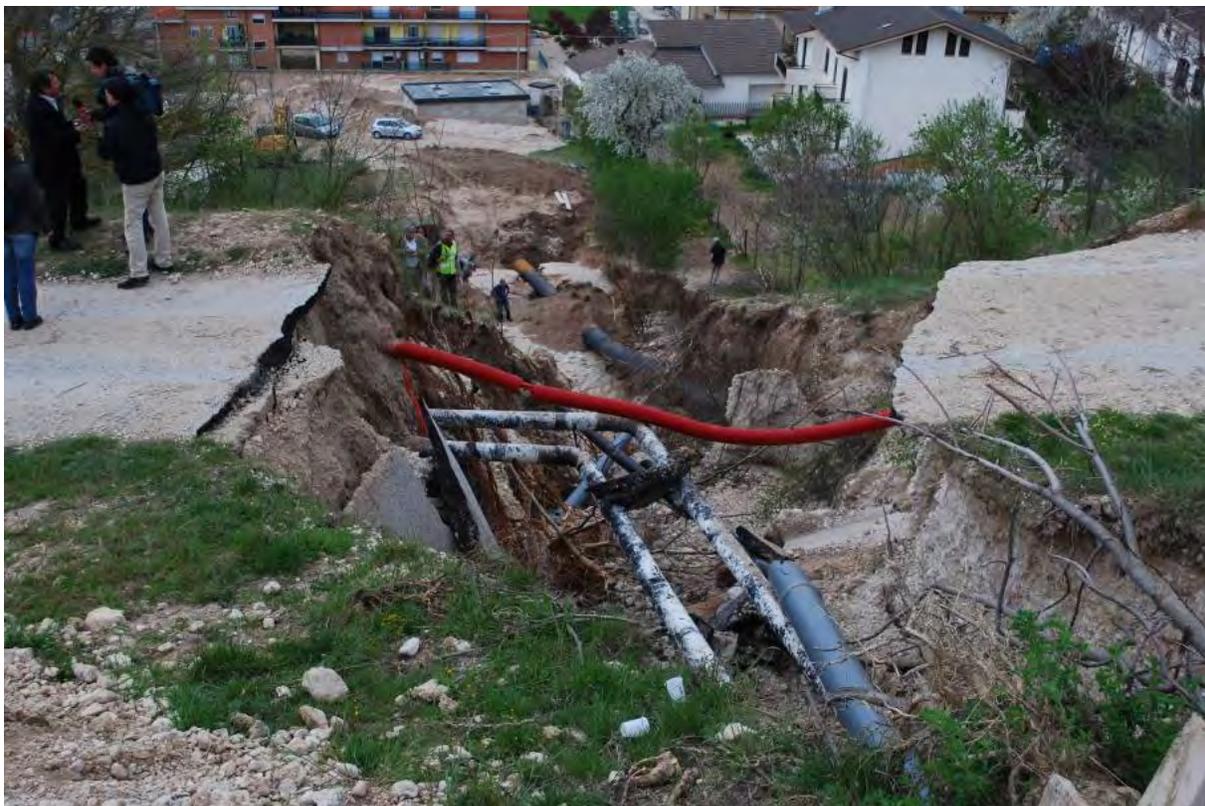
Figure 27. Paganica village: broken major water pipe (repaired) due to co-seismic rupture (Lat. 42,36537N Long. 13,46803E) (Photo by Mylonakis G).

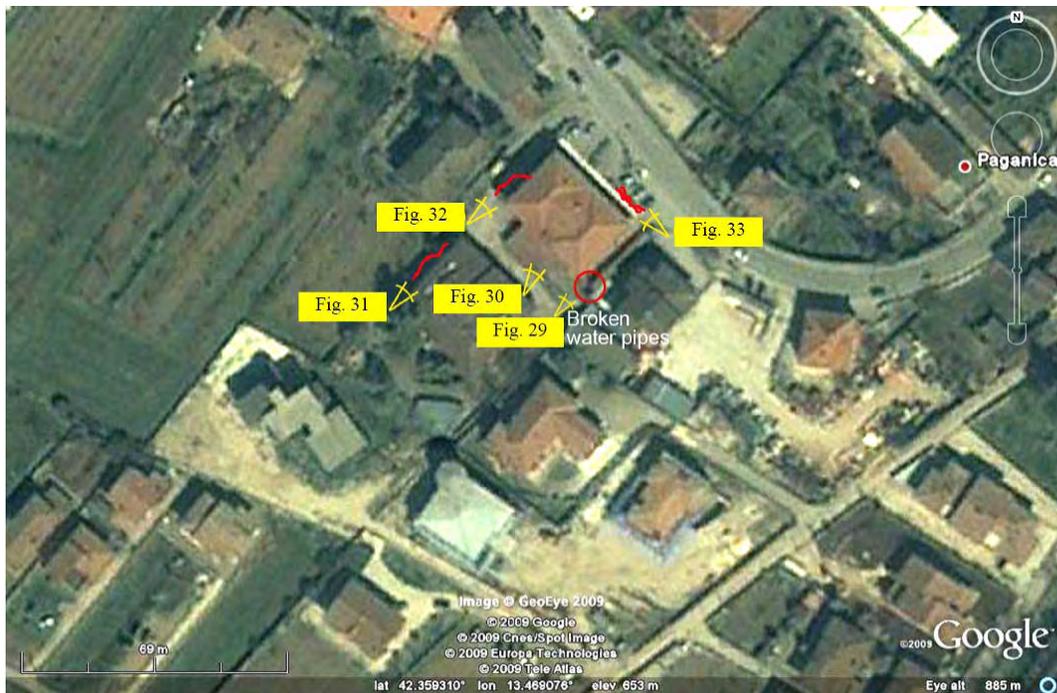
Figure 28. Plan view of Paganica site with marked positions of ground fissures, paved walkway cracks and broken water pipes. Directions of photo shots are indicated by yellow signs.

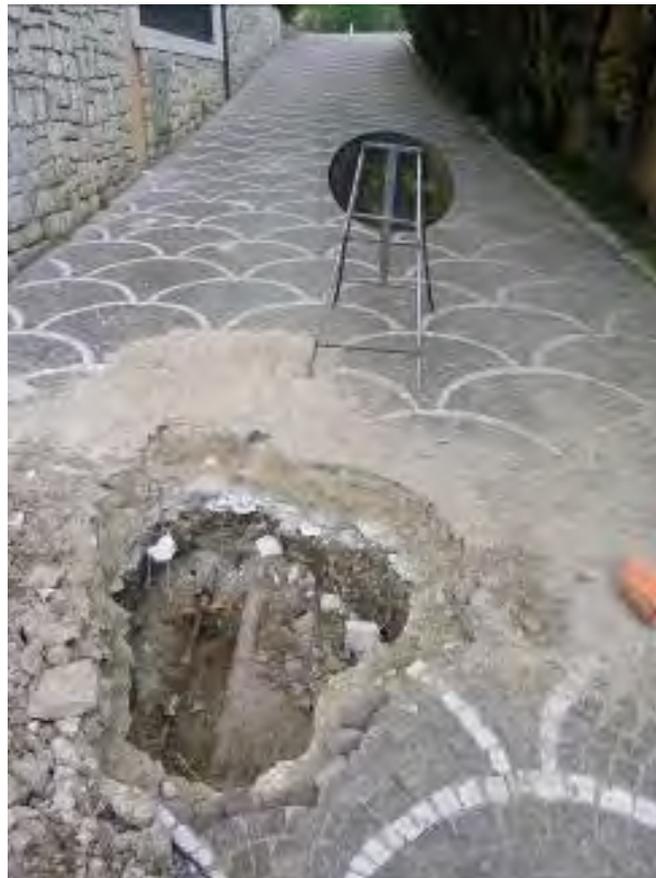
Figure 29. Failure of water pipe. (42.359335°N, 13.468954°E).

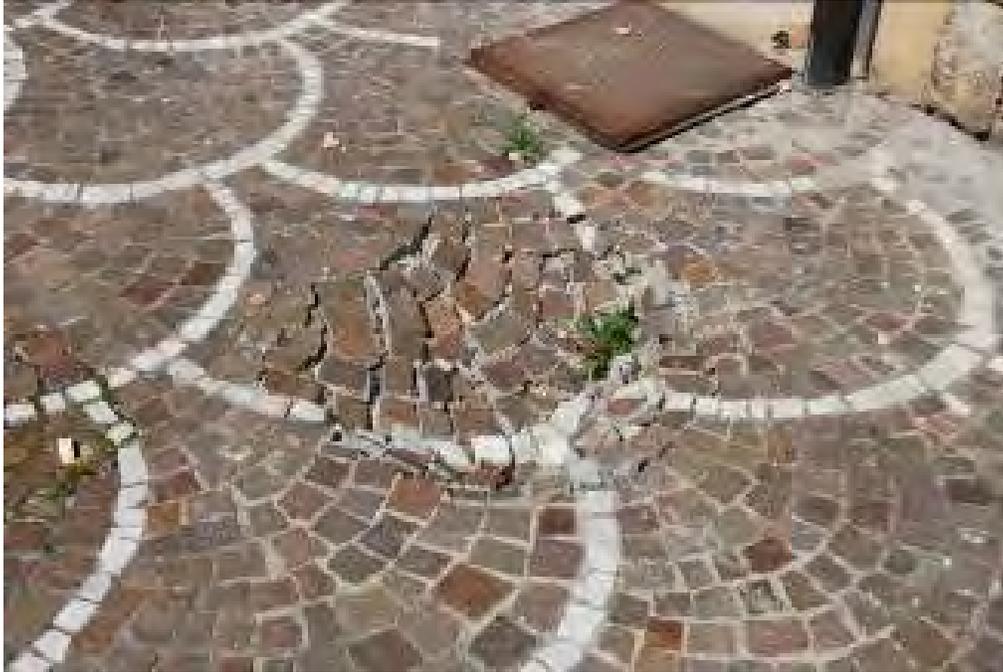
Figure 30. Local settlement close to piping system (42.359335°N, 13.468954°E).

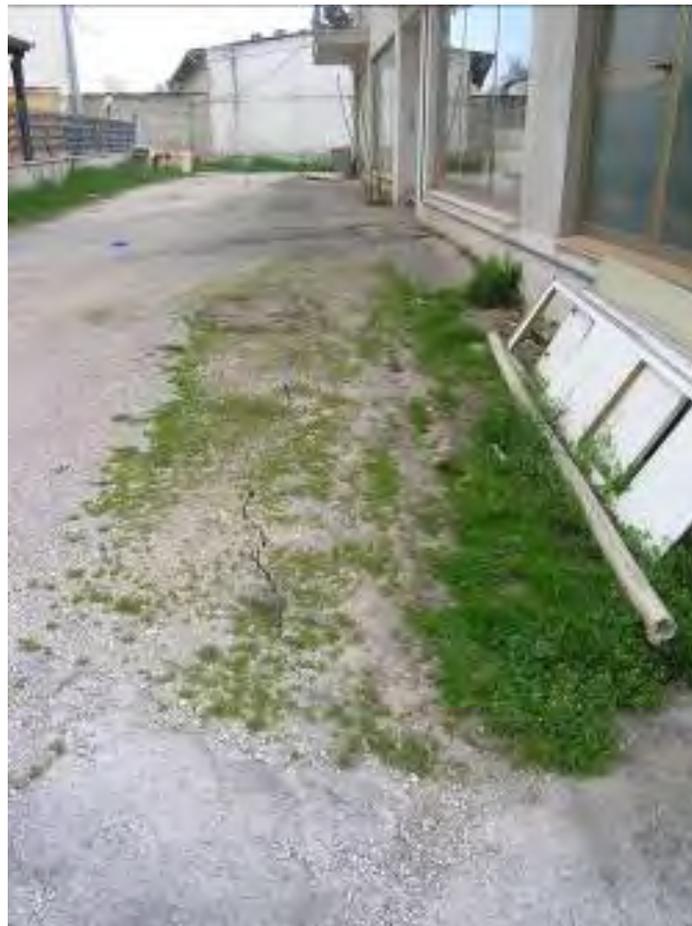
Figure 31. Ground fissures at the side of the building (42.359817°N, 13.468649°E).

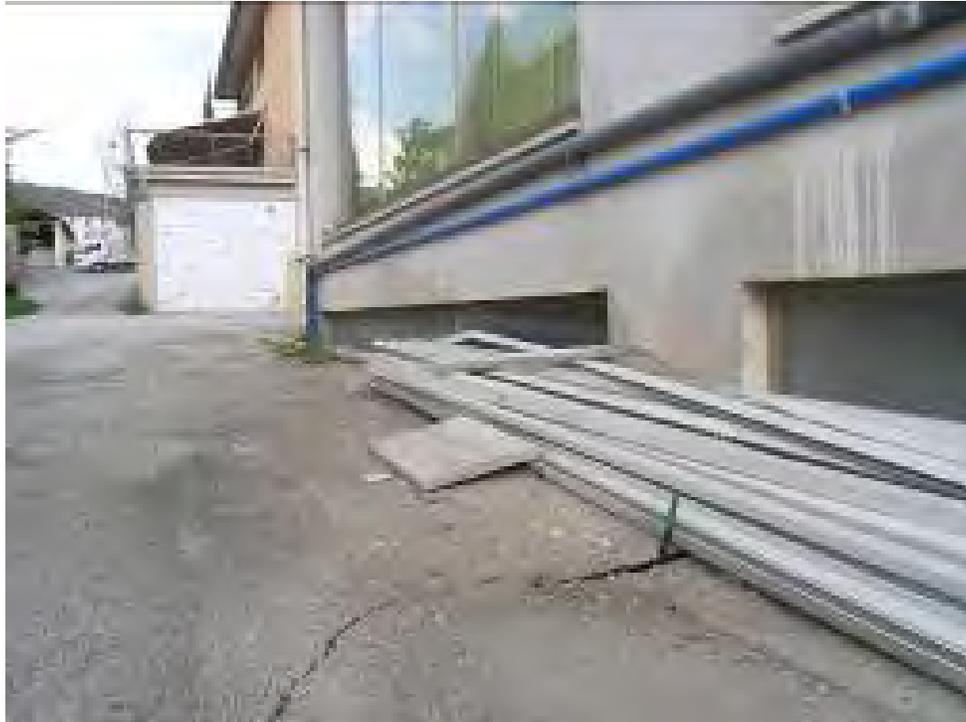
Figure 32. Ground fissures and settlement at the side of the building (42.359817°N, 13.468649°E).

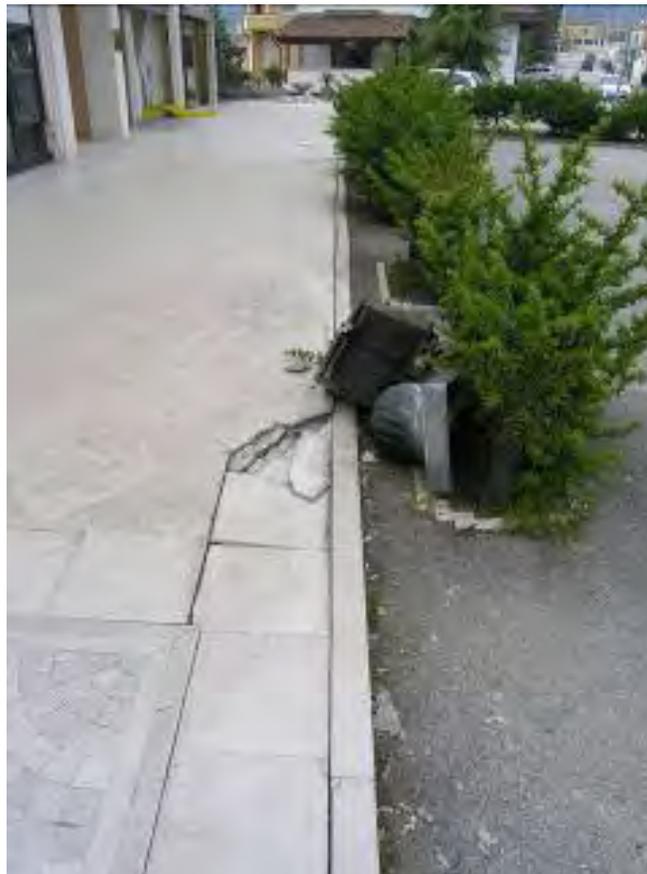
Figure 33. Separation cracks at sidewalk on front of building (42.359335°N, 13.468954°E).

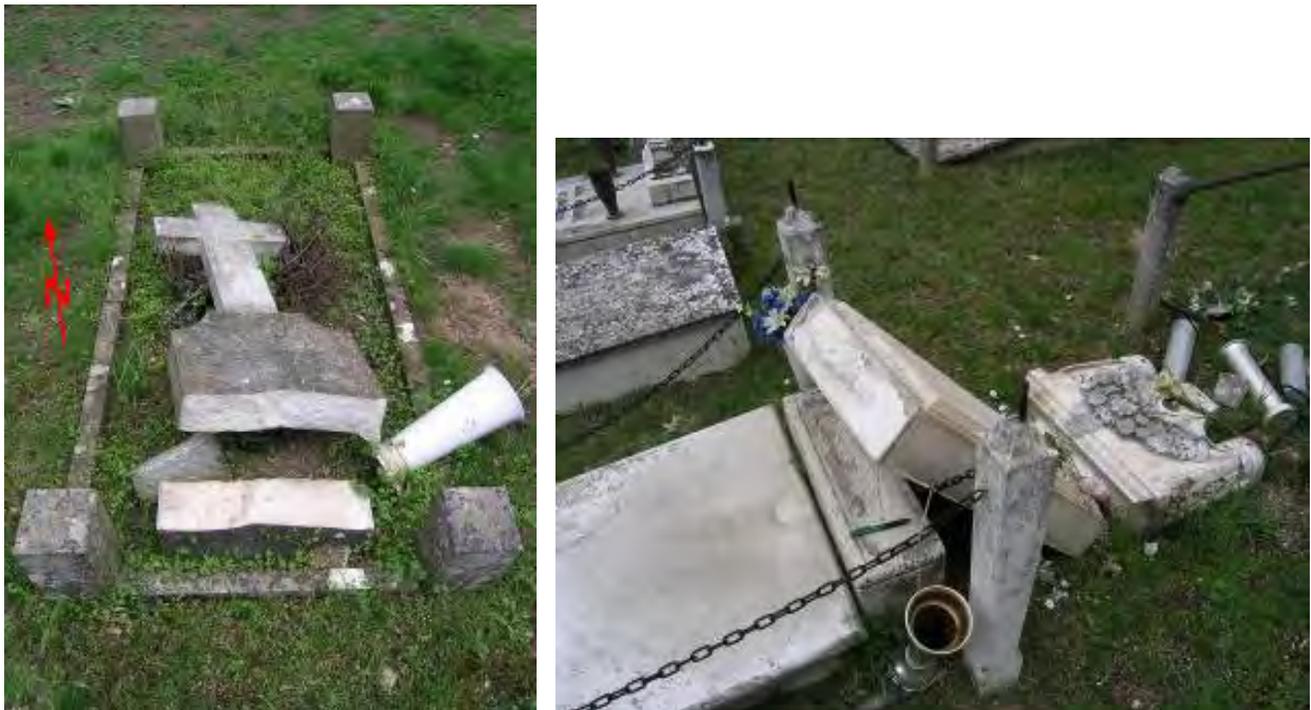
Figure 49. Grave markers breakage.

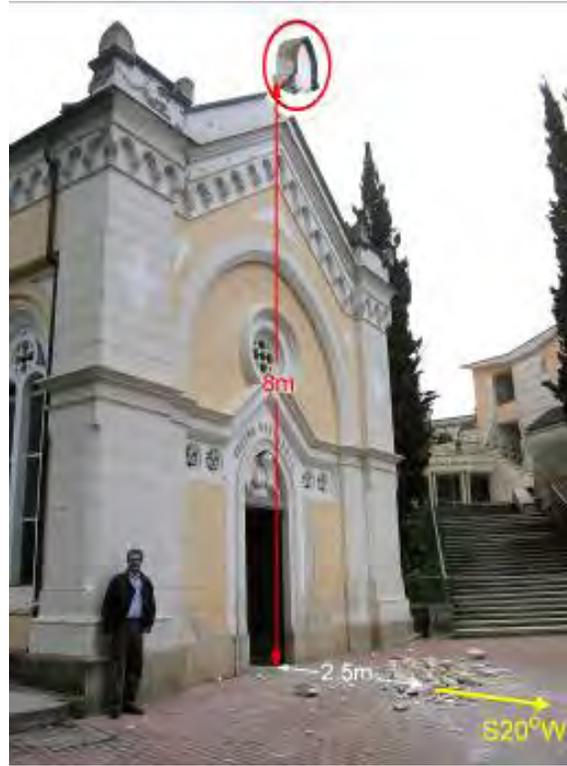
Figure 53. Fall of facade object at mortuary building.

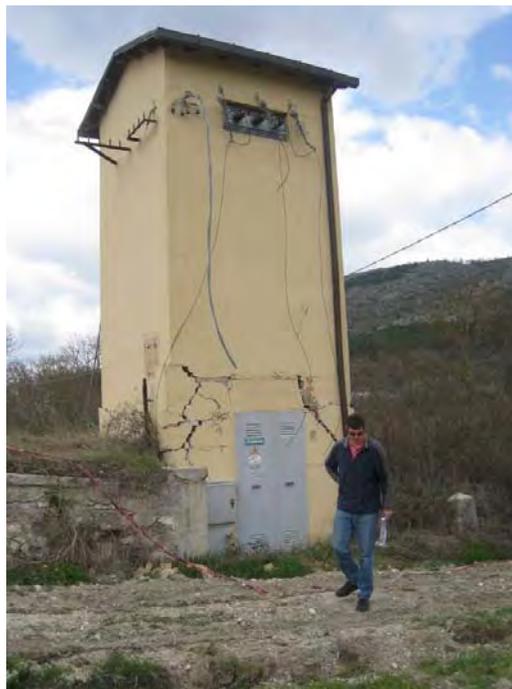
Figure 57. Heavily damaged seismometer station box (not in use at the time of the earthquake, no recording) on the northeast valley beneath the town of Castelnuovo. (42.2982°, 13.6295°).

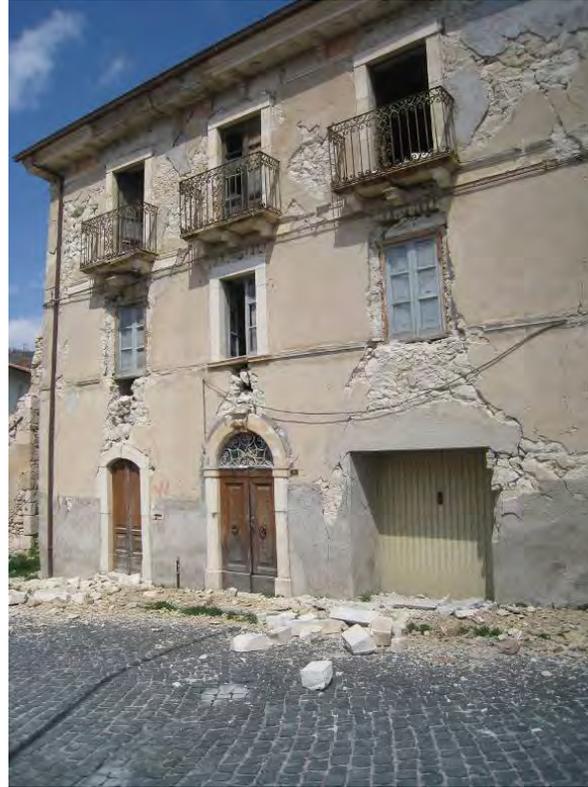
Figure 58. A typical heavily damaged structure in the lower elevation of Castelnuovo. Many structures in the lower elevation neighborhood had less observable damage. (42.2956°, 13.6274°).

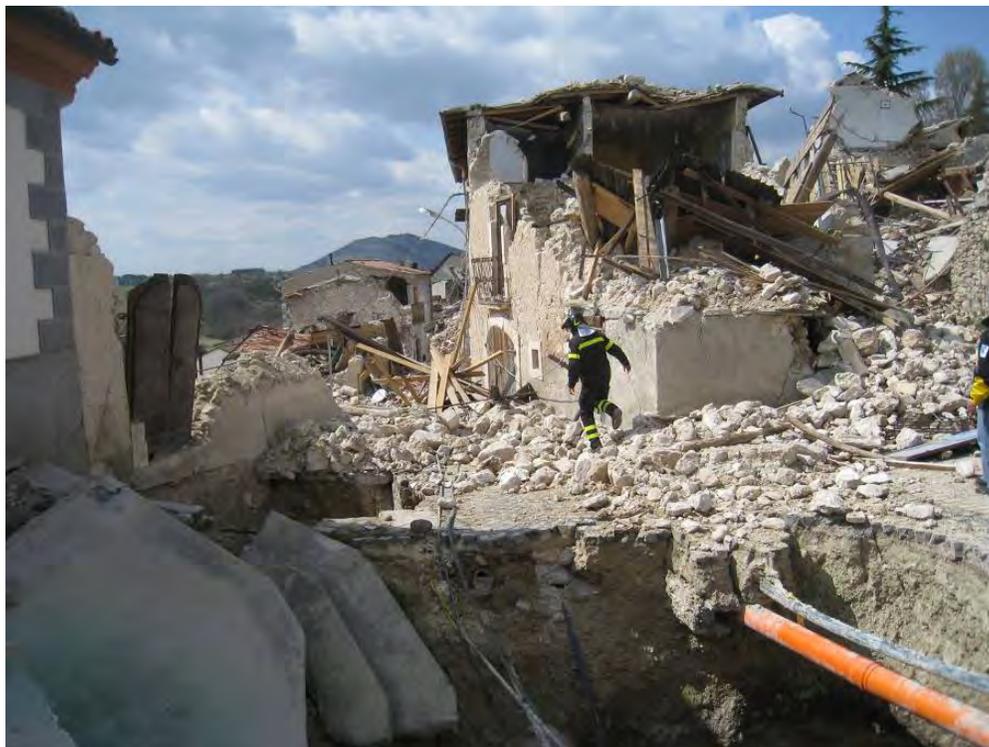
Figure 59. At the highest elevation of the hilltop town of Castelnuovo, almost all of the structures collapsed (D5) or were near collapse (D4). (42.2947°, 13.629°).

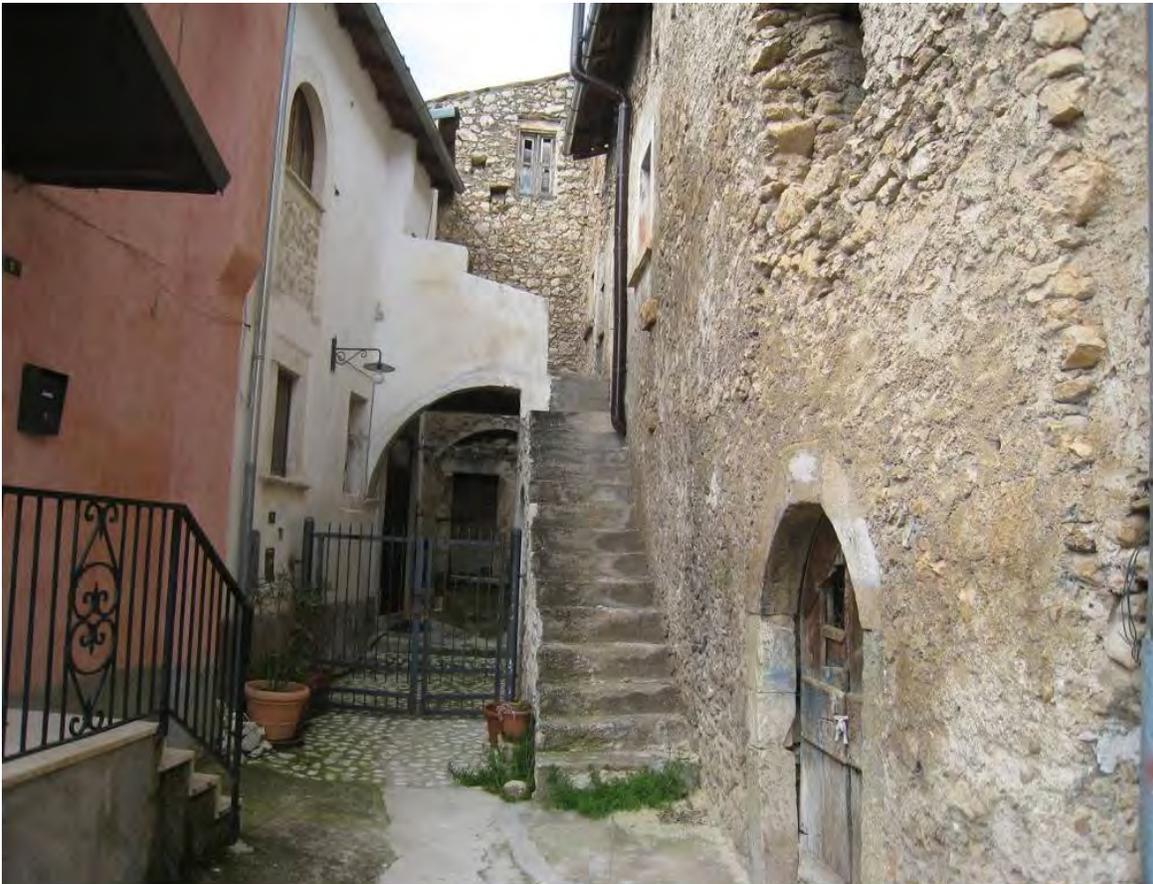
Figure 62. Typical unreinforced masonry structures in the village of San Pio delle Camere suffered no damage (D0), or slight cracking (D1). Structures in this village are similar to those in Castelnuovo. San Pio delle Camere is built on limestone bedrock.

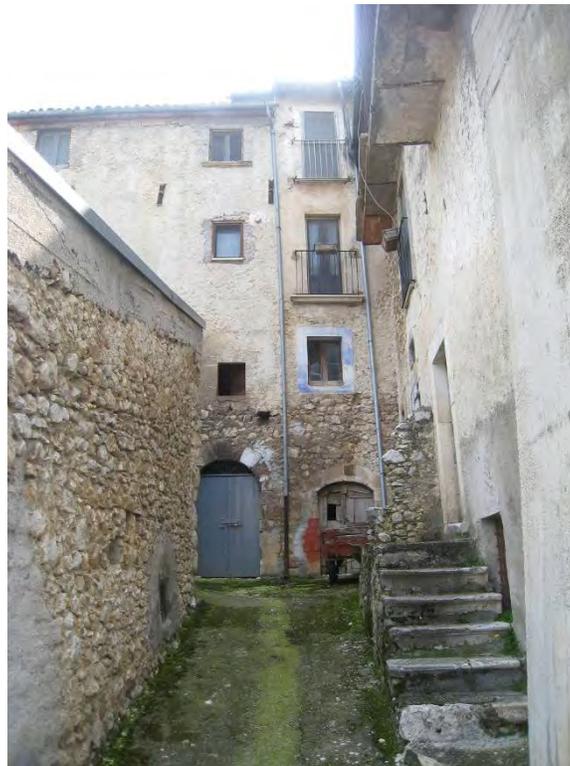
Figure 63. The reconnaissance team observed no damage to the town of Tussio. The town is built on Mesozoic calcareous bedrock (42.2657°, 13.6414°).

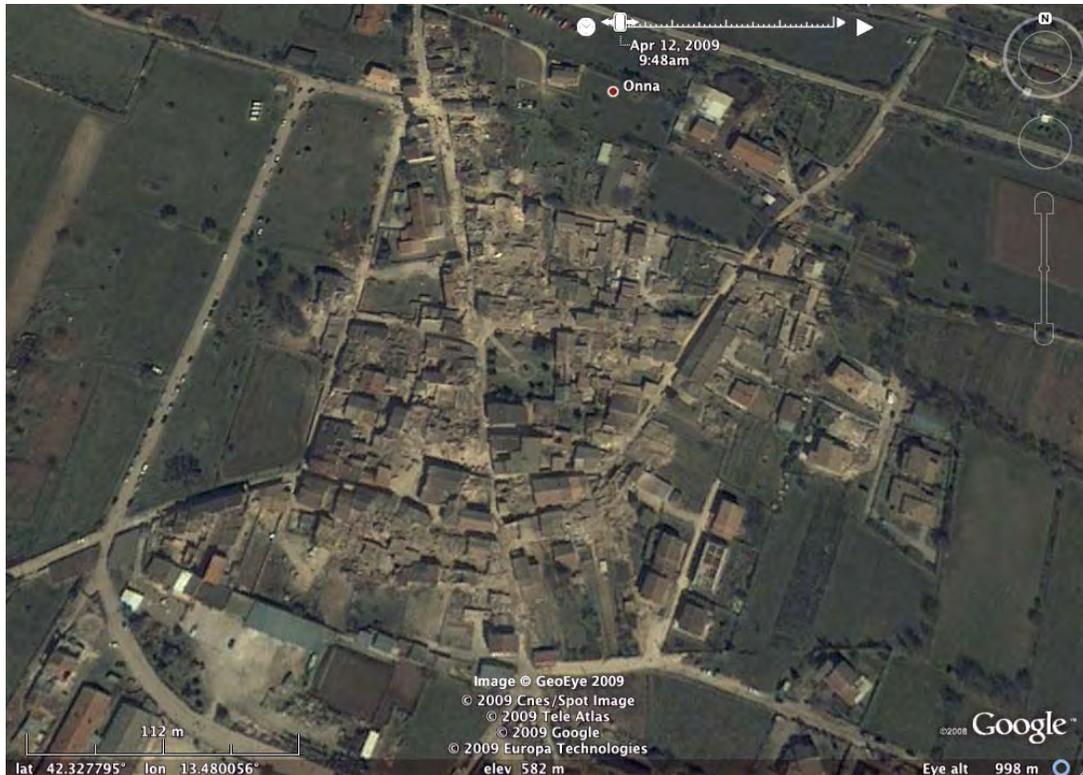
Figure 64. The village of Onna suffered D4–D5 damage in most of the unreinforced masonry structures. Reinforced concrete structures at the margins of the village performed well with only minor damage (D0-D2).

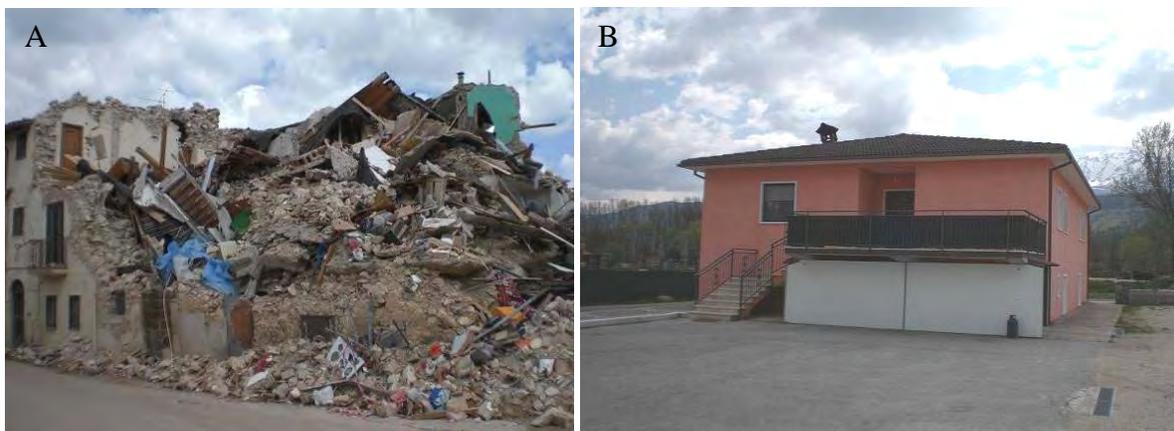
Figure 67. Onna. (A) D5 damage level on masonry building structures, (B) D0 damage on a RC building (except for the tilting of the chimney).

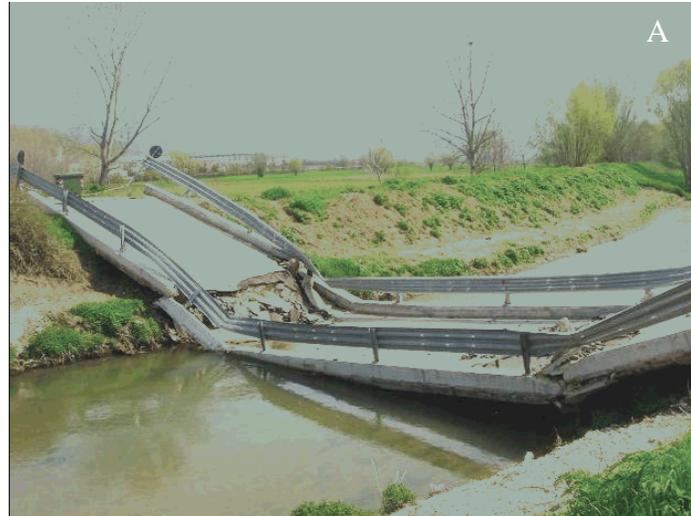
Figure 68. Onna. (A) Collapse (D5).

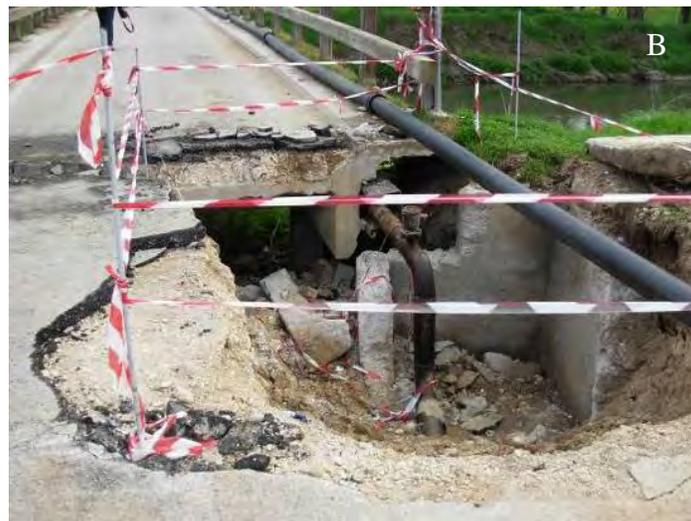
Figure 68. Onna. (B) Intense damage (D4) of RC bridges on the Aterno river.

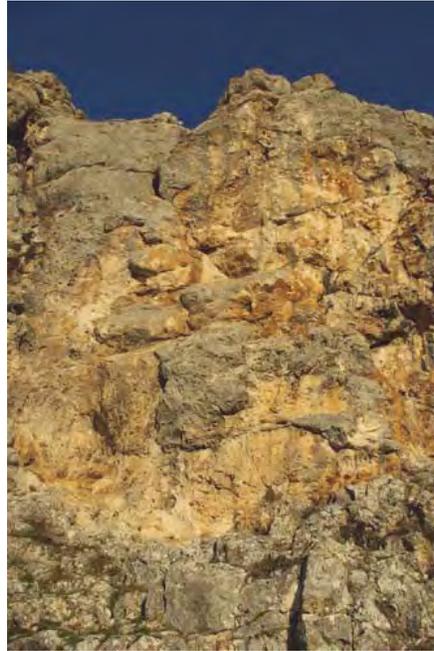
Figure 69. Monticchio: outcrop of the Jurassic limestone formation.

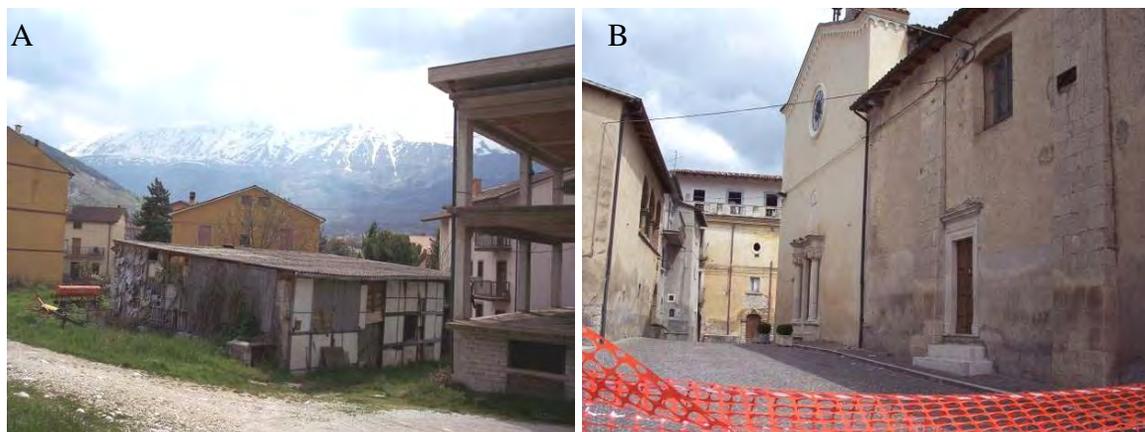
Figure 70. Monticchio. (A) D0 damage level on different building structures, (B) D0 damage on monumental masonry buildings.

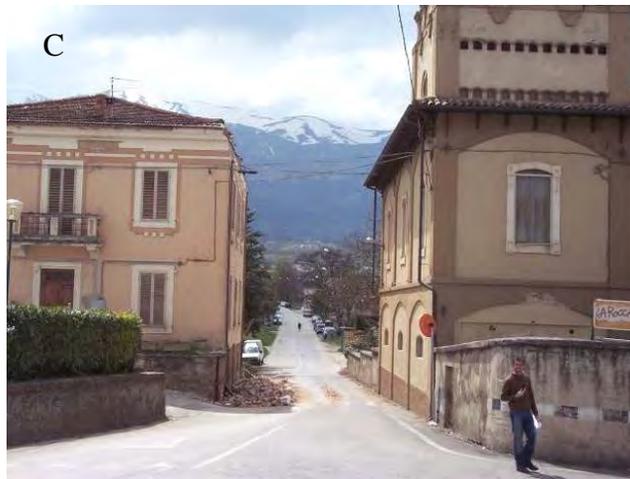
Figure 70. Monticchio. (C) D1 damage (fall of the cornice) on a masonry building.

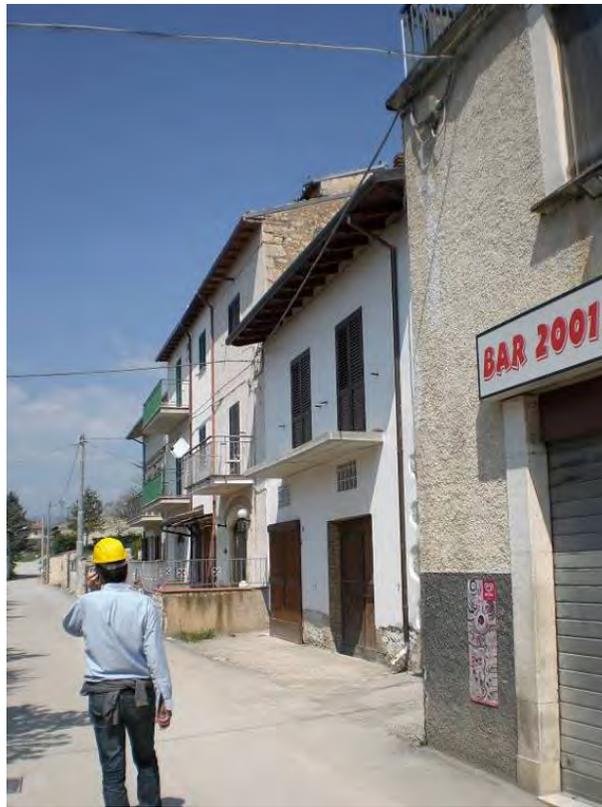
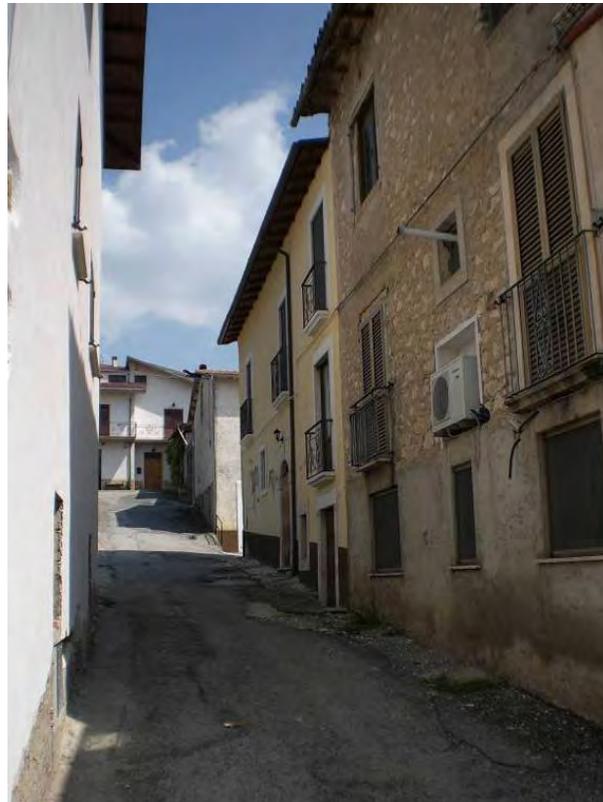
Figure 73. San Gregorio western part: masonry buildings with minor damages.

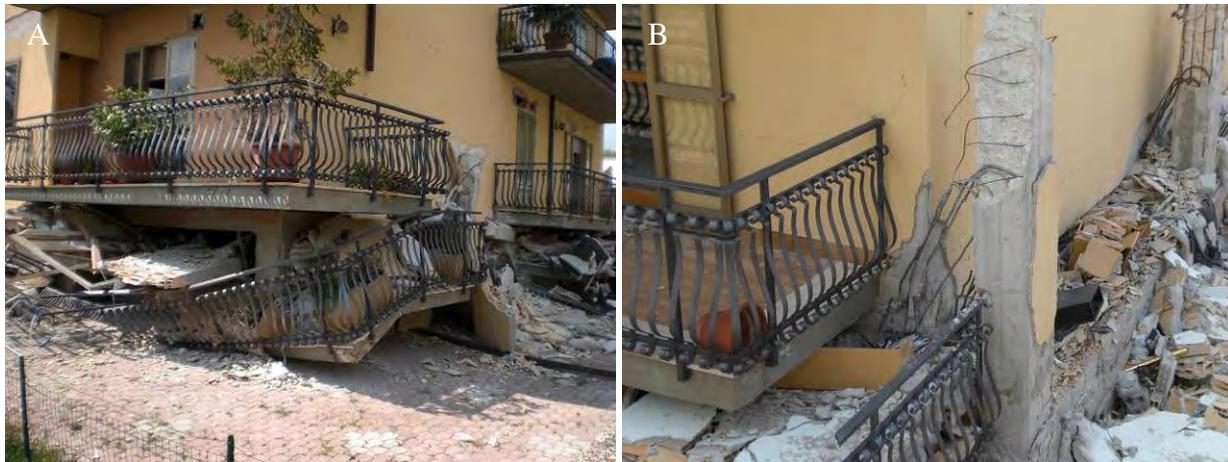
Figure 74. San Gregorio eastern part. (A) RC building “pancake” collapse, (B) Detail of sheared pillars.

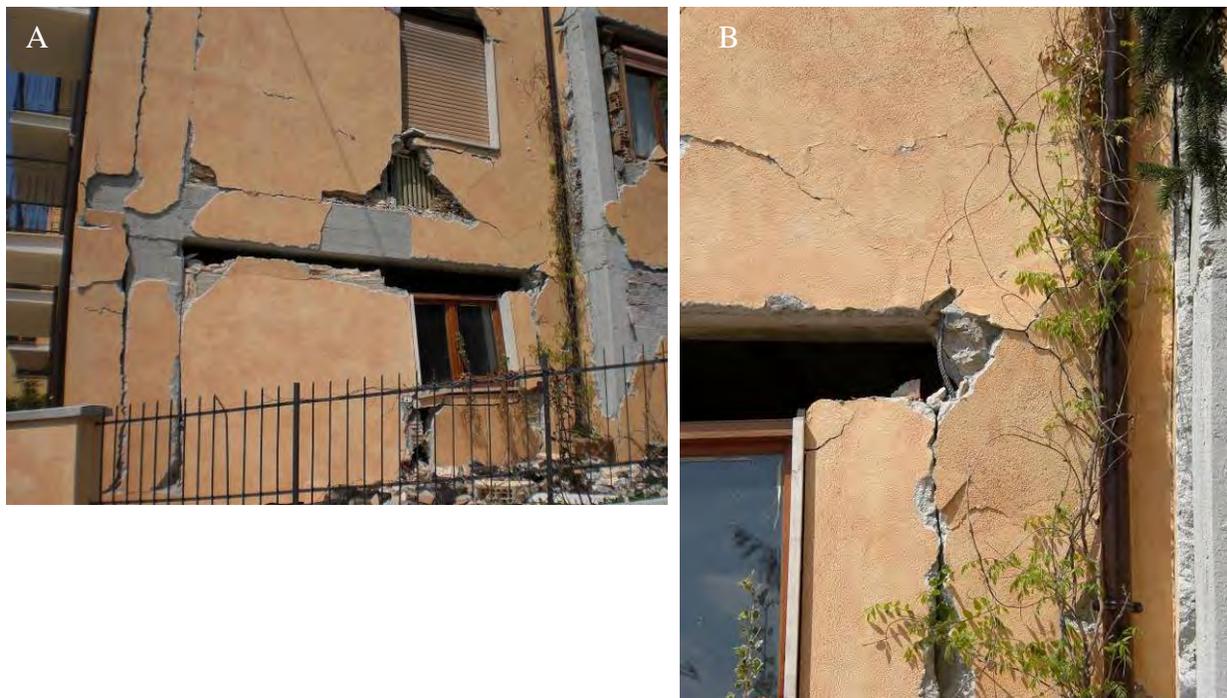
Figure 75. San Gregorio eastern part. (A) RC building with structural damage, (B) Detail of the damage to the beam-column connection.

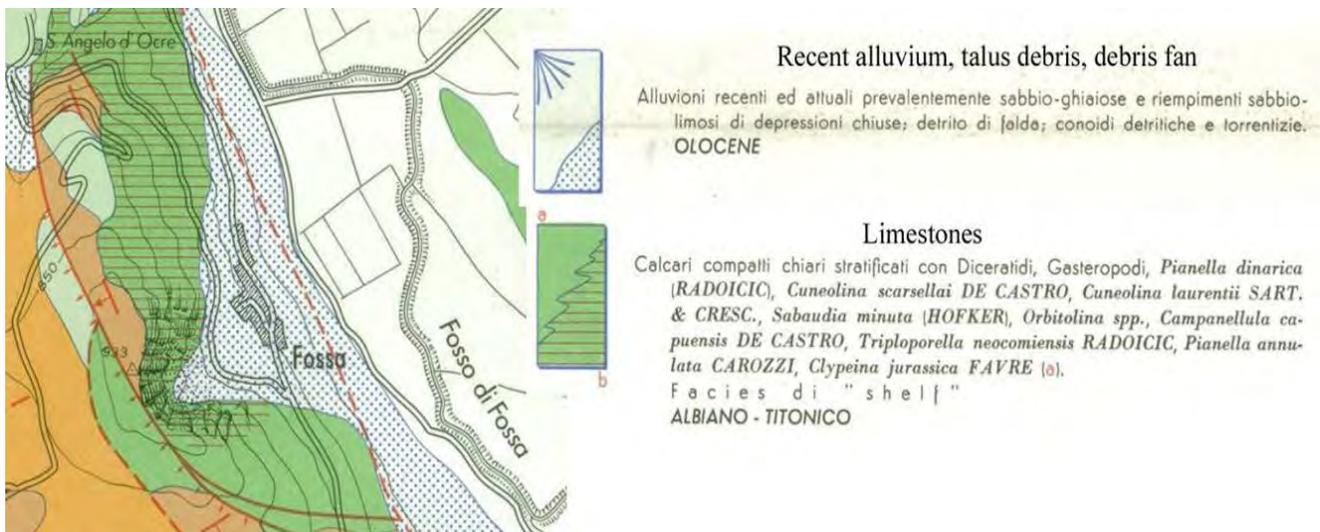
Figure 76. Geological map of Fossa (after Bosi and Bertini, 1970).

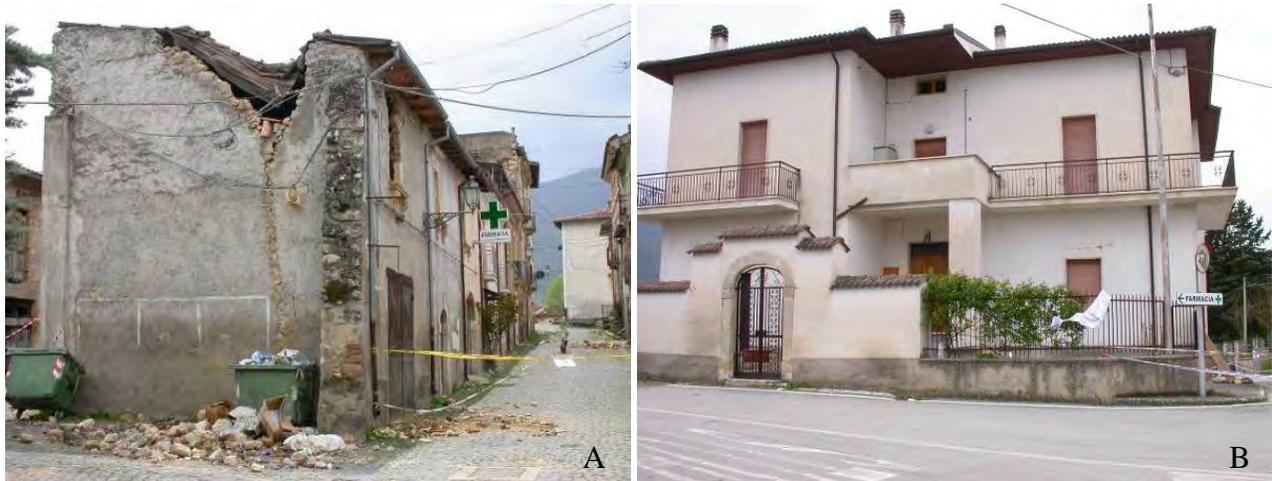
Figure 79. S. Eusanio Forconese village. (A) Partial collapse of masonry building (D4), (B) Slight damage to a RC building nearby (D1).

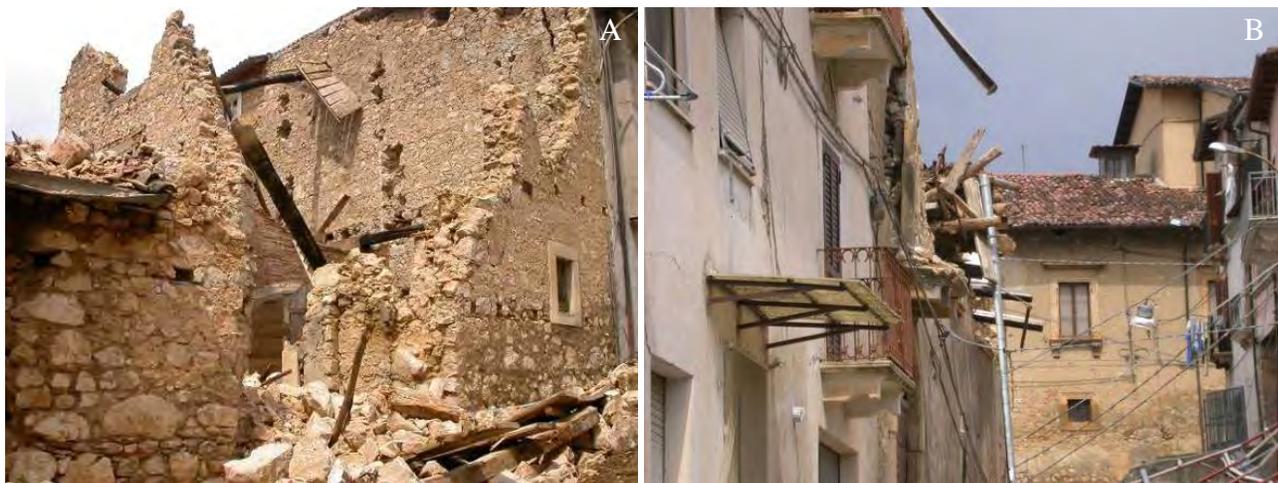
Figure 80. S. Eusanio Forconese. (A) Collapse of old masonry building (D5), (B) Partial collapse of masonry building (D4).

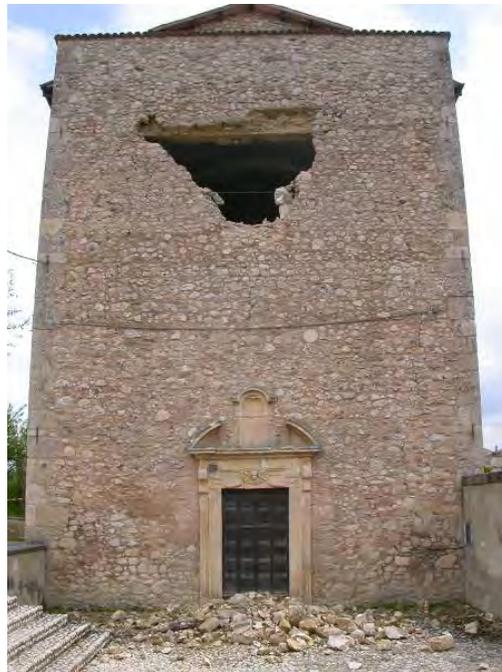
Figure 81. S. Eusanio Forconese: partial collapse of the masonry church (D4).

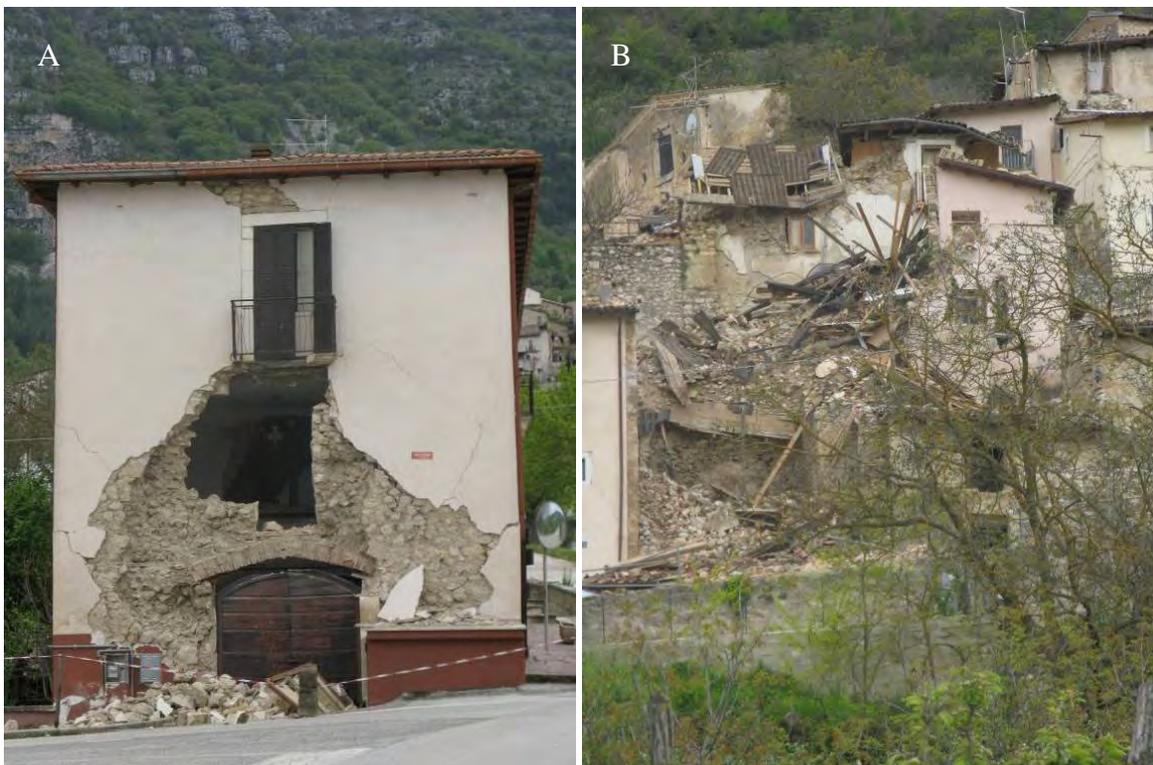
Figure 82. Casentino. (A) Partial collapse of the masonry building at the entrance of the village, (B) Collapse of old poor quality masonry buildings in the historic center.

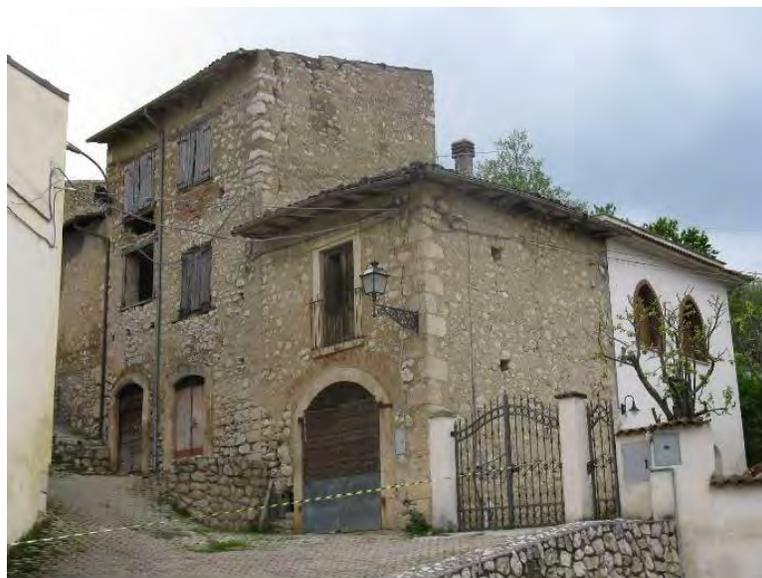
Figure 83. Casentino masonry buildings with some wall cracks.

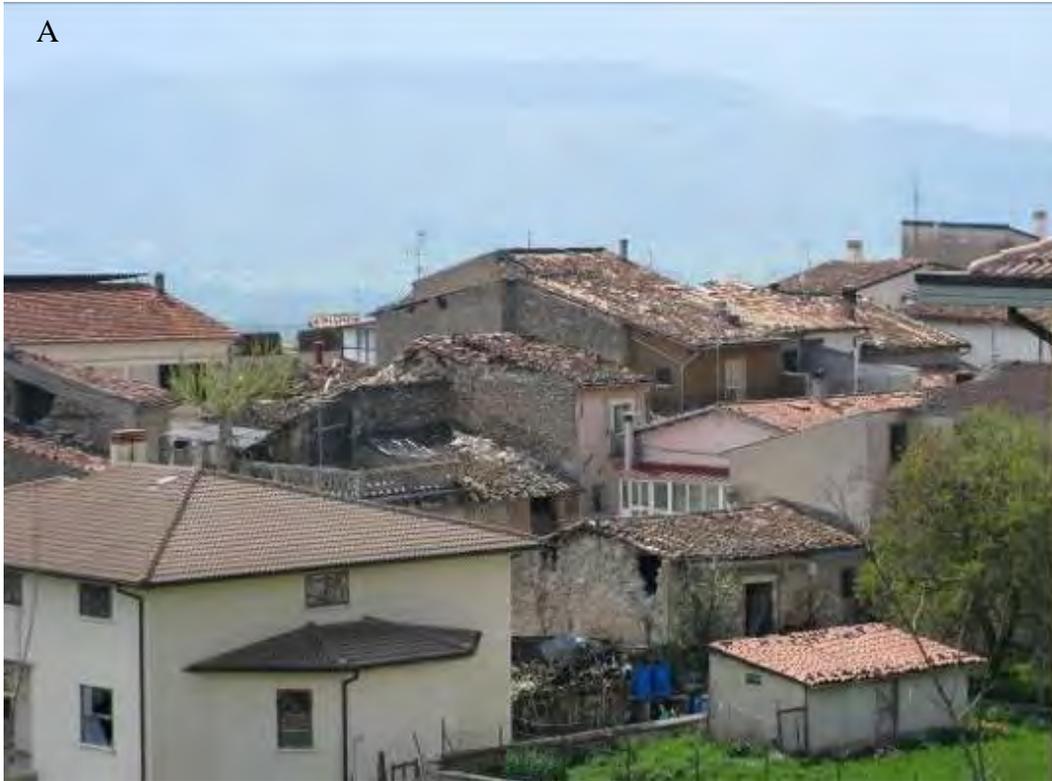
Figure 86. Poggio Picenze. (A) Variable damage (D3-D4) on masonry buildings of different style.

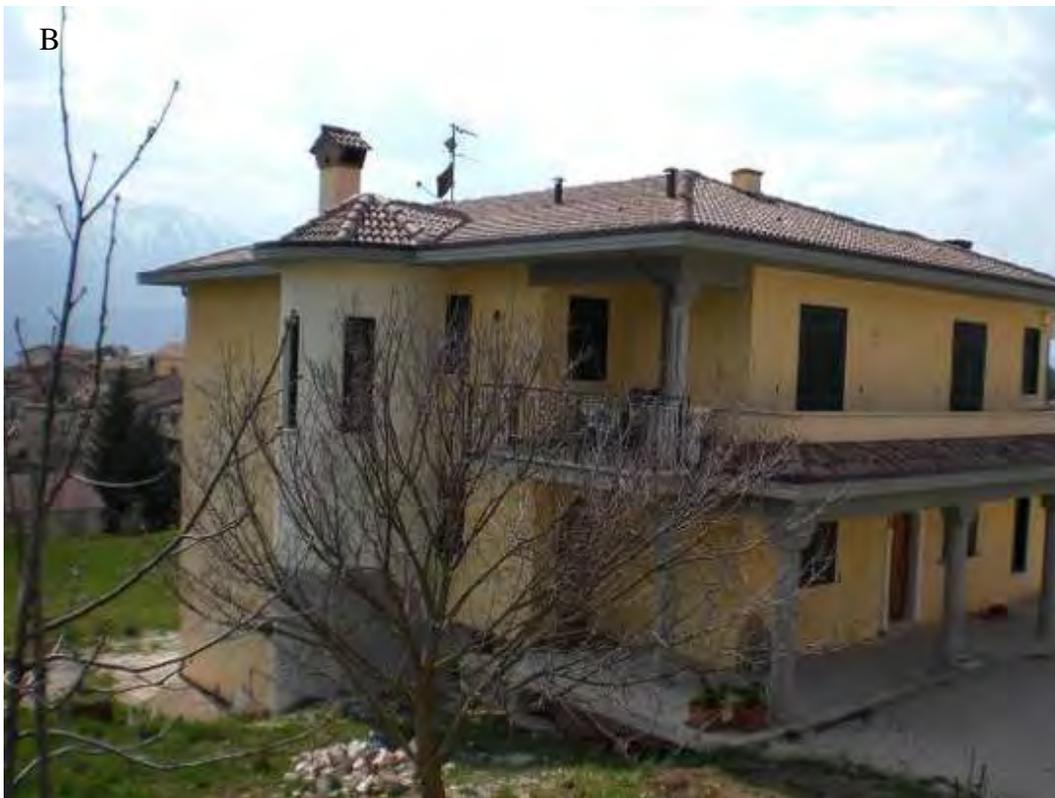
Figure 86. Poggio Picenze. (B) Undamaged RC house (D0) close to the (C) monumental church (D3).

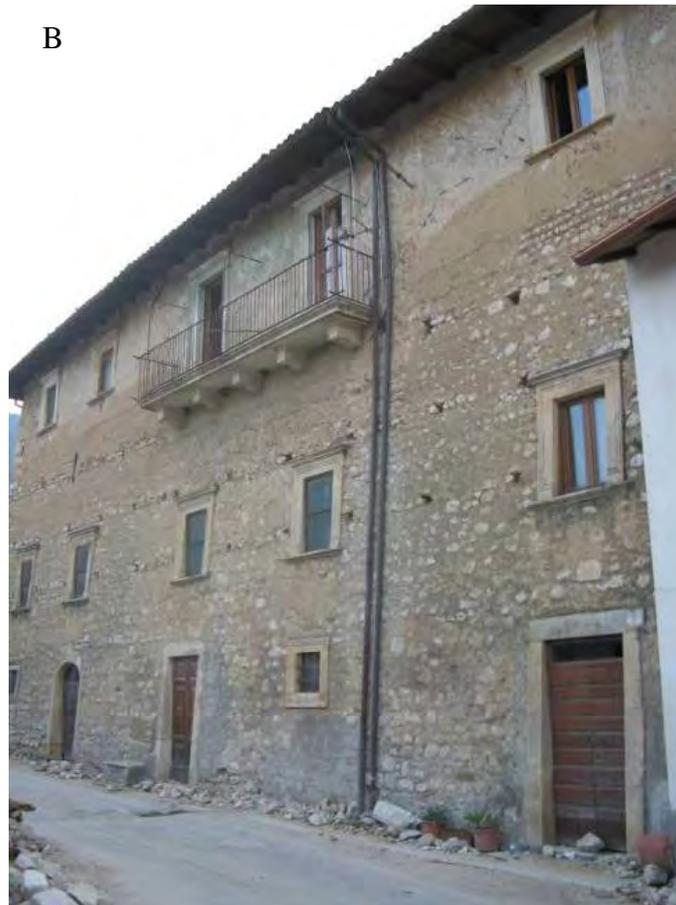
Figure 88. Villa S. Angel. (B) Reinforced masonry in the historic center with minor cracks in the highest story (D2).

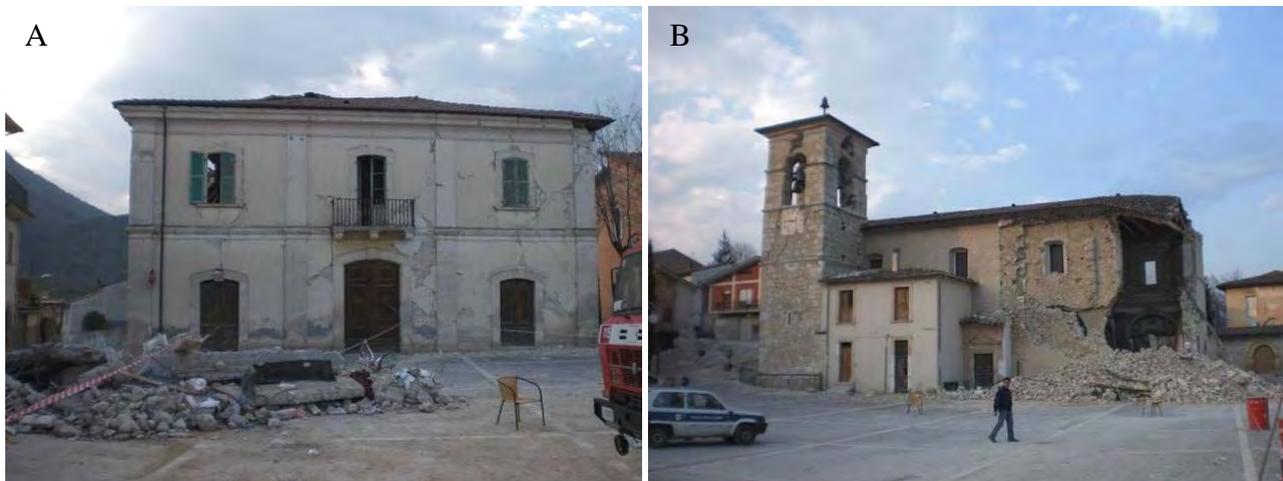
Figure 89. Villa S. Angelo, historic center with (A) masonry building crack,; (B) partly collapsed church.

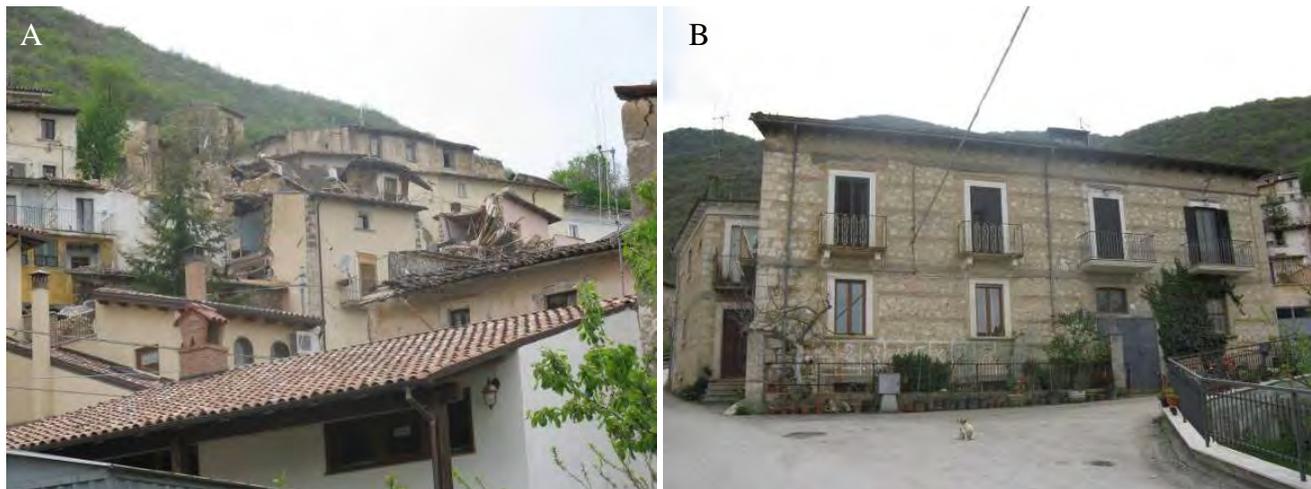
Figure 90. Tussillo. (A) View of the historic center with some collapsed masonry buildings on the background, (B) Masonry building at the entrance of the village showing no damage.
