Seismological and geotechnical aspects of the $M_w=6.3$ L'Aquila earthquake in central Italy on 6 April 2009

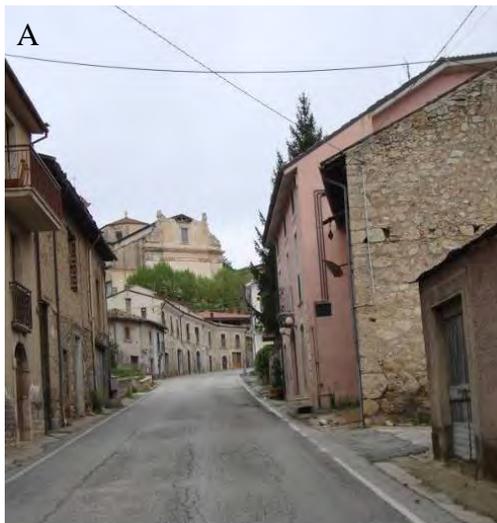
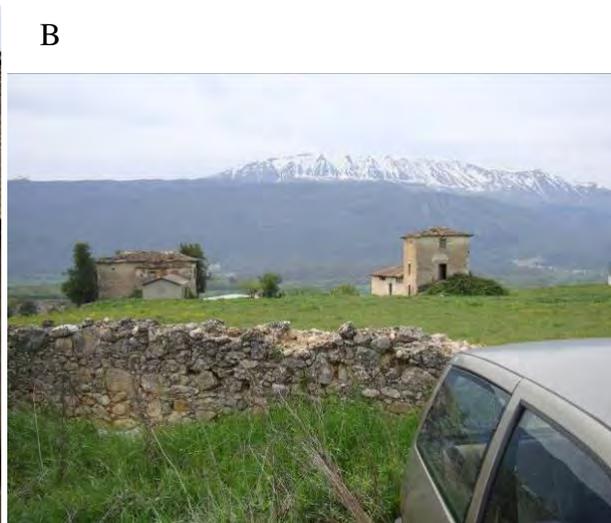
Figure 92. San Demetrio ne' Vestini (A) access road to the village showing mostly masonry buildings with no damage, (B) old masonry buildings with no damages.

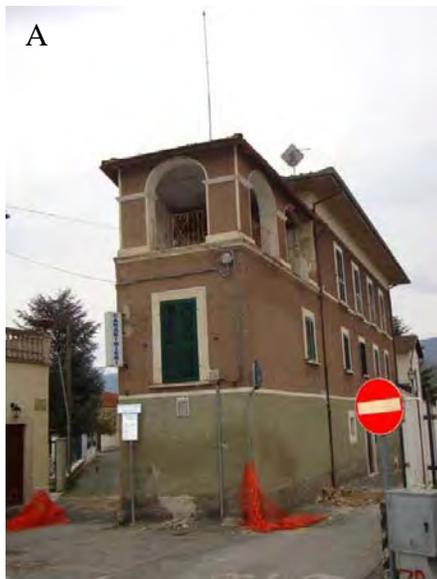
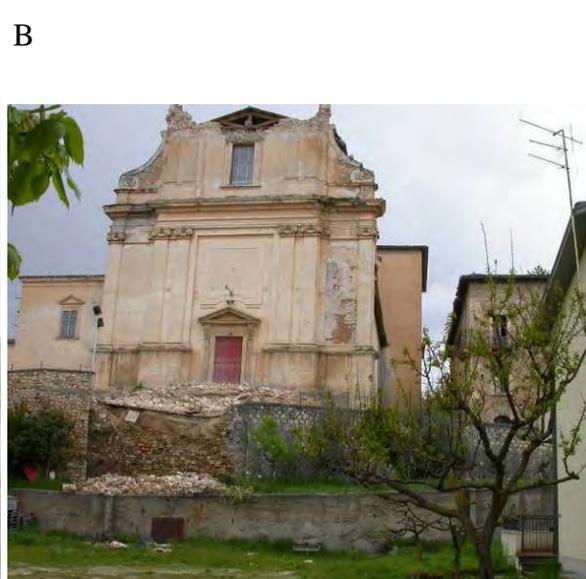
Figure 93. San Demetrio ne' Vestini. (A) "Caserma dei Carabinieri" with cracks (not evident in the picture) and falls from the highest story, (B) Partial collapse of the tympanum of the facade of the Madonna dei Raccomandati church.

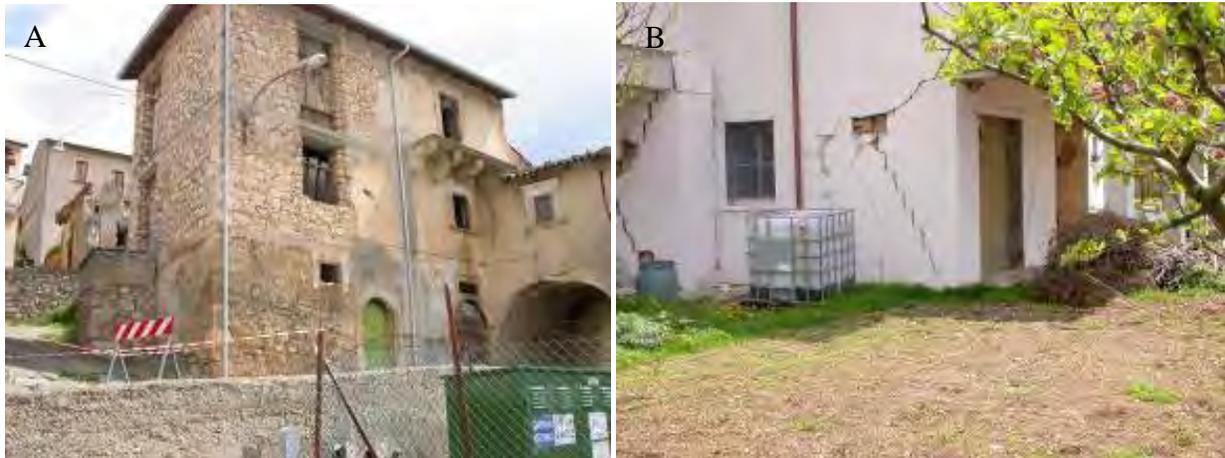
Figure 96. Barisciano. (A) Collapse (D5) of an old masonry building in background, (B) Damages (D1/D2) to RC buildings.

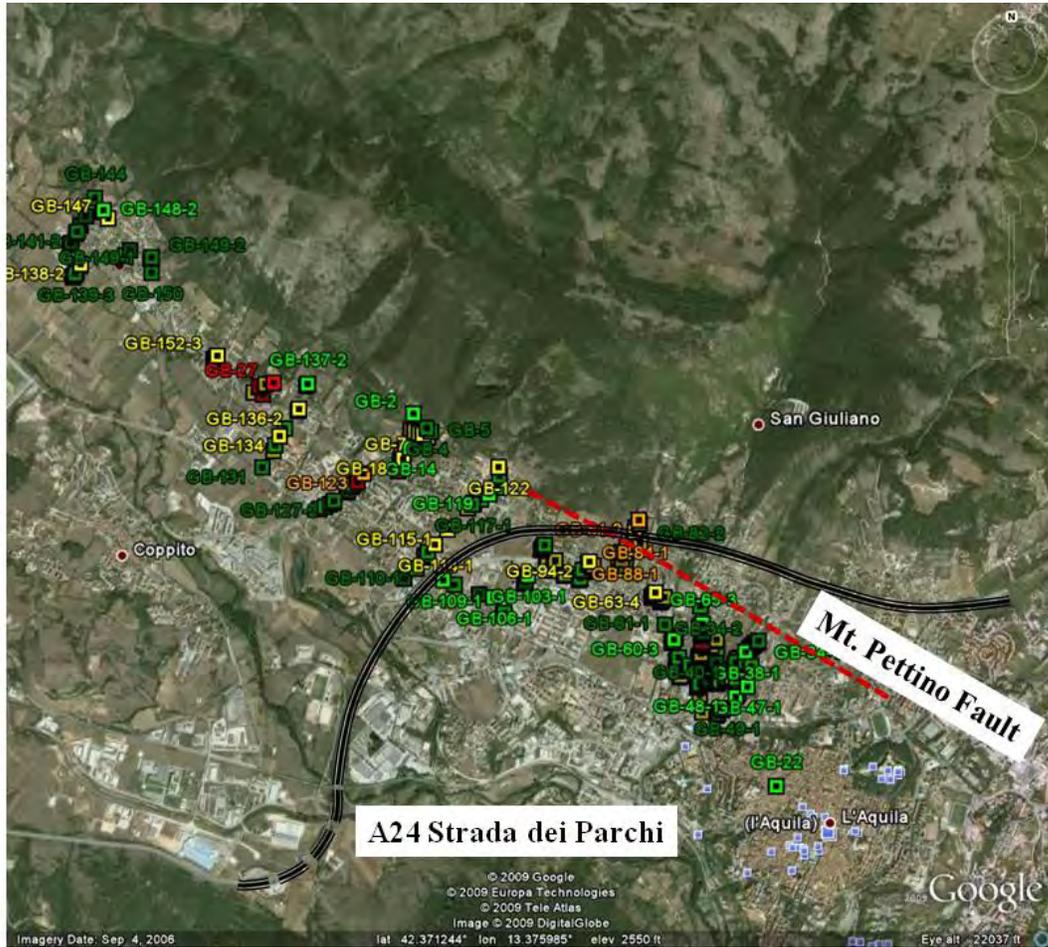
Figure 102. Satellite photo from Google Earth of the L'Aquila with a general view of the building damage survey.

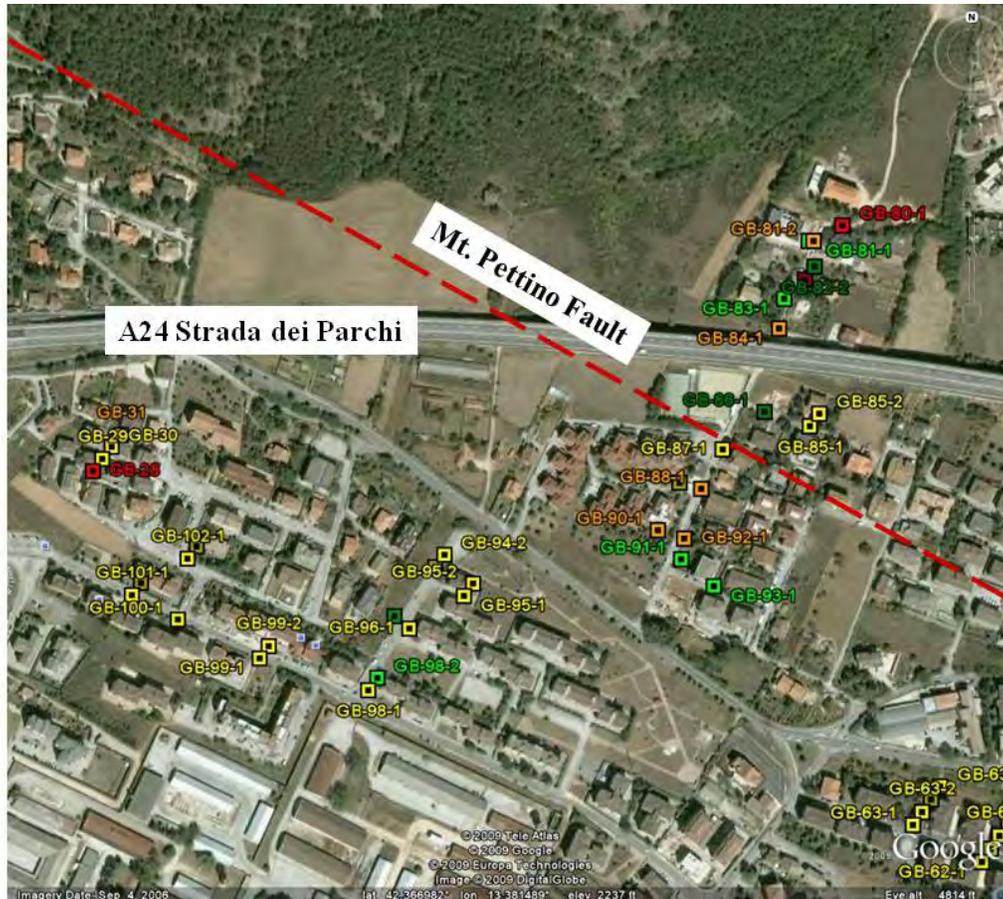
Figure 103. Zone (a) of the building damage survey along the Mt. Pettino Fault.

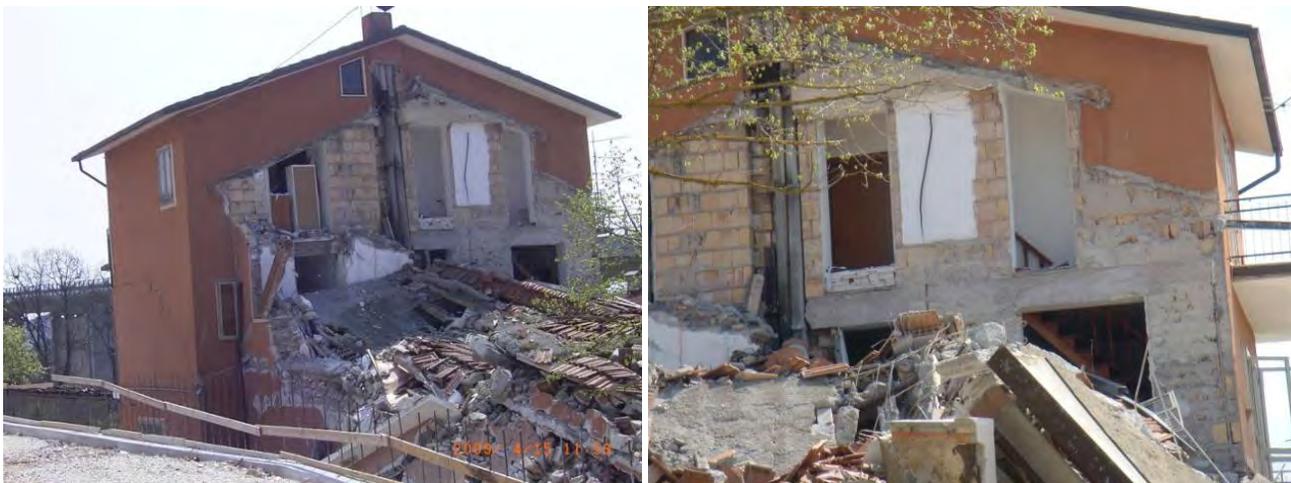
Figure 104. Masonry structure at waypoint GB-82-1.

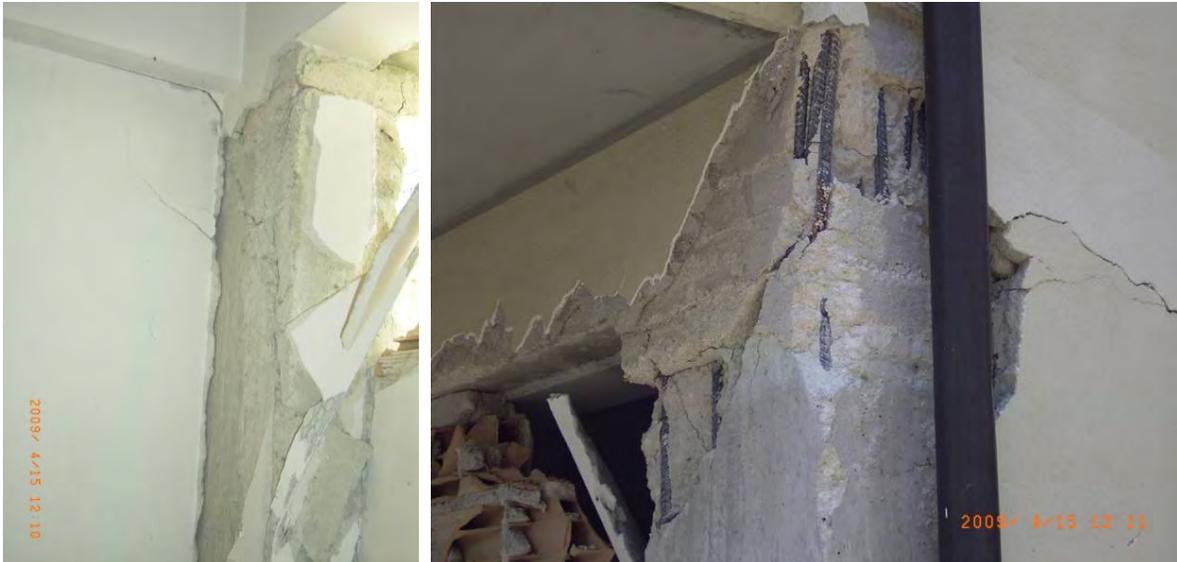
Figure 105. Example of D3 damage in the building at waypoint GB-88-1.

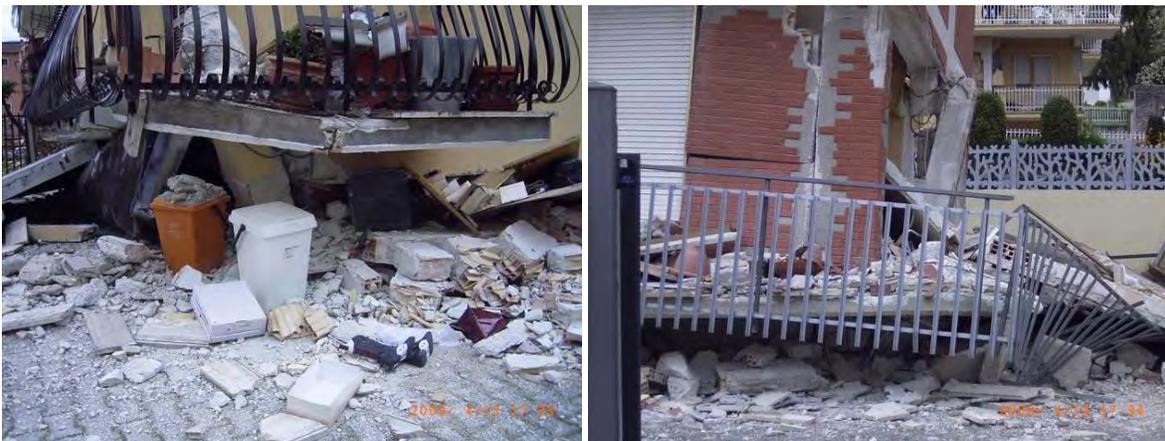
Figure 106. Example of D5 damage in the building at waypoints GB-27-1 and GB-28-1.

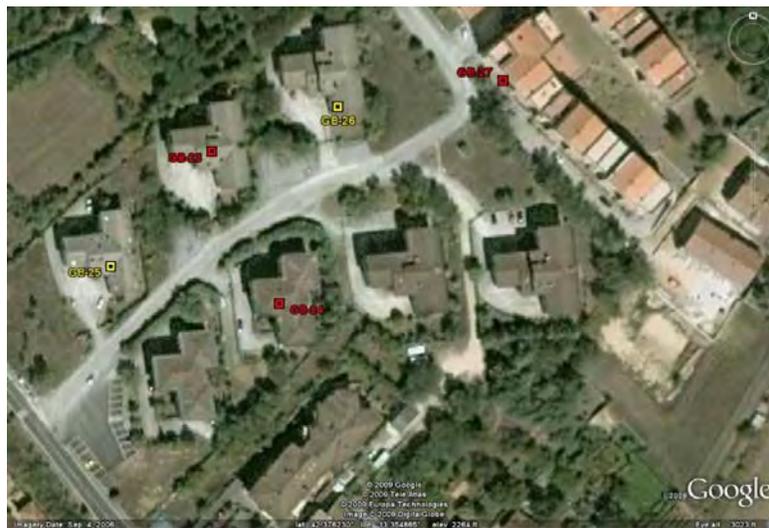
Figure 108. Cluster of damage in zone (d).

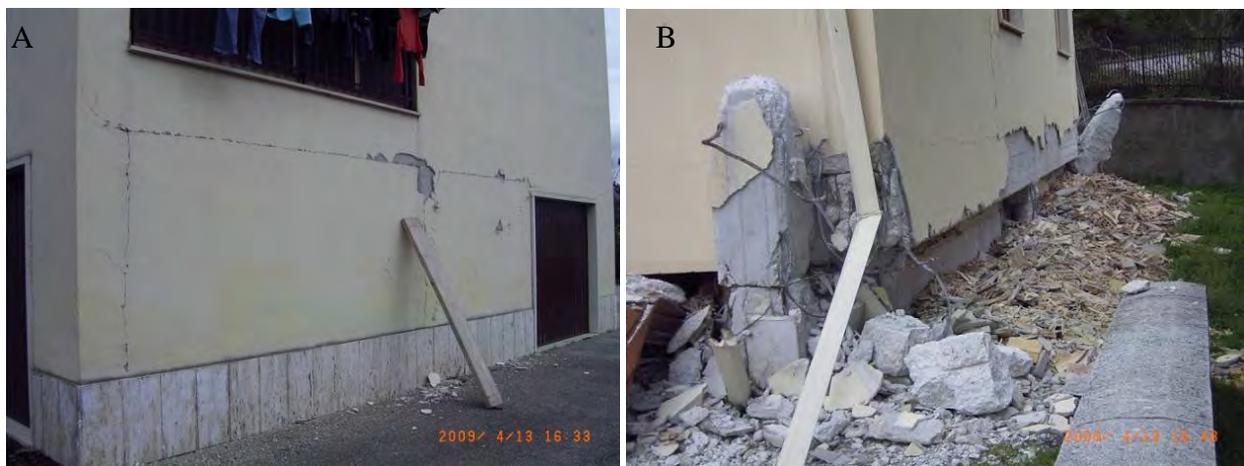
Figure 109. Damage on the structures in the cluster in zone (d). (A) Waypoint GB-22-1 (D1), (B) Waypoint GB-23-1 (D5).

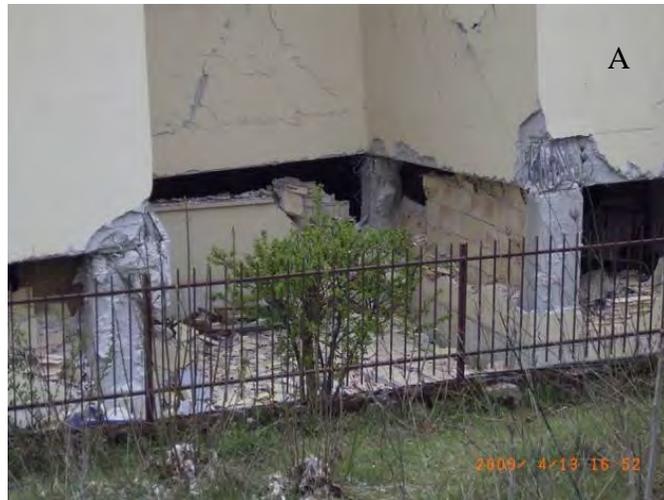
Figure 110. Damage on the structures in the cluster in zone (d). (A) Waypoint GB-24-1 (D5).

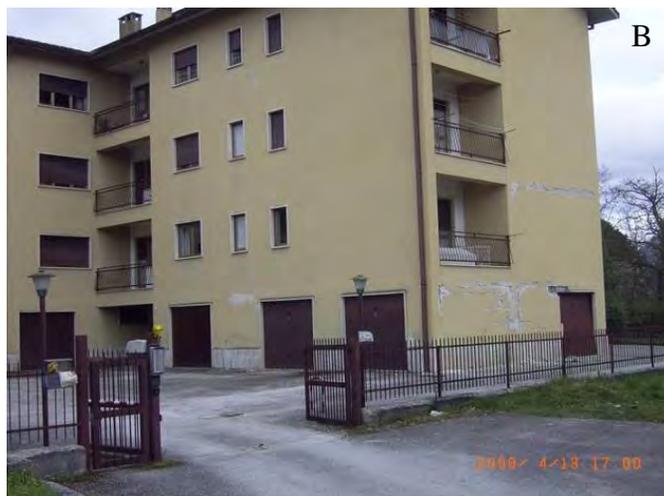
Figure 110. Damage on the structures in the cluster in zone (d). (B) Waypoint GB-25-1 (D2).

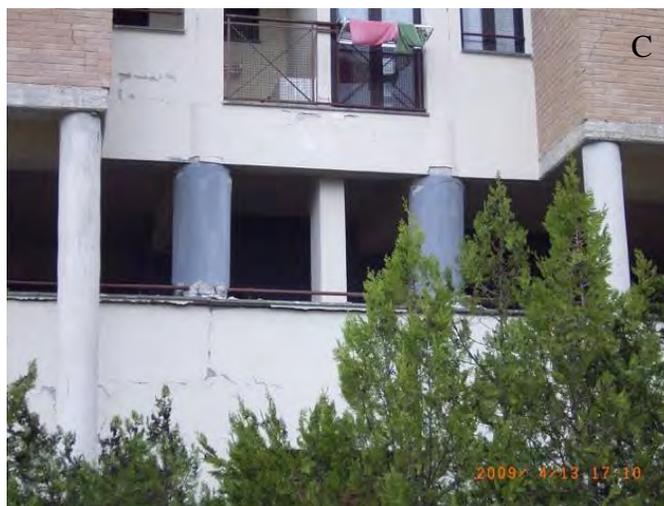
Figure 110. Damage on the structures in the cluster in zone (d). (C) Waypoint GB-26-1 (D2).

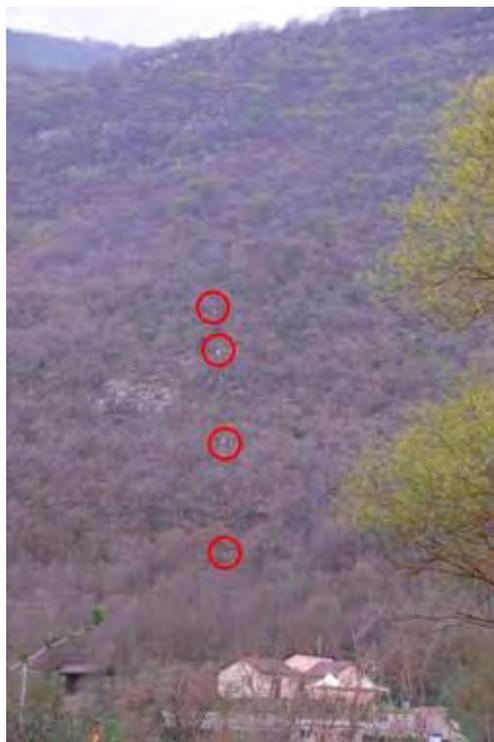
Figure 116. Additional impact marks as indicated by an alignment of fresh scars (42.255N 13.547E).

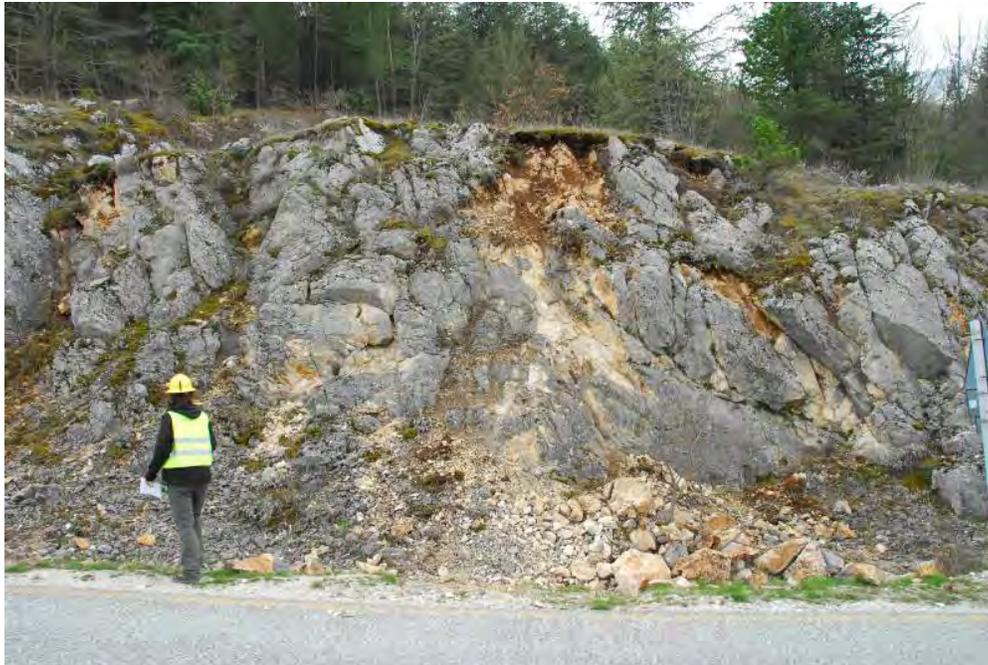
Figure 117. Shallow ravelling-type failure of weathered limestone blocks (42.278N, 13.467E).

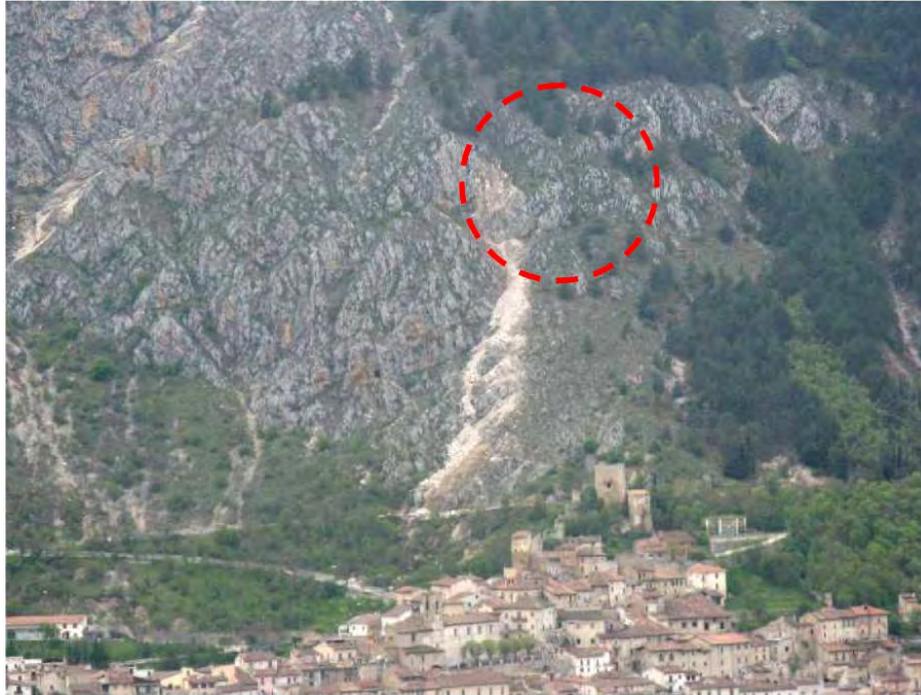
Figure 119. View of Fossa from Mt. Di Cerro. The detachment area of the rock failure that generated the rock avalanche is circled (42.29274N,13.48575E).

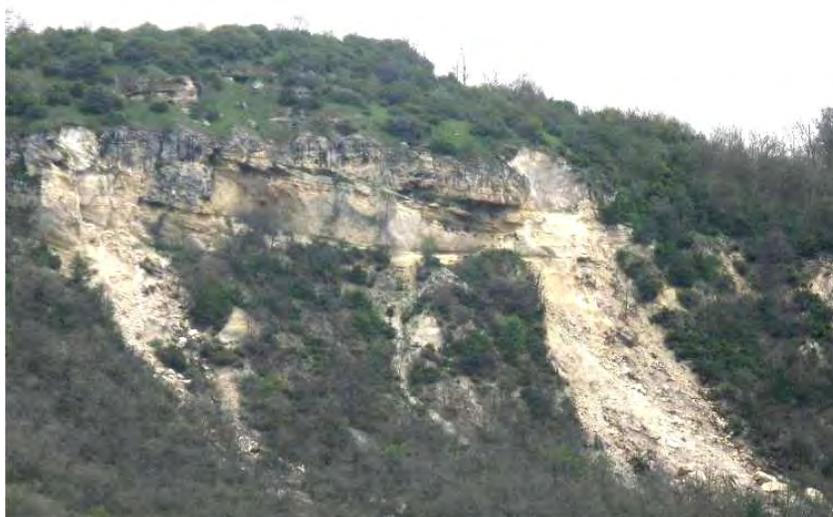
Figure 120. View of the cliff overlooking the northeastern side of Lake Sinizzo. Two failures in the overhanging thick layers of conglomerates are apparent with the related rock avalanches (42.292N, 13.580E).

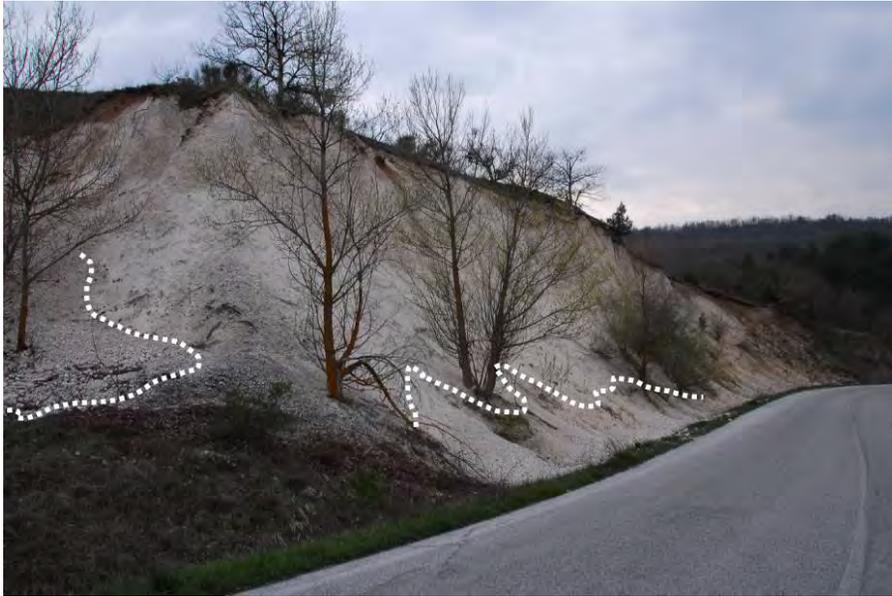
Figure 121. Minor ravelling of weakly cemented sand and gravel; dashed lines indicate the extent of freshly deposited talus along the base of road cut (Via Opi N42.261, E13.581).

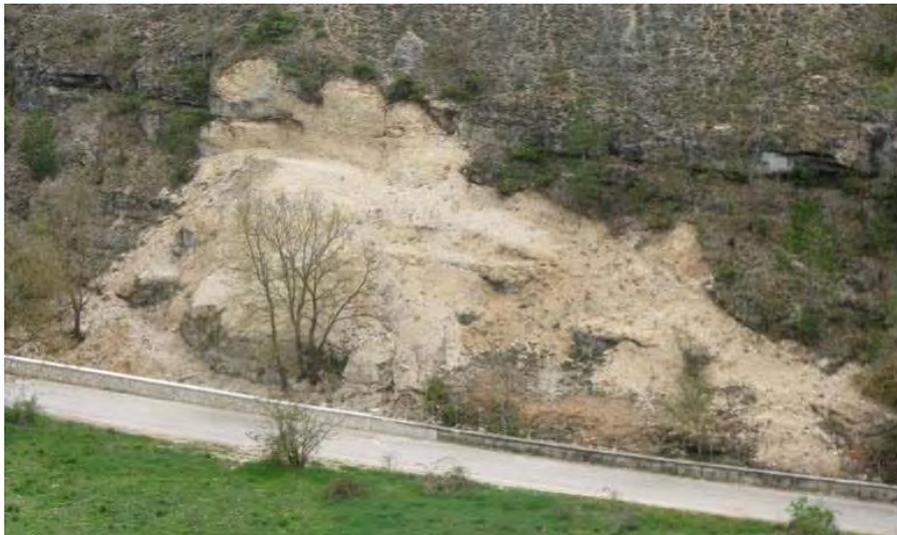
Figure 122. Ravelling along the road from S. Demetrio to Lake Sinizzo (42.28845N,13.56442E).

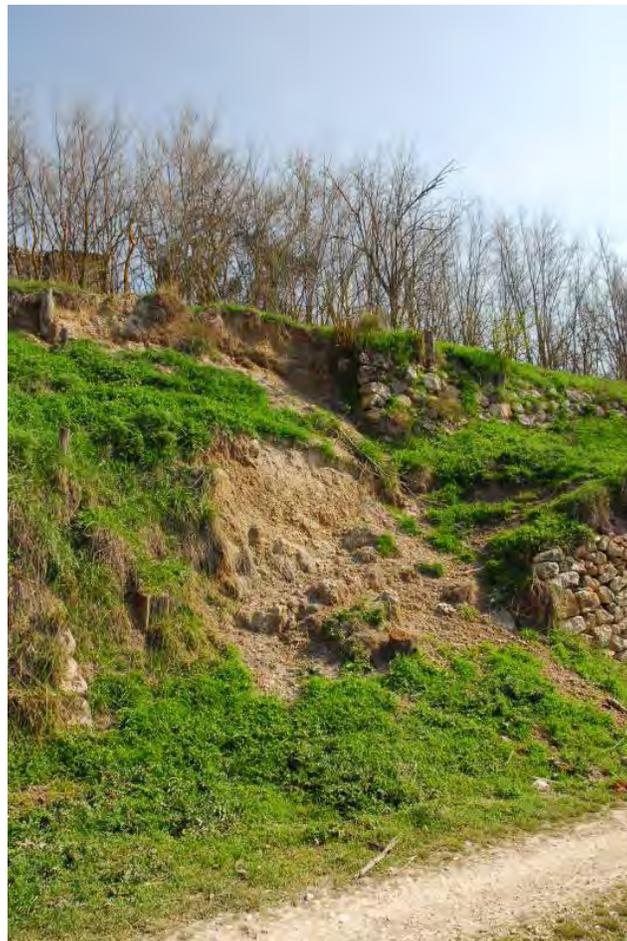
Figure 123. Shallow sloughing of regolith along road cut (southern flank of Castelnuovo N42.294, E13.628).

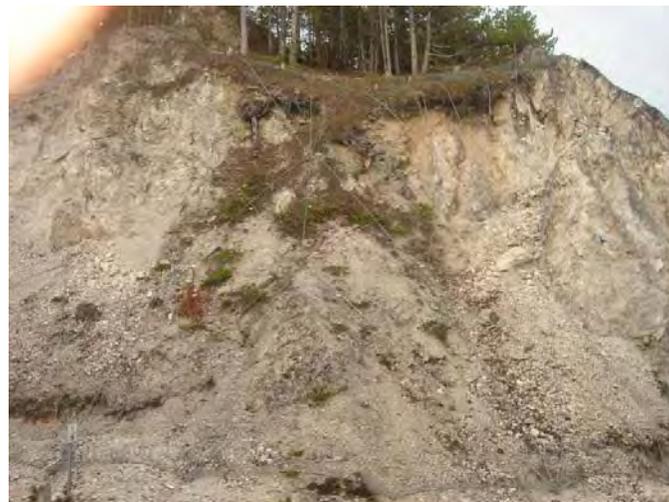
Figure 131. Ravelling in pervasively fractured/cataclastic limestones on a road cut retained by steel-net protections on SS80 at km 18.2: (DC-18-1) (42.4281N, 13.3460E).

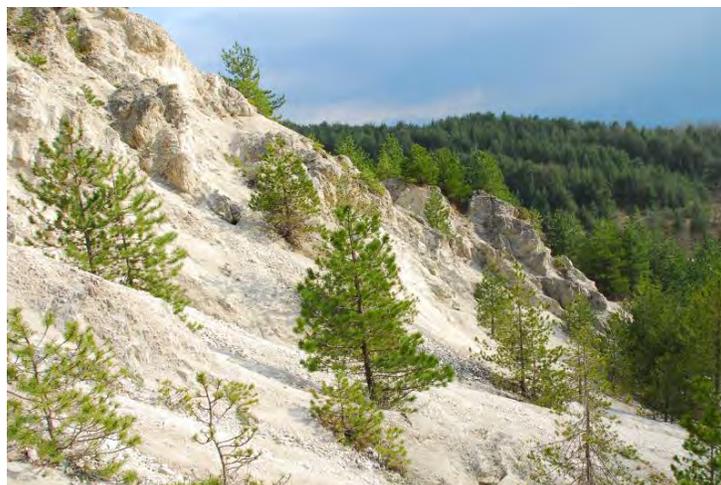
Figure 132. Characteristic erosional scars developed in cataclasite (42.434N, 13.334E).

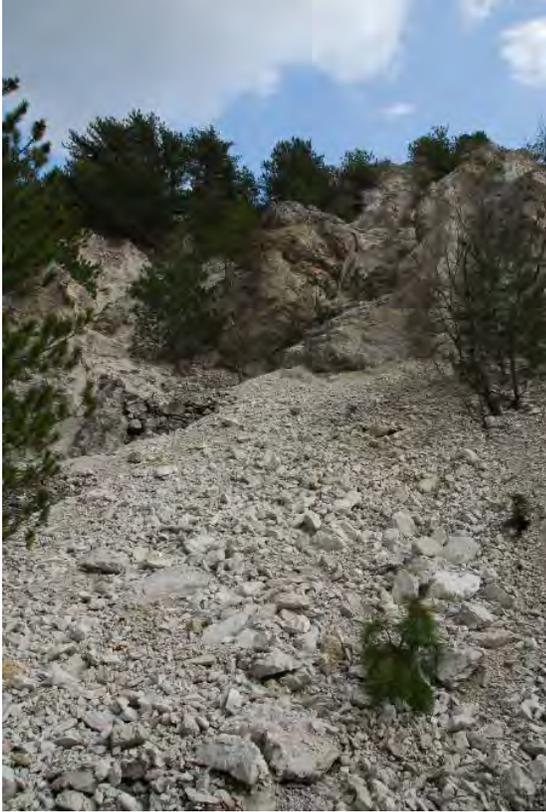
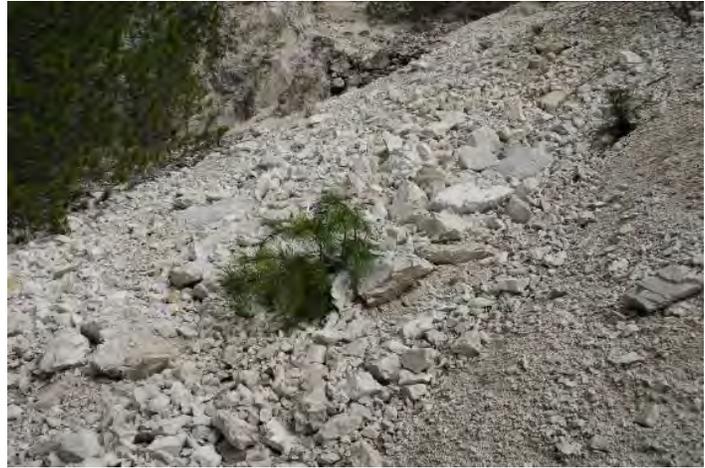
Figure 133. Characteristic ravelling-type failure in natural outcrops of cataclasite; partially buried pine trees evidence recent movement (42.434N, 13.334E).

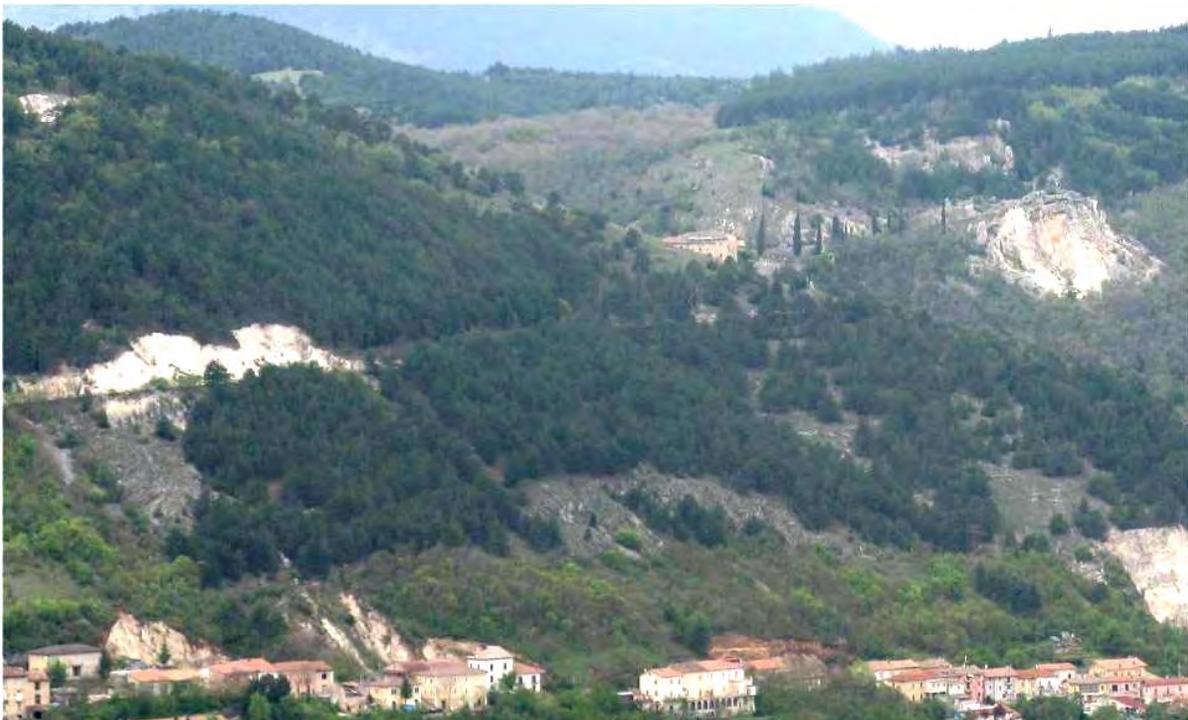
Figure 134. Slides in cataclasites along the road from Fossa to S. Angelo d'Ocre. Detail of the spur on the right is in fig 5.24 (42.29694N, 13.48469E).

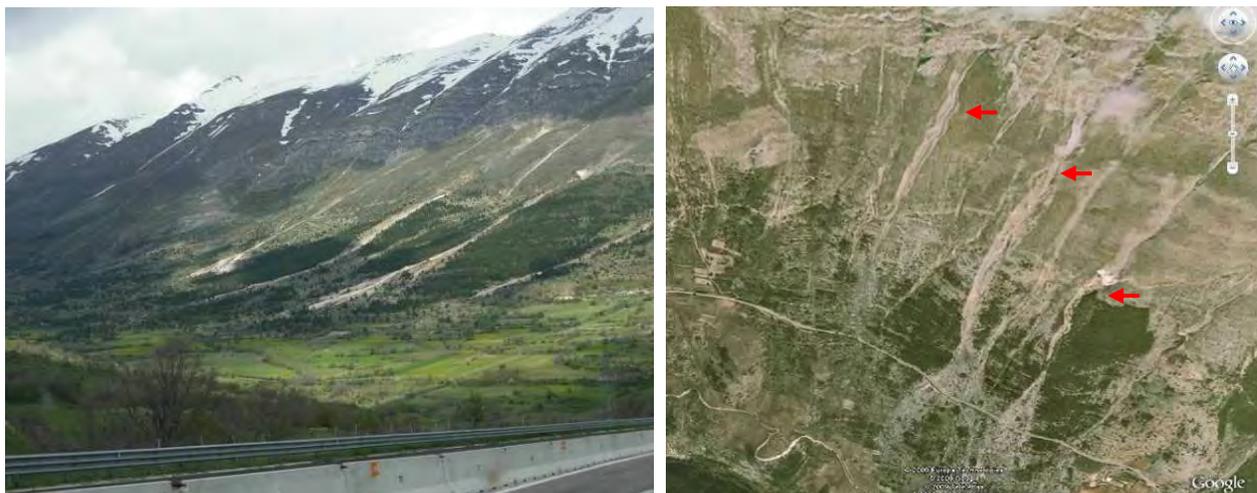
Figure 136. Left view of the Mt. San Franco flank on 4-30-2009. Right: image from Google Earth taken before the earthquake showing the debris flows (42.4368N, 13.5796E).

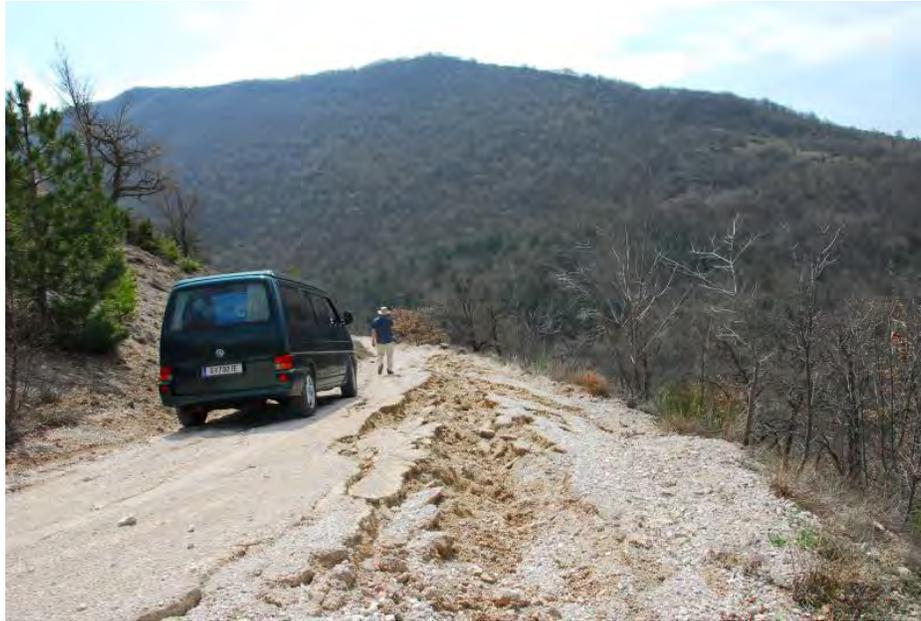
Figure 138. Failure of side-hill fill embankment (42.420N 13.376E).

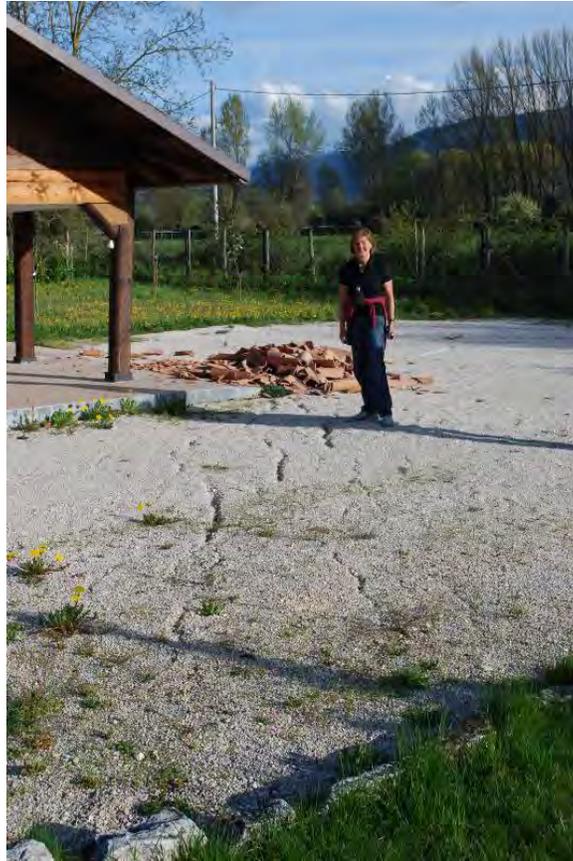
Figure 140. Ground fissures developed in alluvial floodplain directly south of central Onna and approximately 150 m from the Aterno River. Orientation of fissures is approximately parallel to the river (42.325N, 13.480E).

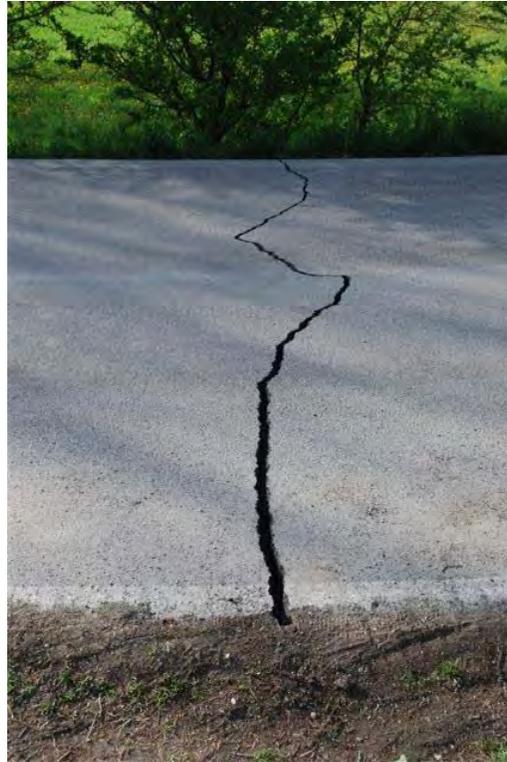
Figure 142. Typical tensile condition of road cracks, not extending into neighboring sub-base or approach fill embankment (42.324N, 13.478E).

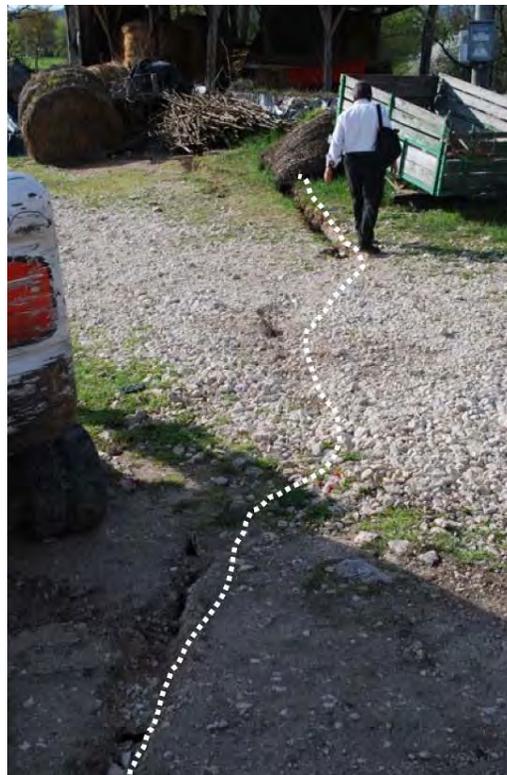
Figure 143. Ground cracks up to 1.0 m deep, 20 m long, and with maximum of 15 cm vertical displacement (down-dropped toward river) developed directly adjacent to bridge abutment (42.324N, 13.478E).

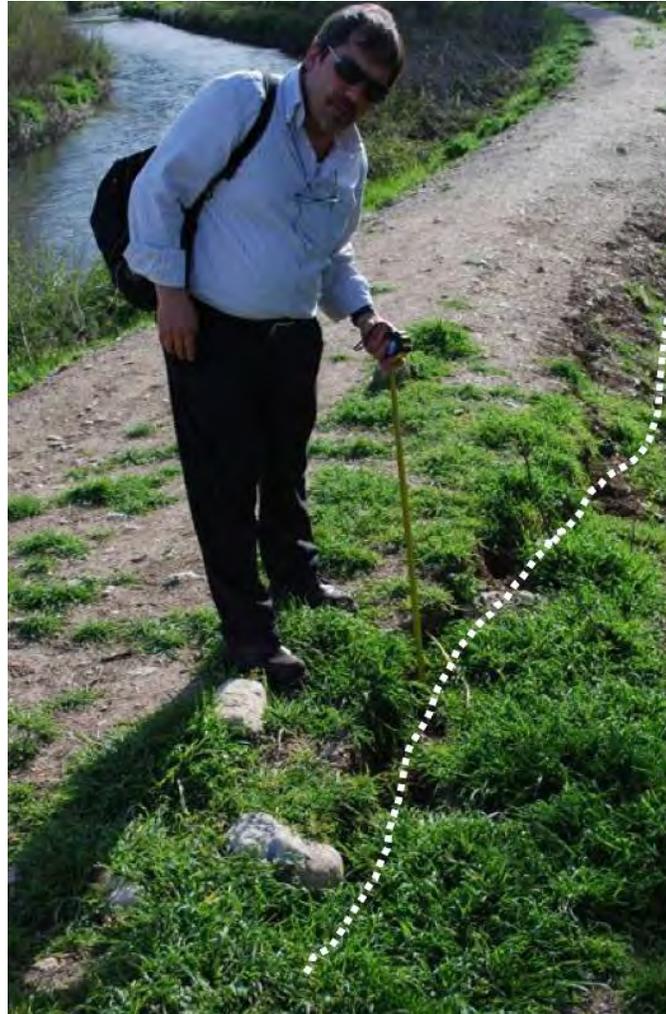
Figure 144. Ground cracks developed along levee crest adjacent to bridge abutment (42.324N, 13.478E).

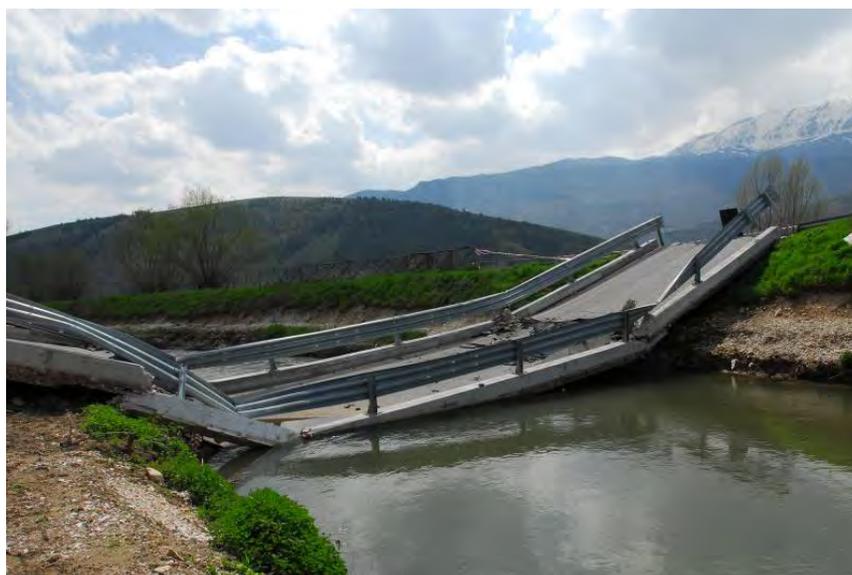
Figure 145. Bridge collapse along the Aterno River, approximately 450 m north of Monticchio (42.325N, 13.463E).

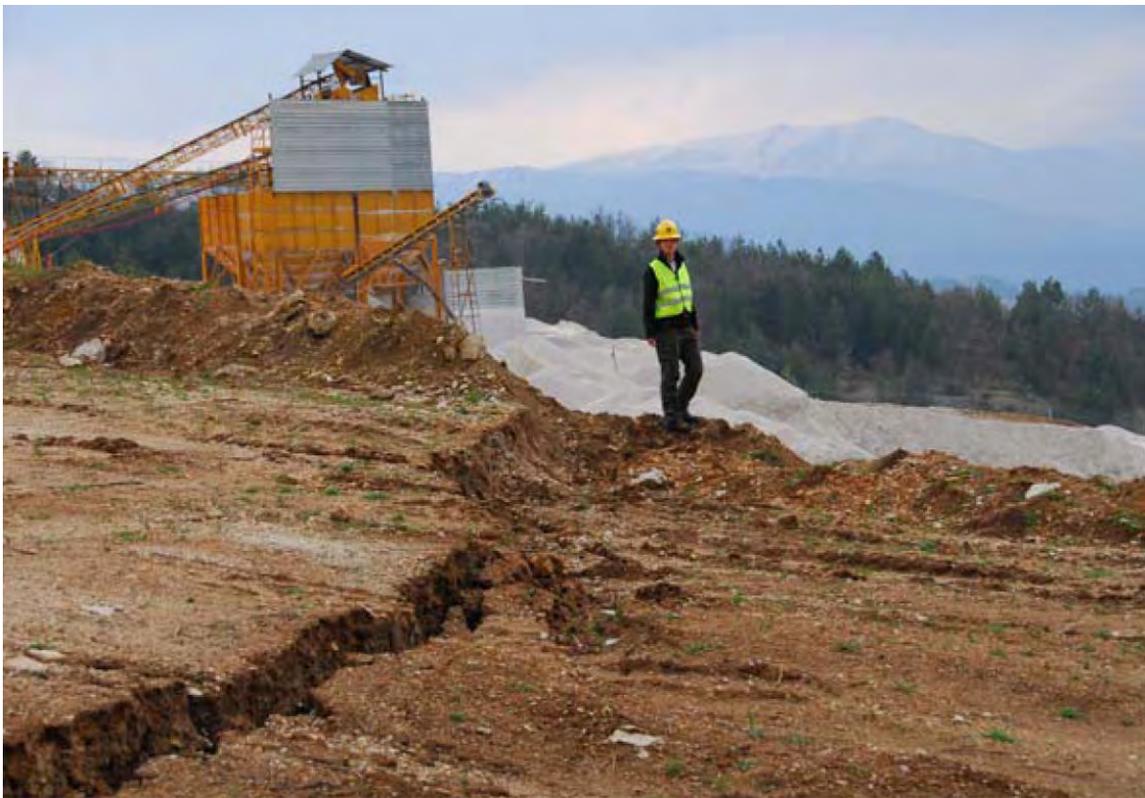
Figure 149. Shear failure developed in fill material, with vertical displacement increasing to approximately 40 cm at free slope face (42.435N, 13.330E).

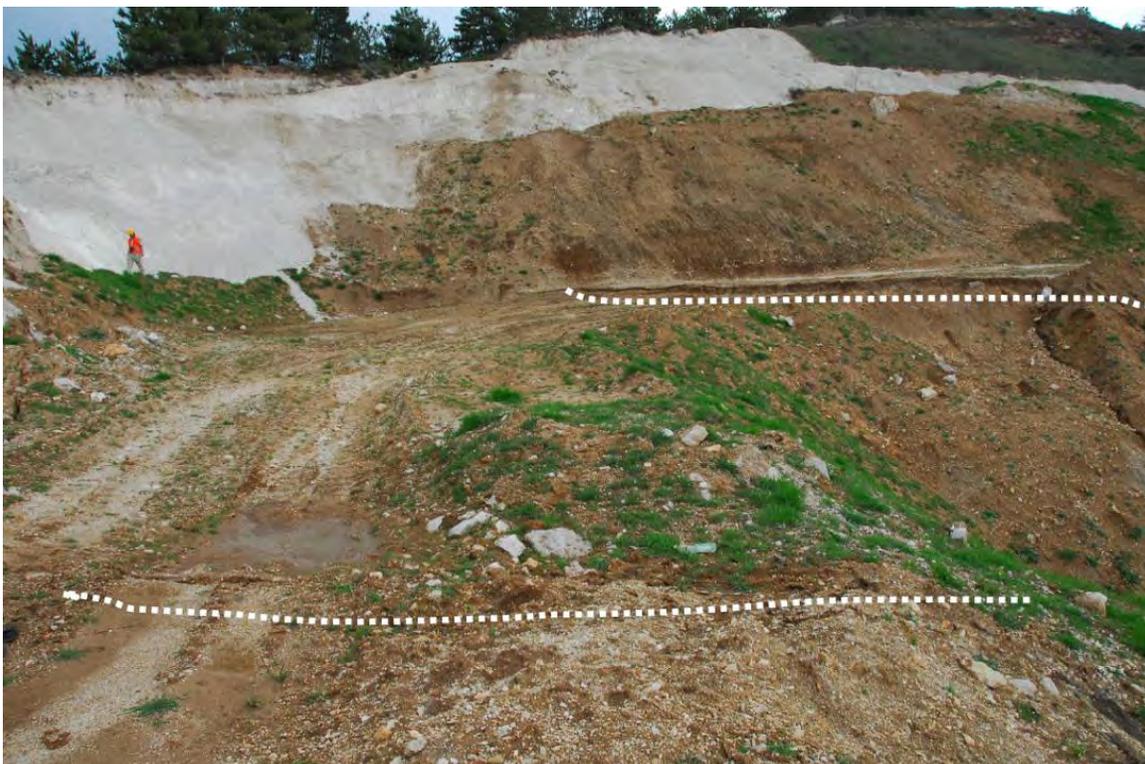
Figure 150. Graben structure (between lines) created by parallel down-dropped shears (42.435N, 13.330E).

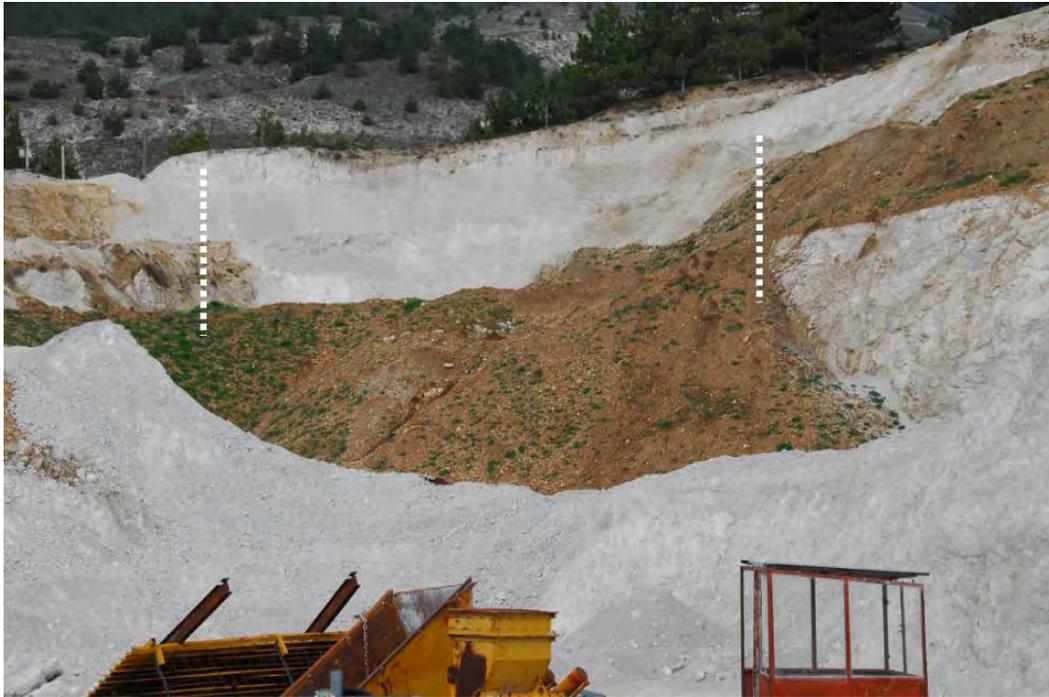
Figure 151. Graben structure (between vertical lines) and bedrock boundary conditions (42.435N, 13.330E).

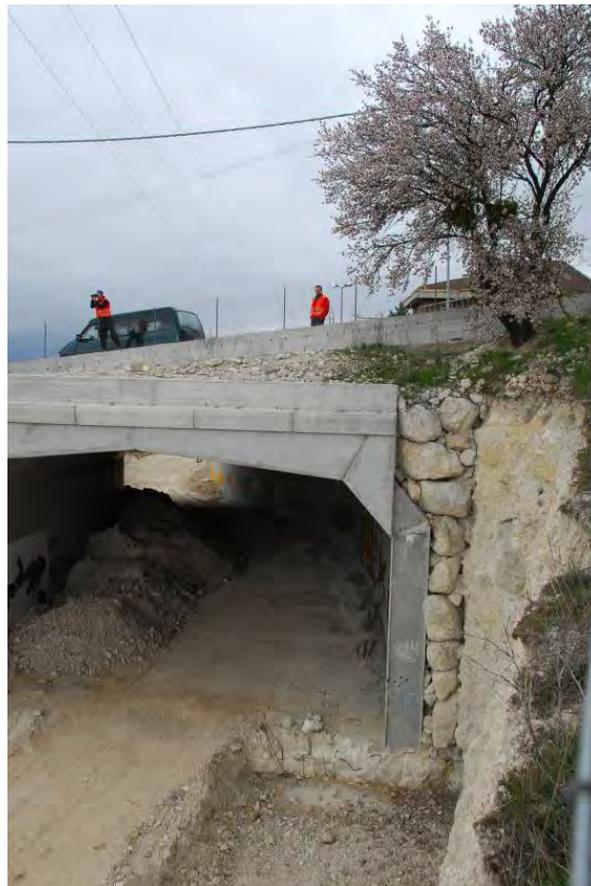
Figure 152. Boulder fill placed along side wall of cut-and-cover structure (42.358N 13.415E).

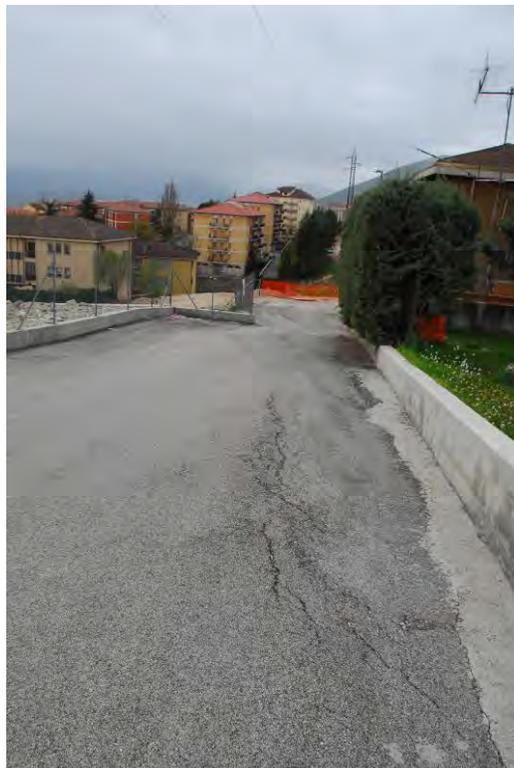
Figure 154. Cracks in the overlying asphaltic surfaces and a narrow settlement trend along the sidewall of the cut-and-cover structure (42.358N 13.415E).

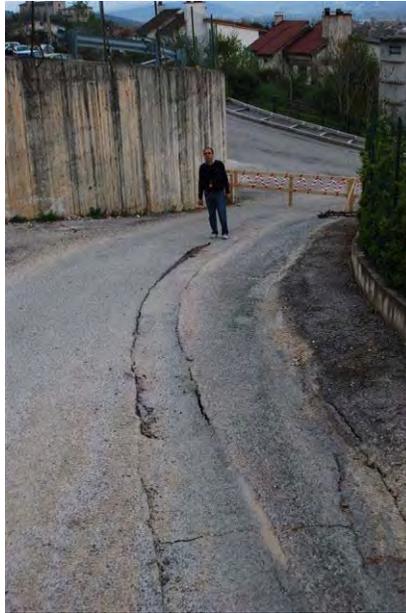
Figure 155. Seismic compression of trench backfill in the town of Paganica (42.365N, 13.465E).

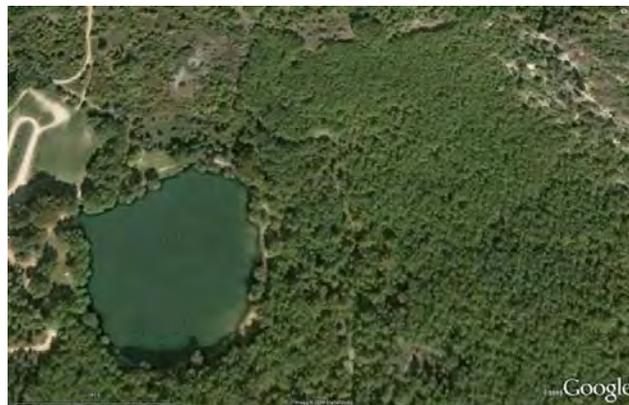
Figure 156. Overview of Lake Sinizzo with location of impounding embankment indicated by vertical white line (42.291N 13.576E).

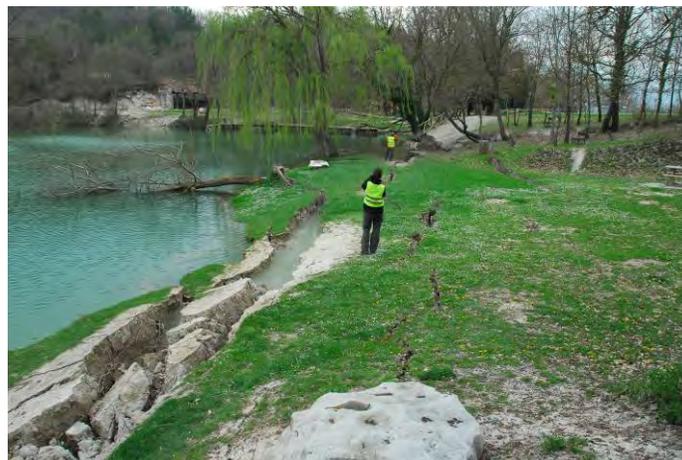
Figure 158. Ground cracks along the northwestern perimeter of Lake Sinizzo (42.291N, E13.576).

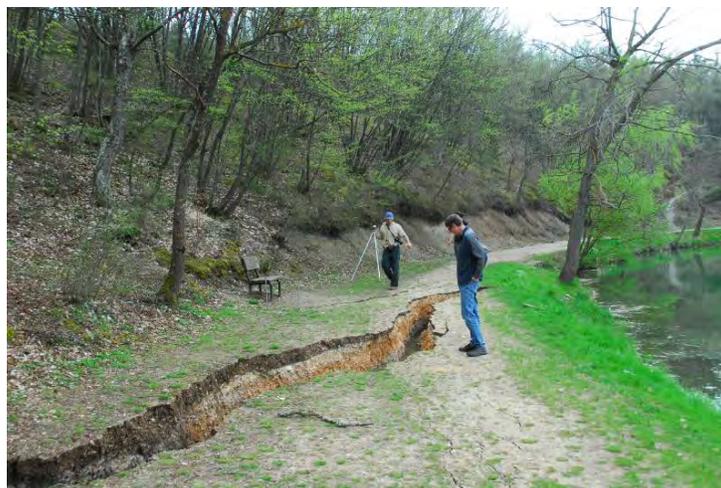
Figure 159. Ground cracks along the eastern perimeter of Lake Sinizzo (42.291N, E13.576).
