Seismological and geotechnical aspects of the $M_w=6.3$ L'Aquila earthquake in central Italy on 6 April 2009

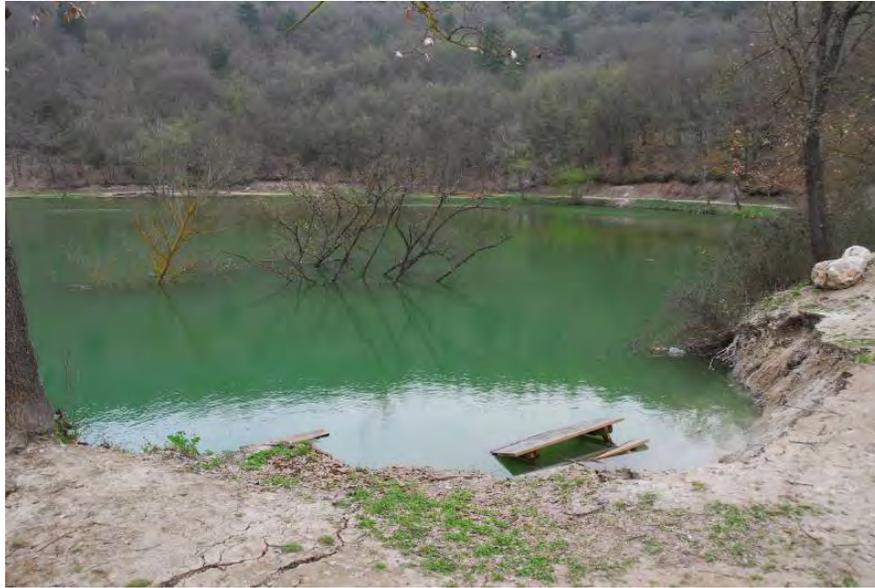
Figure 160. Submerged trees located several meters from the western margin of Lake Sinizzo; picnic table within arcuate landslide scar at shoreline. (42.291N 13.576).

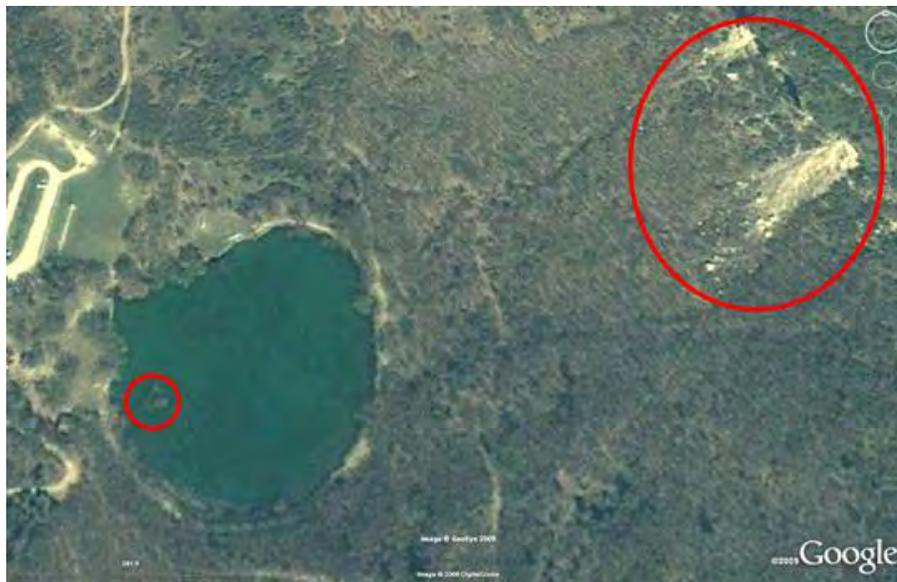
Figure 161. Post earthquake satellite imagery showing submerged trees within small circle and rock slope failures within large circle; compare to pre-earthquake imagery shown in Figure 146 (42.291N 13.576).

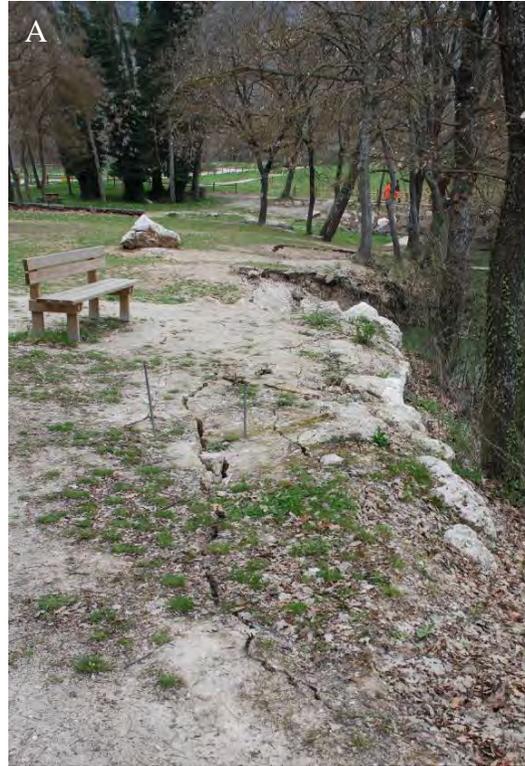
Figure 162. Ground cracks at the southwest corner of Lake Sinizzo (location WP 18) as observed on (A) 11 April 2009.

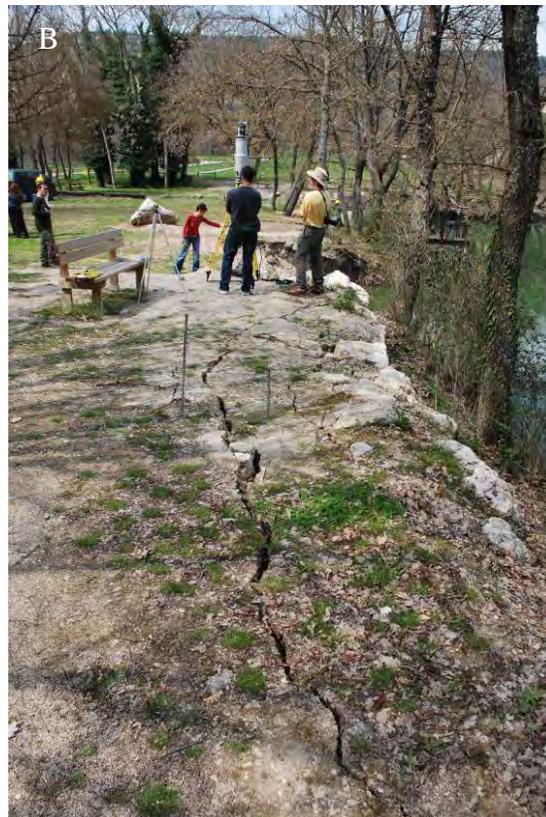
Figure 162. Ground cracks at the southwest corner of Lake Sinizzo (location WP 18) as observed on (B) 15 April 2009.

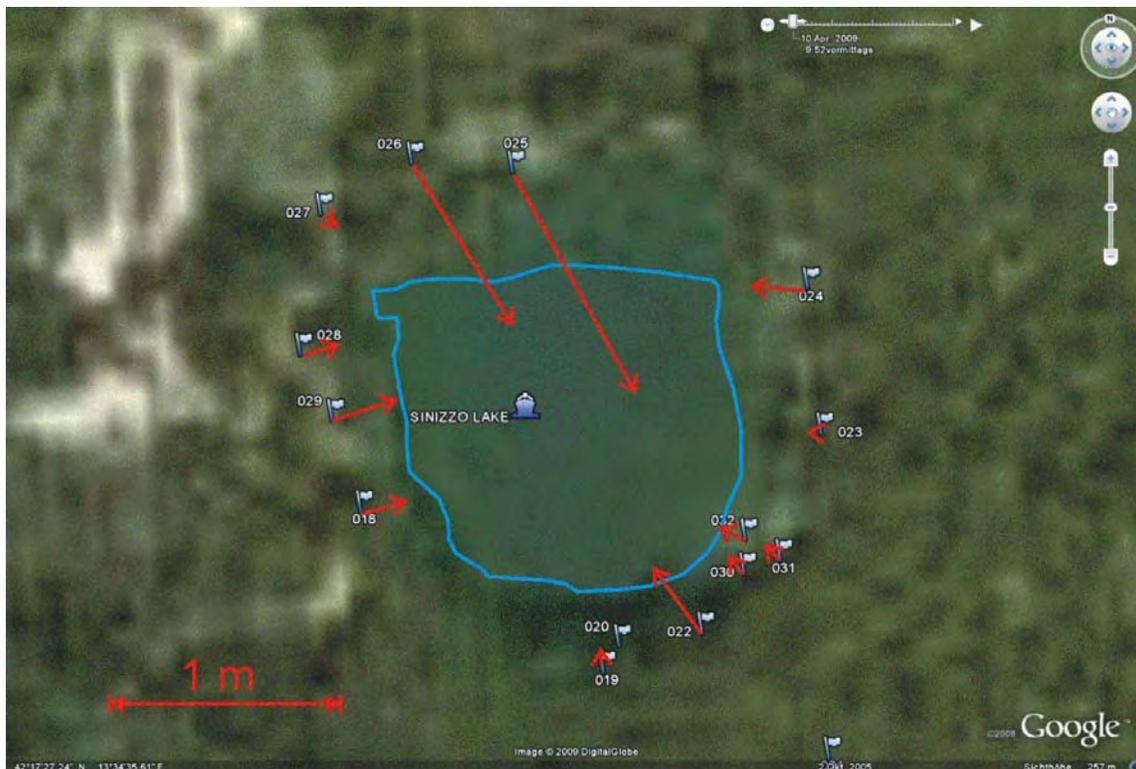
Figure 163. GPS waypoints indicating measurement locations around Lake Sinizzo. The red arrows indicate the orientation and maximum cumulative crack opening measured at each location.

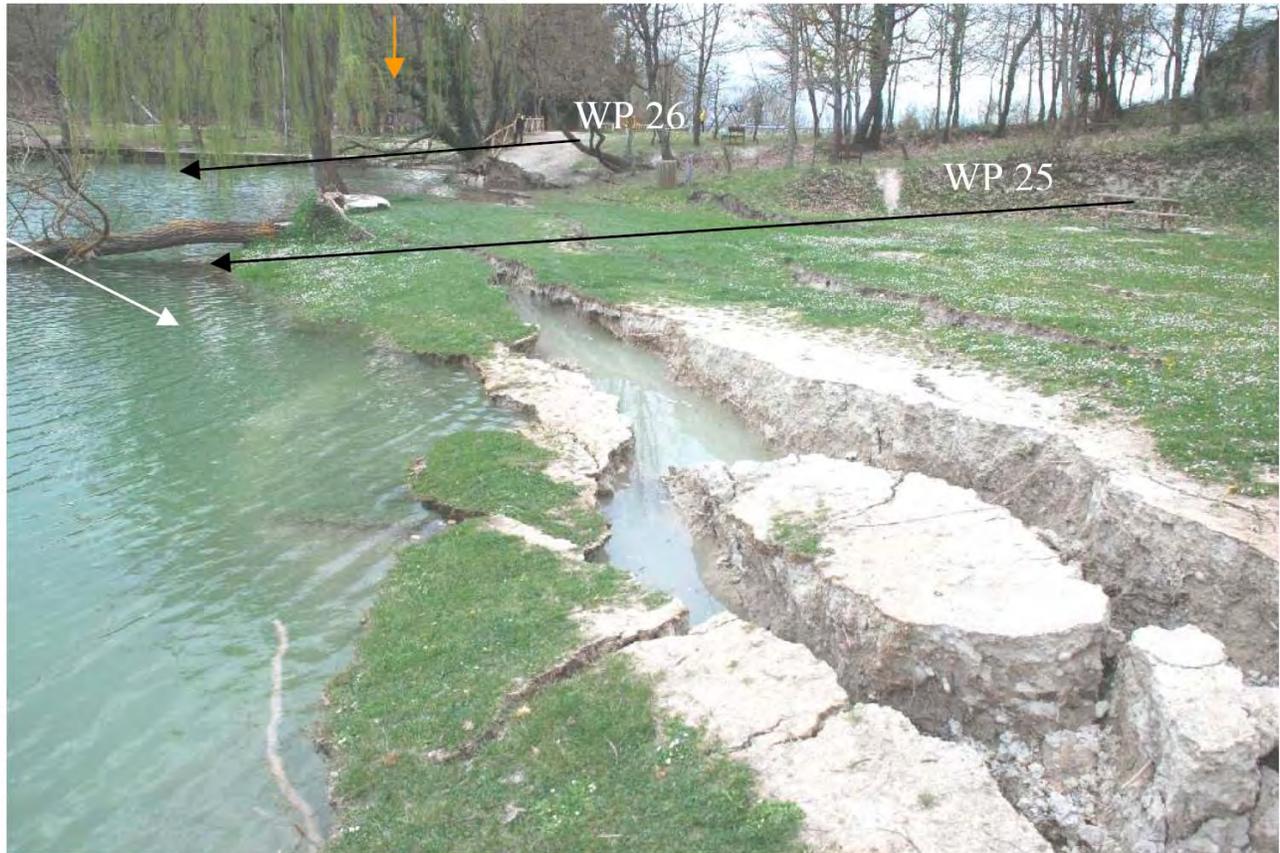
Figure 164. Blocks lying under the water (white arrow) were not included in the traverses (WP 25 and WP26). The orange arrow shows where the fence (and the slump below it) truncated the traverse at WP 27. (Photo E. Button).

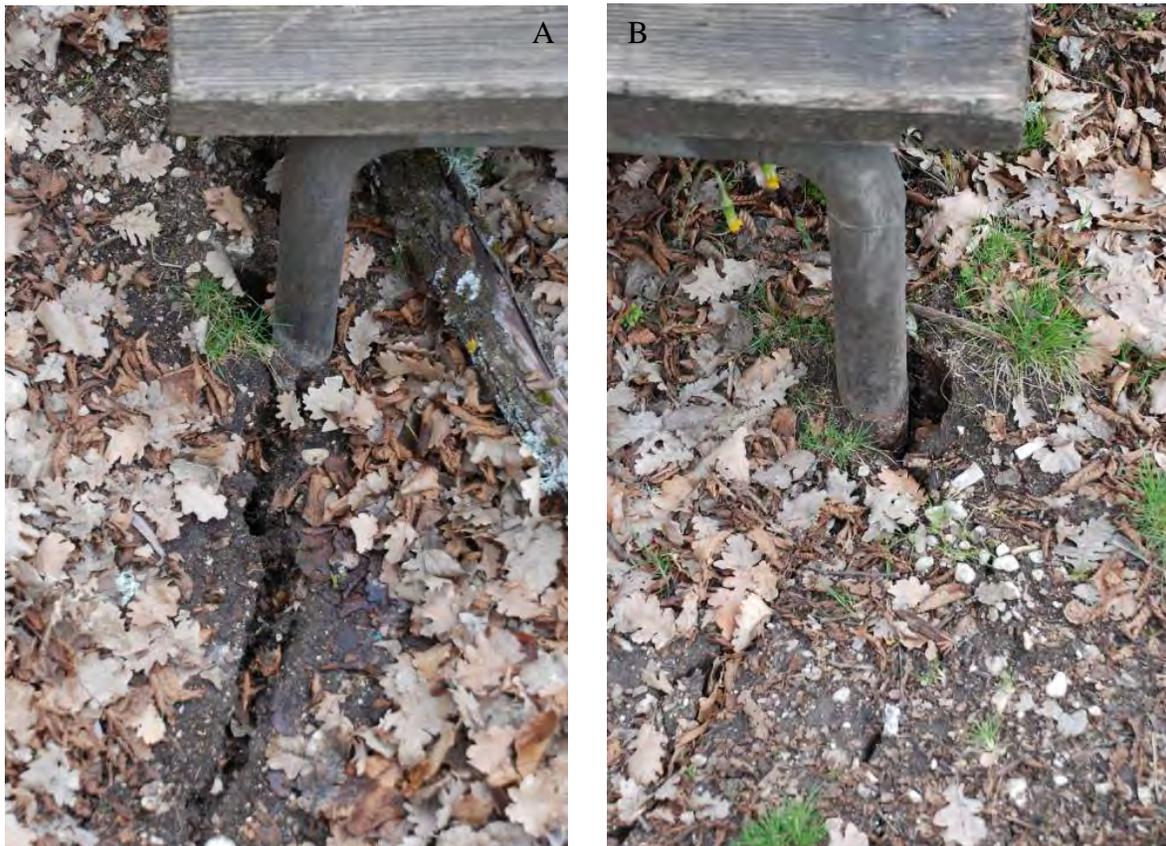
Figure 167. Characteristic deformations associated with the corners of the park bench at WP 31. (A) corner C2, (B) corner C3.

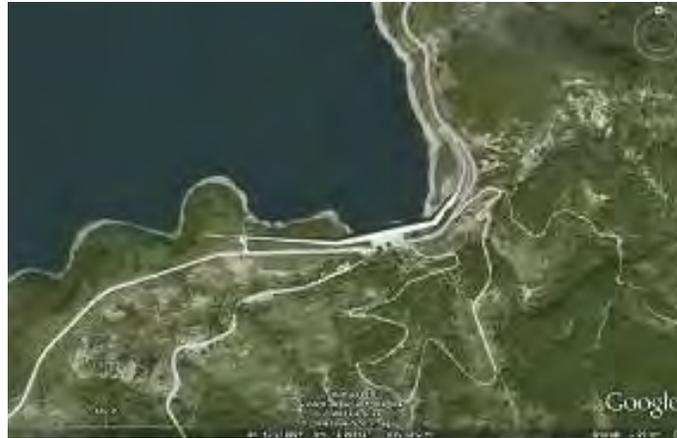
Concrete Dam Cross Section

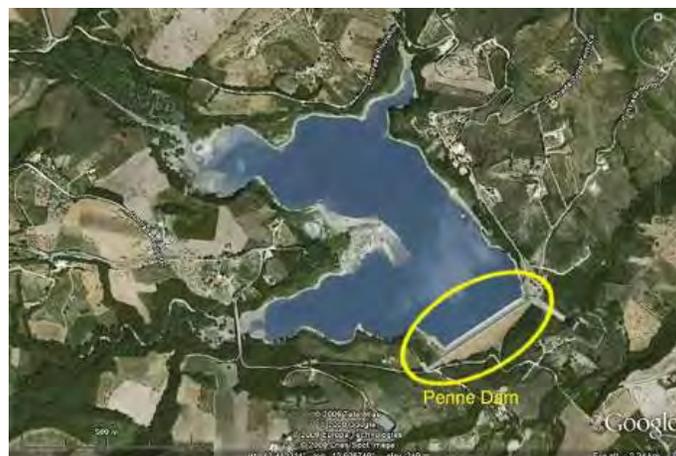
Figure 184. Location map for Penne reservoir and dam (42.438809°N, 13.913265°E).

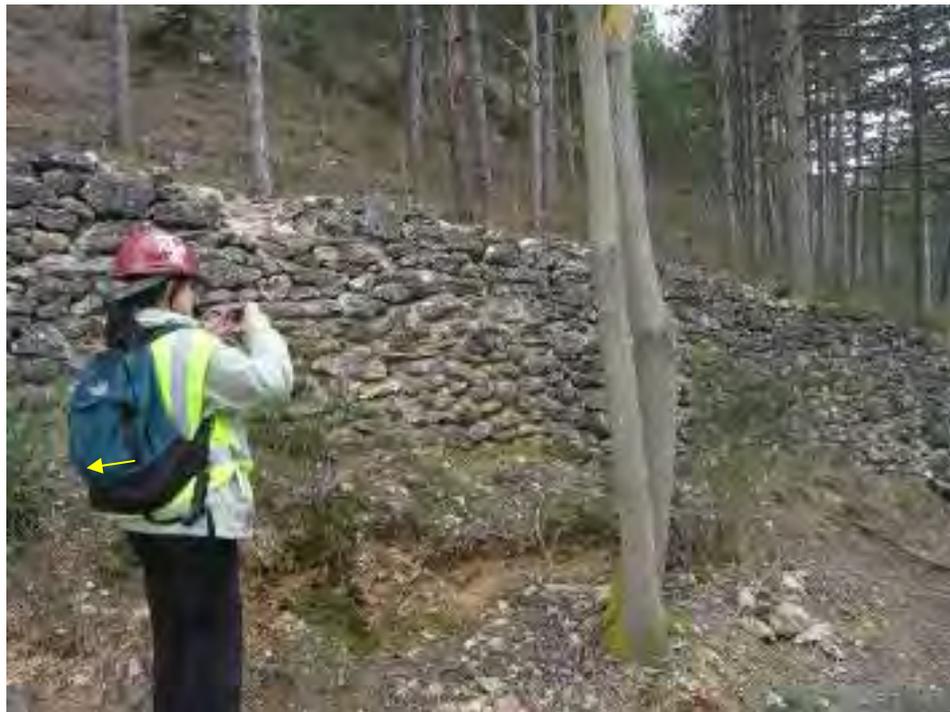
Figure 185. Minor damage on masonry wall in severely shaken Pettino area ($42.374011^{\circ}\text{N}$, $13.367498^{\circ}\text{E}$).

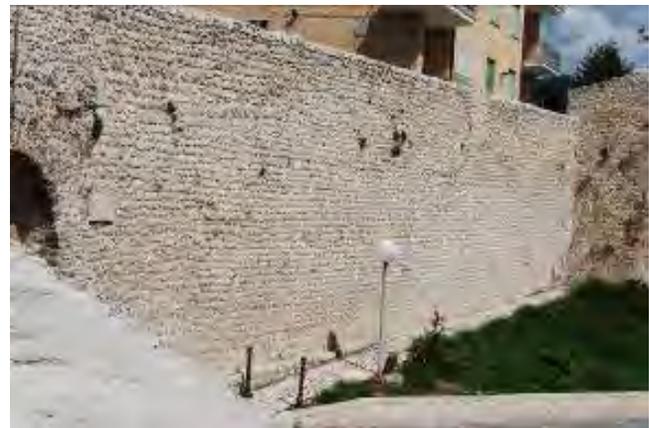
Figure 186. Stone masonry wall at L'Aquila city ($42.348710^{\circ}\text{N}$, $13.403900^{\circ}\text{E}$). Note the (tolerable) outward movement at the center of the wall and the pavement cracks behind the wall.

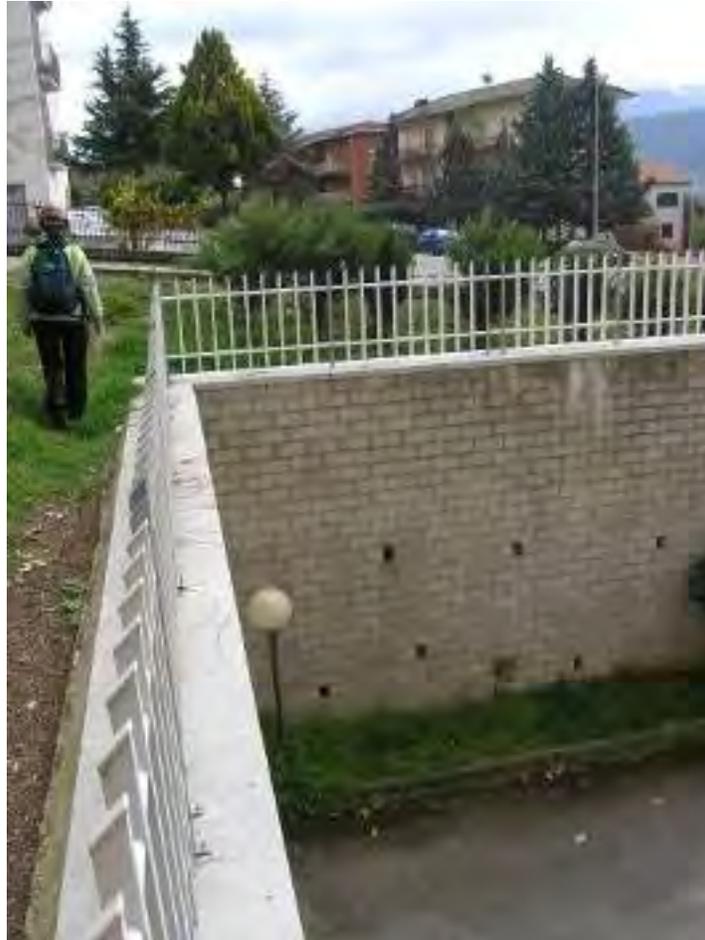
Figure 187. Undamaged wall at the severely shaken Pettino area ($42.373050^{\circ}\text{N}$, $13.366106^{\circ}\text{E}$).

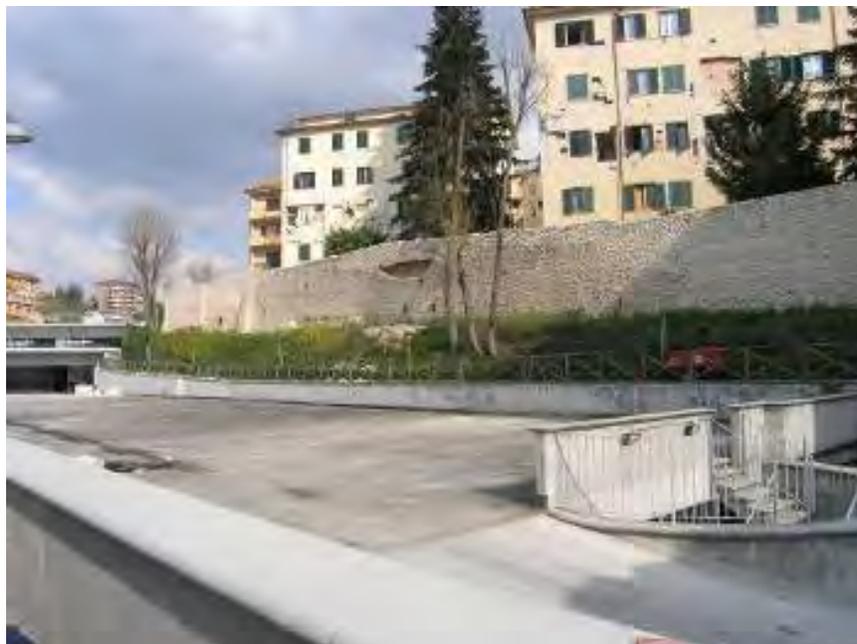
Figure 188. Damaged wall at downtown L'Aquila ($42.356056^{\circ}\text{N}$, $13.389524^{\circ}\text{E}$).

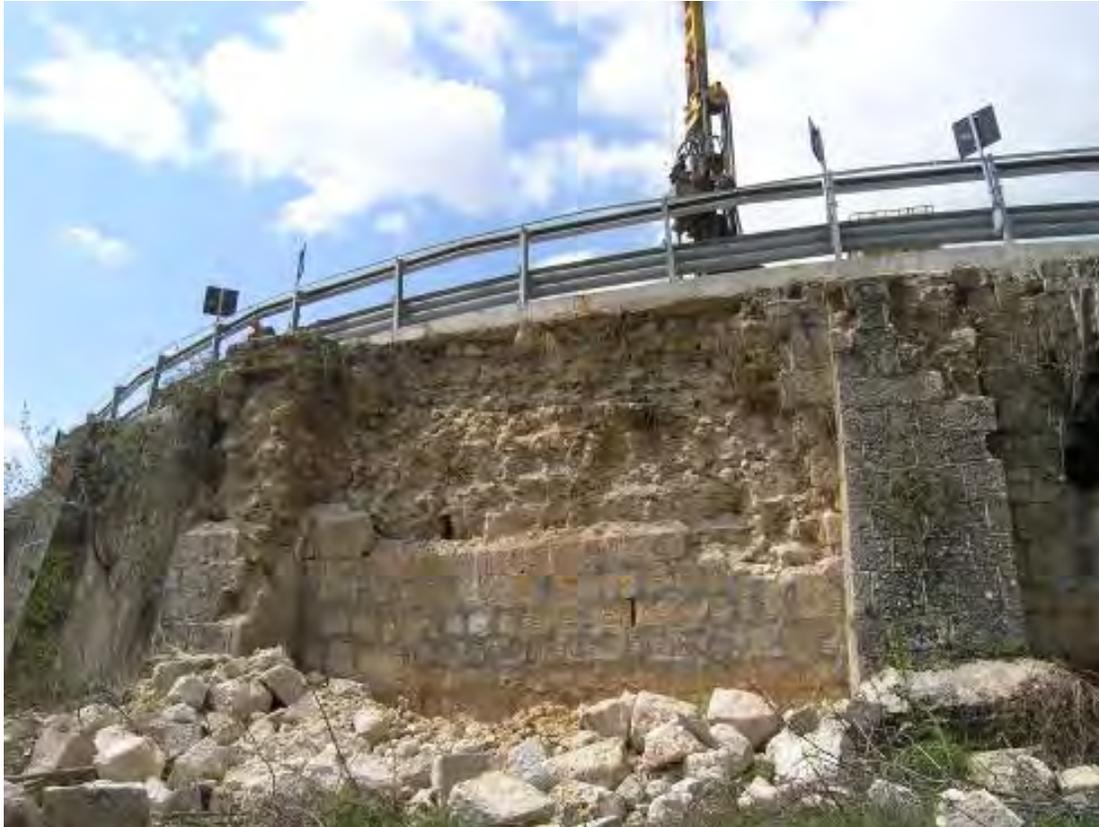
Figure 189. Partially collapsed wall at SS80 highway between L'Aquila and Campotosto ($42.420510^{\circ}\text{N}$, $13.358394^{\circ}\text{E}$).

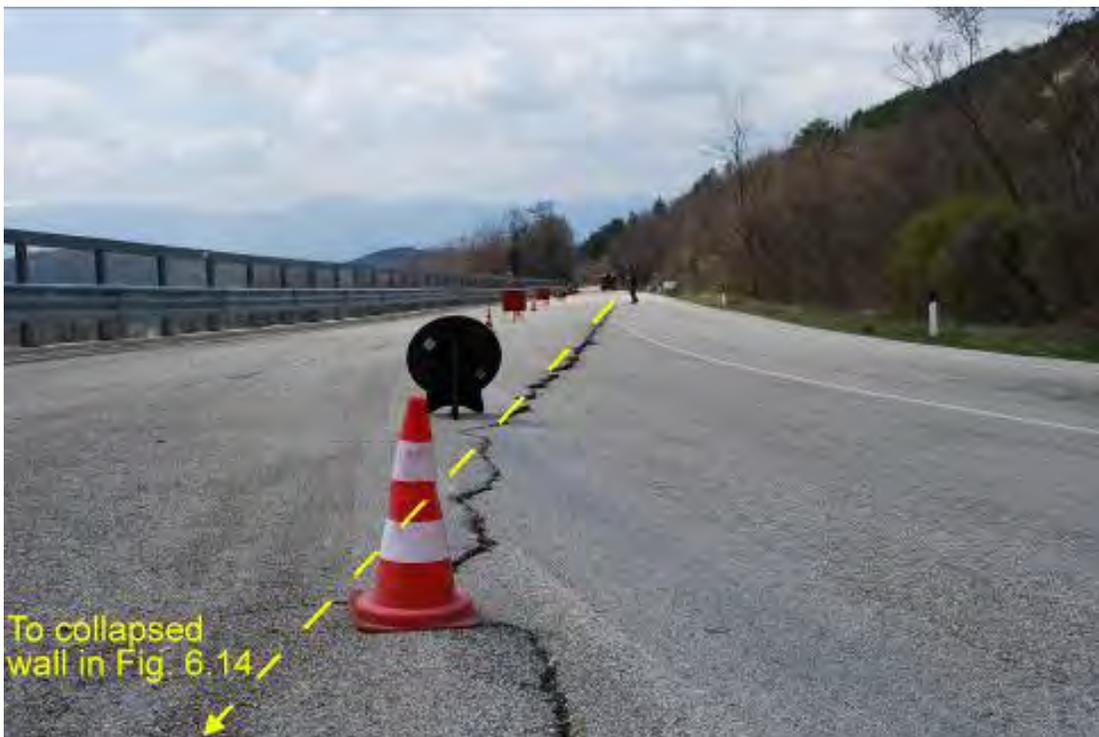
Figure 190. Pavement cracking in SS80 roadway (from L' Aquila to Campotosto) in the location of collapsed masonry retaining wall ($42.420510^{\circ}\text{N}$, $13.358394^{\circ}\text{E}$).

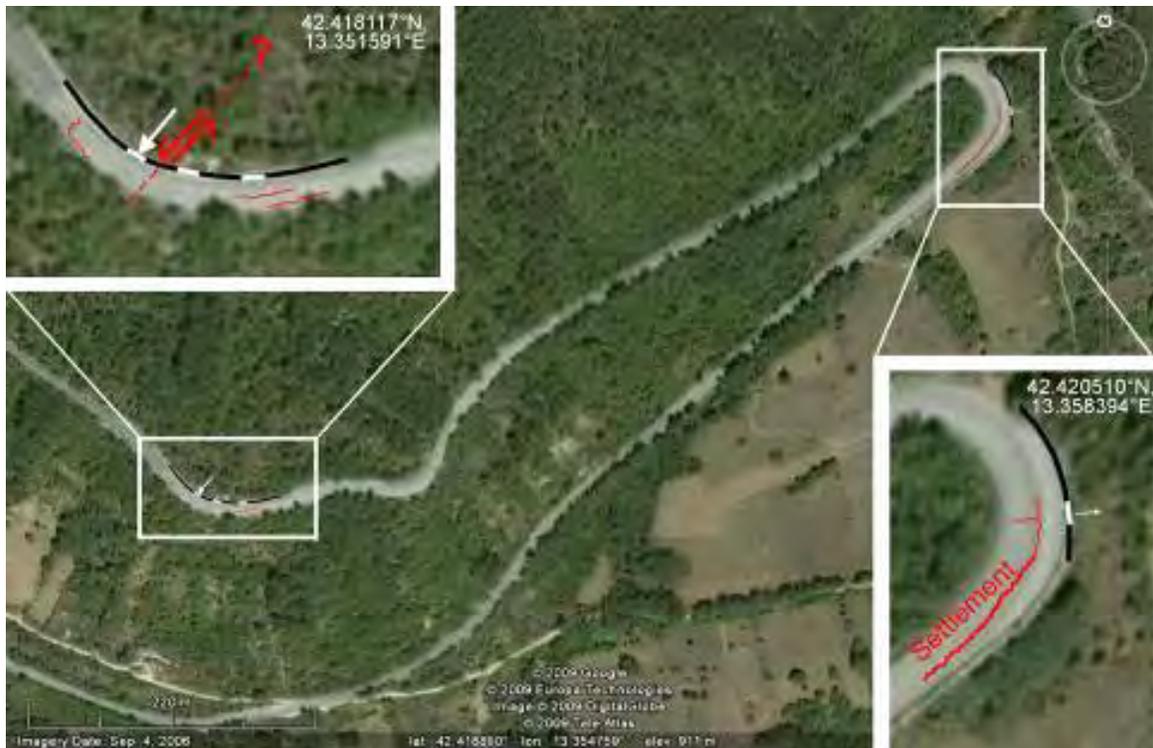
Figure 191. Locations of observed pavement cracking and associated retaining wall failures.

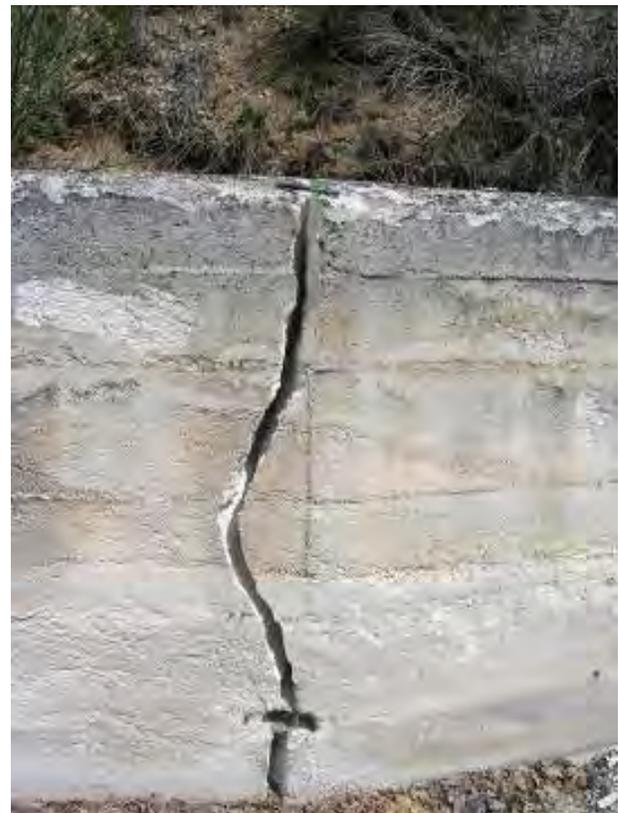
Figure 192. Ruptured retaining wall due to slope instability at SS80 highway between L'Aquila and Campotosto (42.418117°N, 13.351591°E).

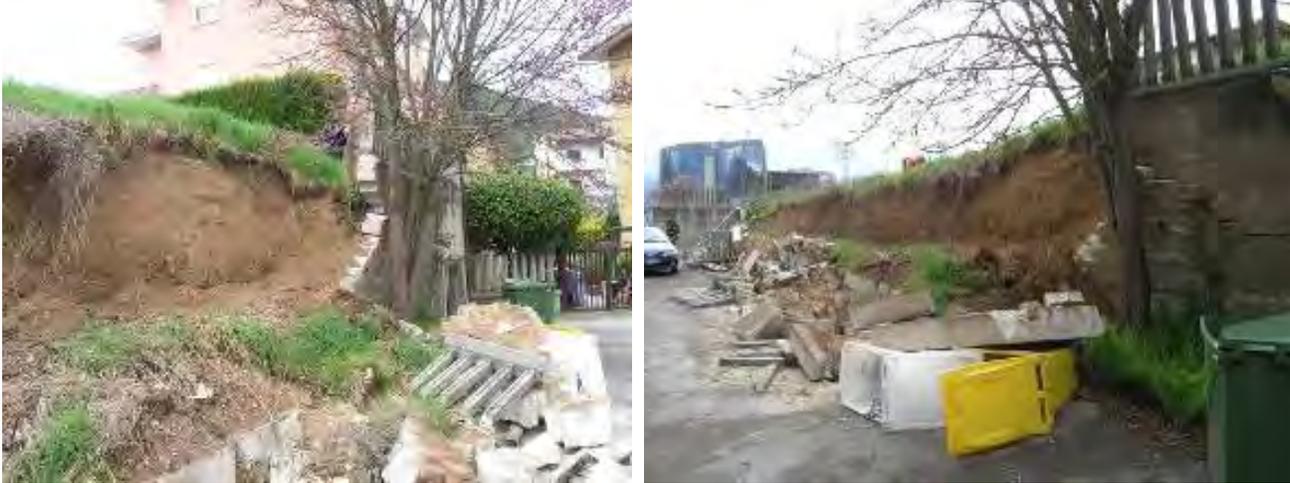
Figure 193. Toppling of masonry retaining wall at the outskirts of L'Aquila (42.366803°N, 13.376561°E).

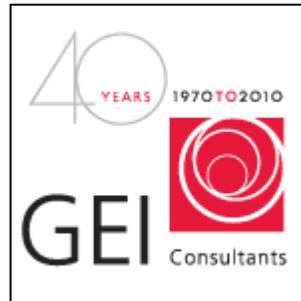
Contact the journal administrator at journal@geoengineer.org if your company wishes to fund the International Journal of Geoenvironment Case Histories.
