How to survive earthquakes: the example of Norcia

ABSTRACT:

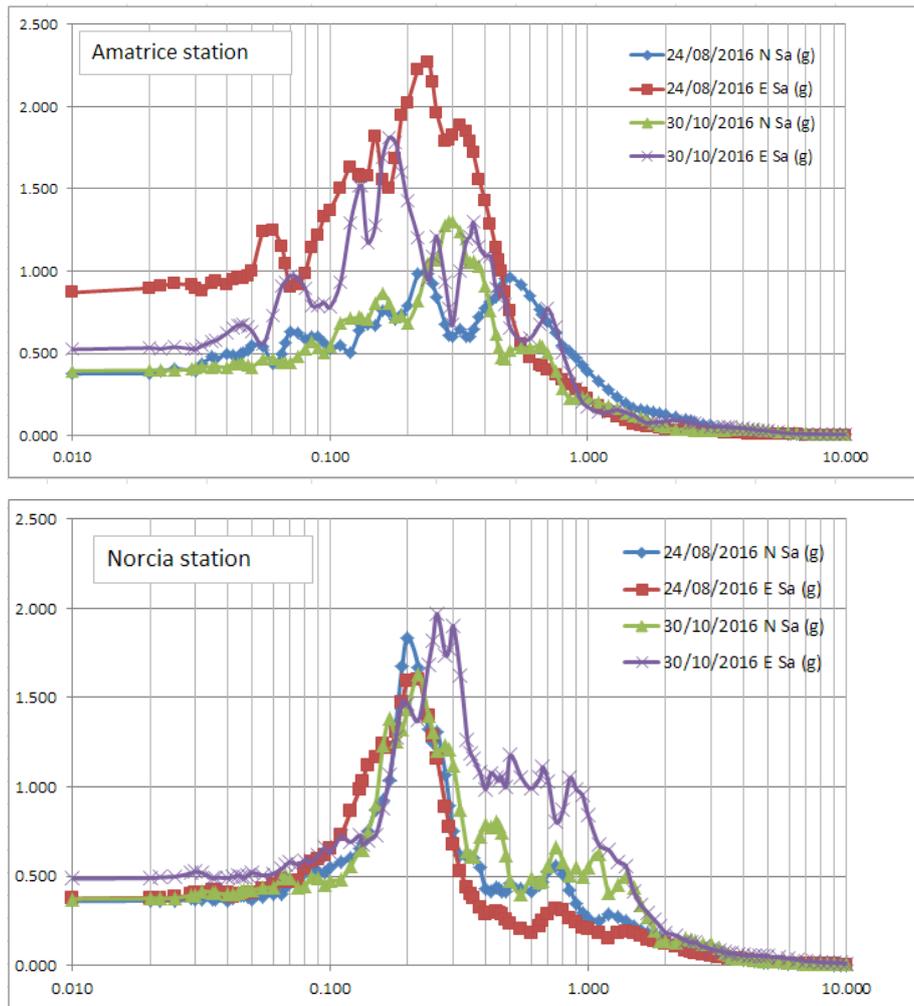
Figure 1 shows the spectra for horizontal accelerations recorded in stations located in Amatrice and Norcia. Both spectra refer to the earthquakes of 24th August and 30th October, as these were the strongest ones in each town and the ones that caused more damaged in each.

Figure 1. Response spectra for Amatrice and Norcia, east-west direction. Data provided by Luzi et al., 2016.

If we compare the spectra with the highest accelerations in each location, in the east-west direction, we realise that in Amatrice the maximum spectral acceleration was 2.27g for a period of $T=0.24s$ and in Norcia it was 1.9g for a period $T=0.3s$. The Amatrice earthquake produced higher spectral accelerations than the Norcia earthquake for periods below $T=0.46s$, therefore producing stronger effects in stiffer constructions, i.e. low-rise. The differences are stronger below $T=0.2s$. The Norcia earthquakes produced stronger effects in more flexible constructions than the ones in both Amatrice and Norcia stock of buildings. But the main issue here is that, qualitatively, the two earthquakes are comparable and therefore the large difference in performance cannot be attributed to differences in the seismic actions alone.

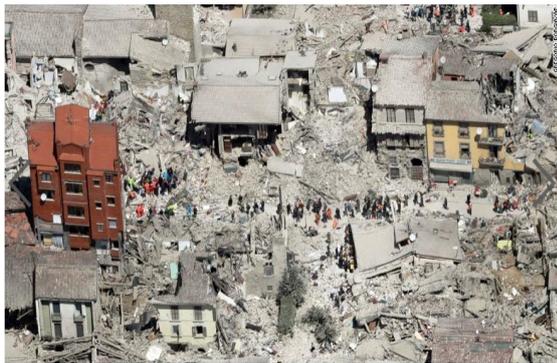
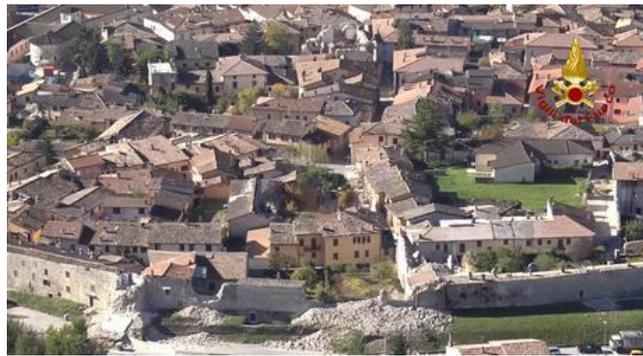
Figure 2 – Amatrice and Norcia after the earthquakes

The result of the seismic crisis of August and October 2016 was the destruction of Amatrice. However, in Norcia, despite damages in many houses and some collapses of historical constructions, as the exterior walls and churches, most of the houses are standing and, above all, nobody died. Figure 2 provides a good comparison of the state of both villages after the earthquakes.

Amatrice, after the 24 August 2016 earthquake

Norcia, after the 30 October 2016 earthquake

In fact, in Amatrice around 300 people died while in Norcia there were no mortal victims after August and October earthquakes. The policy of strengthening buildings applied in Norcia for 4 decades is strongly responsible for this significant difference. Yet, another important factor also contributed to this outcome. In October, Norcia had already felt the shaking due to the earthquake of Amatrice on 24th August, immediately after which some of Norcia population was reallocated in order to evaluate structural stability of their homes. Before the last and stronger earthquake in October, Norcia was also shaken 2 times in the previous days, by two other earthquakes on 26th October not so strong, although causing some minor damages, mostly non-structural. The population was, therefore, on alert, and because of that, when the main earthquake took place on 30th October, at 7h 41m am, many people were sleeping on cars and not in their homes.

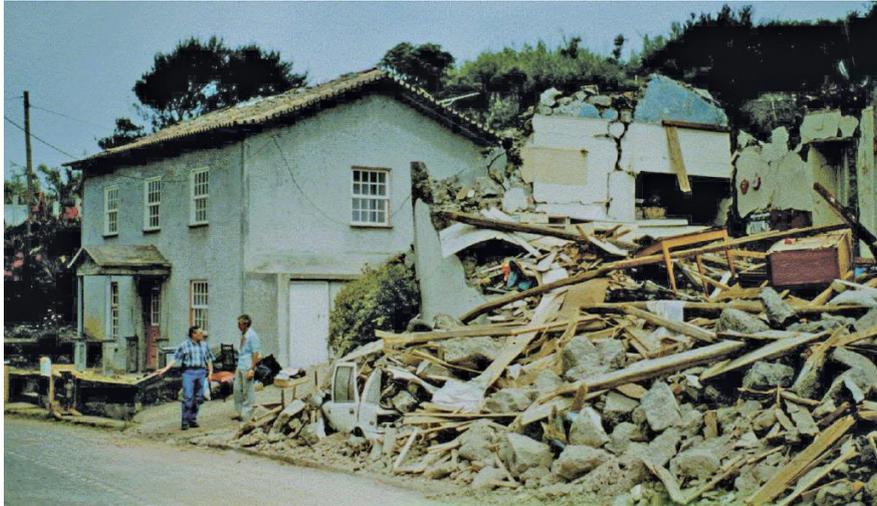
Other comparisons between the seismic performance of old strengthened and unstrengthened constructions, lead to the same conclusion. Figure 3 shows one of those examples: two adjacent houses in the island of Faial (Azores, Portugal) stroke by a violent earthquake on the 9 July 1998 (M_w6.1). Both houses have similar systems and materials (old masonry) and none of the original constructions had been designed to resist earthquakes. However the left hand side house had been strengthened against earthquakes and the other had not.

Figure 3 - Difference of seismic performance between adjacent constructions

The houses were so close that there were no geotechnical differences between their locations and both were subjected to the same seismic action. The comparison is clear and straightforward: the figure shows that the strengthened house resisted the earthquake with minor damage and the unstrengthened house collapsed.

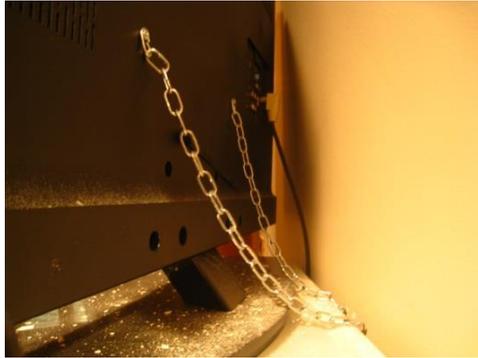
Figure 4 – Televisions connected to walls by chains to avoid toppling

Even though properly strengthened houses survive strong earthquakes, they vibrate and deform during the vibration. These may introduce relevant non-structural damage, part of which can be avoided by appropriate measures taken by common citizens, which is the subject of the KnowRISK project. Moreover, reducing non-structural damage reduces the probability of people getting injured by falling objects and reduces economic damage. Note that the reduction of economic damage is also important for the affected populations to resume their normal life. Figure 4 shows a recent example in Norcia: during the August earthquake the television fell down and broke. After that a new television was bought to replace the broken one, but was fixed with chains, as shown in figure 4 (photo shot by the KnowRISK team on 28 October). The result was that the television suffered no damage during the 26 October earthquakes. The above example has already been used by the Portuguese team in KnowRISK actions in schools, during which young students are taught on how to reduce seismic risk from non-structural elements at school and at home.

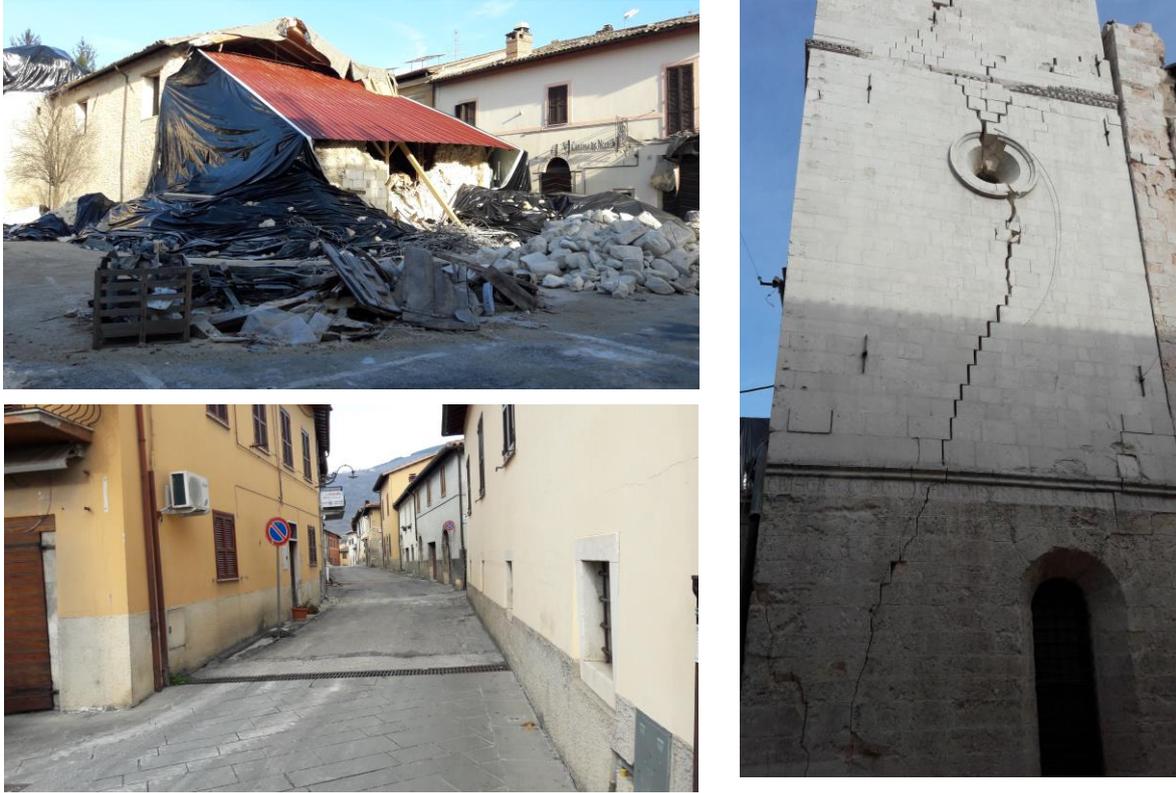
Norcia was strongly hit by the sequence of October earthquakes, mainly by the one of 30th October. However, damage was much less extensive than in Amatrice. Some monumental constructions suffered partial collapses and several constructions inside town were damaged, a few ones strongly. Figure 5 shows some of those cases. The photos were taken by the KnowRISK team on 19th December 2016, one month and a half after the major earthquake that hit the town.

Figure 5 - Damage in Norcia after the October 2016 earthquakes

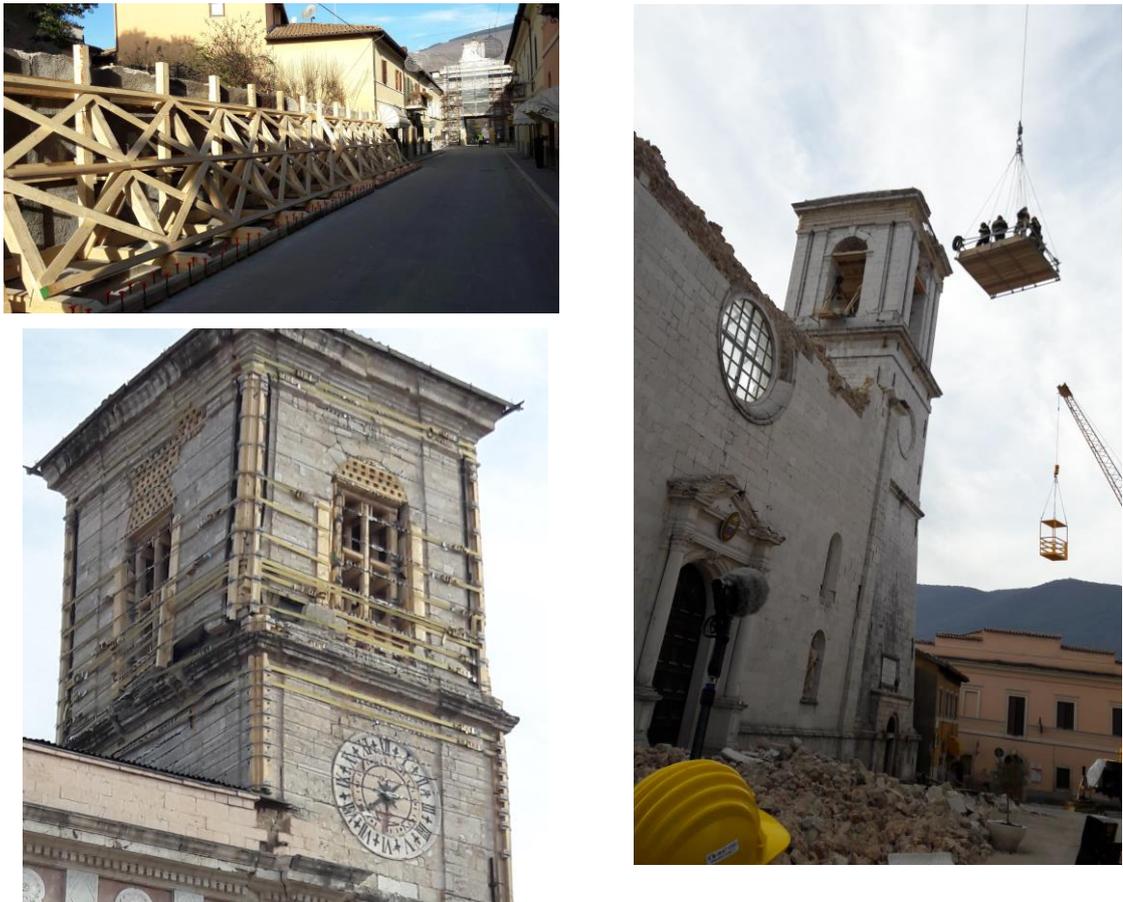
Figure 6 - Bracing of unstable constructions in Norcia by the fire brigades

In general, in Norcia, most constructions appeared, from the outside, to have no damage or slight damage, but there were also a few with parts in risk of collapse. In these conditions, any aftershock could lead to more damage, making unsafe to walk normally in the streets. Therefore, the centre of Norcia was closed to the public, until conditions to walk safely in the streets are re-established. This comprises essentially two conditions: i) all constructions in which there is partial risk of collapse to the streets must be braced to avoid that risk, and ii) the seismic crisis must be over. When the KnowRISK team visited Norcia in December, together with members of the Italian fire brigades, those works of bracing unstable structures were going on in several parts of the town, which may take a few months to complete. Figure 6 illustrates some of those cases.
