International Journal of Disaster Risk Reduction

Debris-flow hazard assessment at the archaeological UNESCO world heritage site of Villa Romana del Casale (Sicily, Italy)

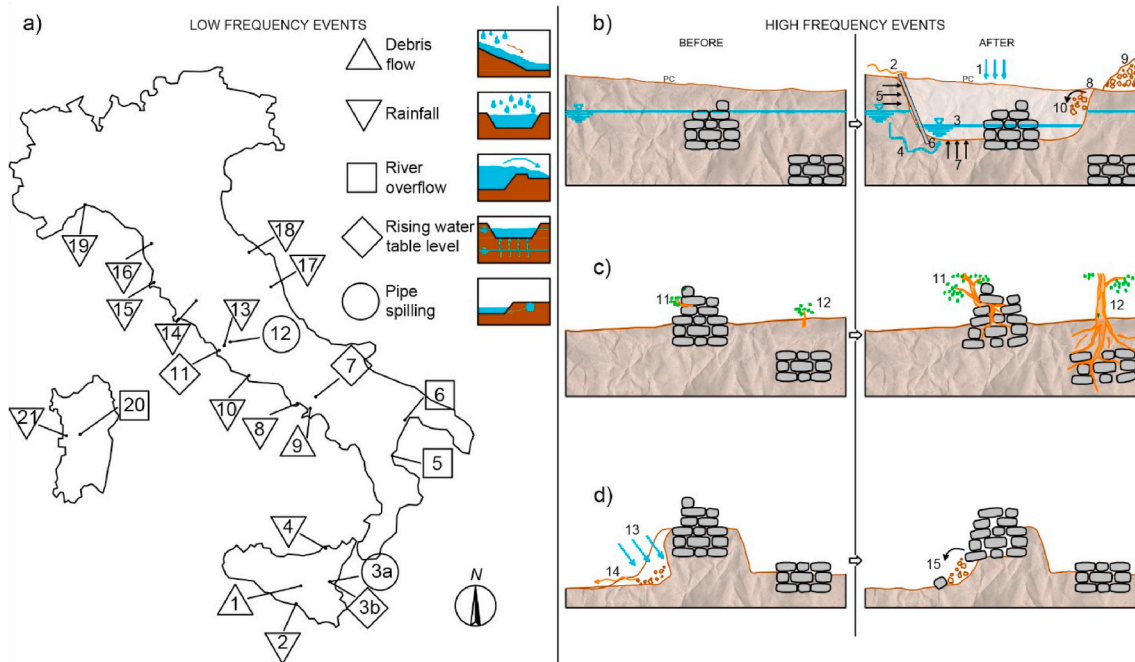
Fig. 1. (a) Digest of archaeological sites damaged by water or extreme hydraulic events during the last years: 1 - Villa Romana del Casale, 1991; 2 - Area Archeologica Demaniale Bosco Littorio, 2015; 3 - Greek-Roman Theatre and Roman Amphitheatre of Catania, recurrent phenomenon; 4 - Roman villa in Patti Marina, 2009; 5 - Sibari Archaeological Park, 2013; 6 - Metaponto Archaeological Park, 2009, 2011, 2013; 7 - Prehistoric village and Anfiteatro Laterizio in Nola, recurrent phenomenon; 8 - Macellum of Pozzuoli (wrongly known as Serapi's Temple), recurrent phenomenon; 9 - Pompeii Archaeological Park, 2009, 2010; 10 - Fonte di Lucullo in Sabaudia, 2015; 11 - Ancient Ostia Archaeological Park, 2015; 12 - Mausoleum of Augusto in Rome, 2014; 13 - Villa Rustica in Dragona, 2017; 14 - Città del Tufo Archaeological Park: Nercopolis of Sovana, 2012; 15 - Baratti and Populonia Archaeological Park, 2015; 16 - Mound of the Etruscan Prince in Pisa, 2015; 17 - Late-republican Sanctuary of La Cuma Archaeological Park, 2016; 18 - Roman City of Suasa Archaeological Park, 2011; 19 - San Domenico Excavation site: Fortezza del Priamar in Savona, 2016; 20 - Roman Theatre in Fordongianus, 2016; 21 - Mont'e Prama Archaeological Site, 2015. All the information have been gathered from online newspapers and websites. (b) hydraulic problems connected with archaeological excavation: 1 - direct rainfall; 2 - flood caused by surface runoff, often with debris transportation; 3 - excavation site bottom flood; 4 - filtration regimes due to different water table levels; 5 - earth push on bulkheads; 6 - bulkhead failure due to filtration problems; 7 - excavation site bottom uplift 8 - non-protected excavation site edge; 9 - incoherent earthworks waste materials too close to the excavation site edge; 10 - incoherent materials fall. (c) 11 - ruderal vegetation on unearthed structures; 12 - deep growth of plants roots. (d) 13-Weathering phenomena; 14 - eroded materials natural removal; 15 - structural failures in archaeological remains.

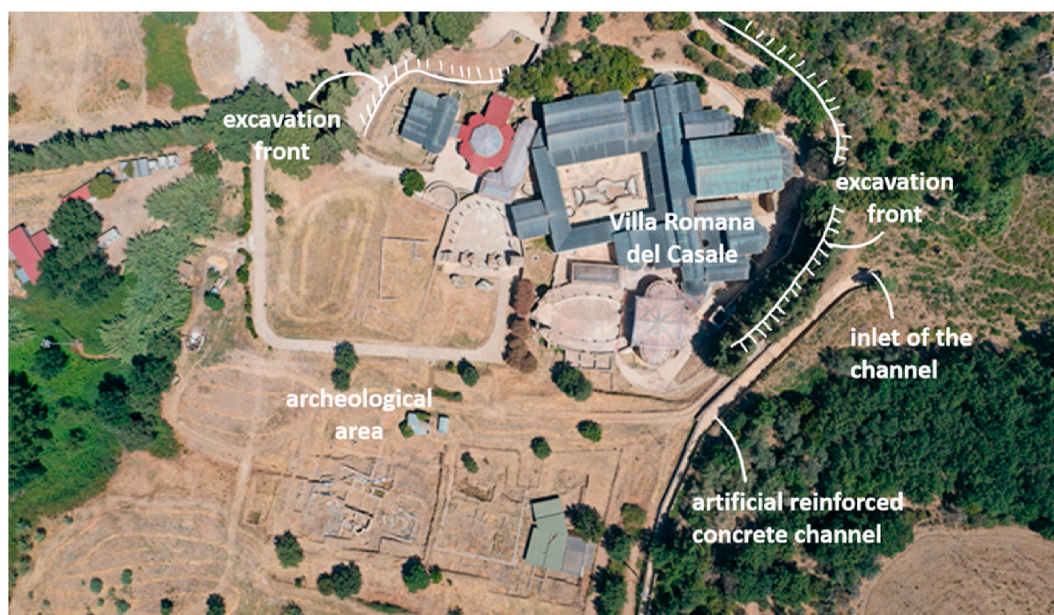
Fig. 2. Aerial image of the archaeological site of the Villa Romana del Casale taken during one UAV survey.

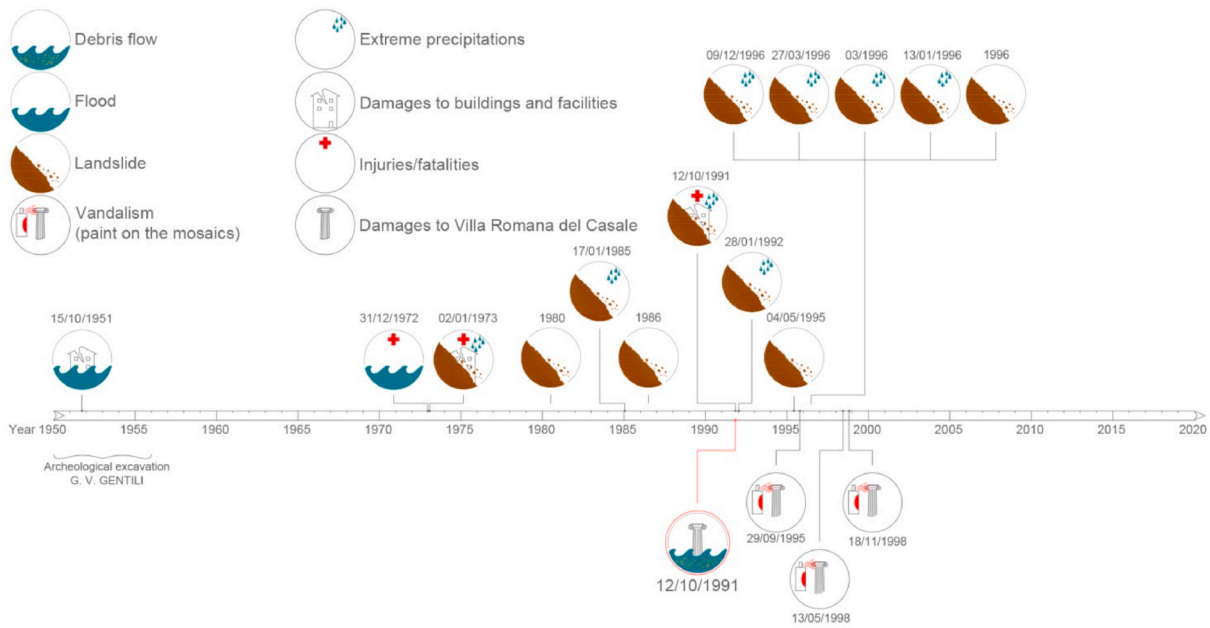
Fig. 5. Main flood and landslide events occurred in the Piazza Armerina region and the archaeological site since 1950. The region is highly prone to landslides, debris flows, floods and related hydraulic problems. Sometimes in addition to damages to structures there are casualties. Hydraulic risk represents a main problem both for property and population.

Fig. 5 reports a timeline of the events occurred over the last 70 years. Data about extreme events come from newspaper’s articles, in which the word “landslide” sometimes refers improperly both to landslides and debris flows. Thus, in Fig. 5 each event that was not clearly addressed as “debris flow”, or that was impossible to recognize as “debris flow”, has been classified as “landslide”. The figure shows that almost each

landslide event was connected with intense and prolonged precipitation. These events hit not only property, with damages to buildings and infrastructures, like the 1951 flood, but also people, with casualties and injuries, like the 1973 and 1991 landslides and debris flows.

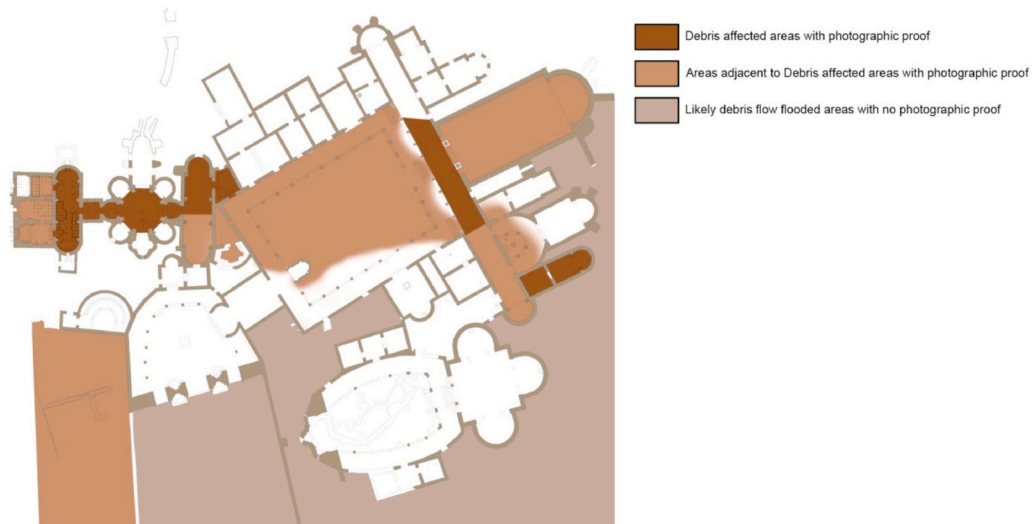
Fig. 7. Map of areas flooded in 1991. In dark brown areas with debris on the mosaics recorded through photos; in mid brown adjacent areas, which very likely have been invaded by debris, even if there are no photographs; in light brown areas likely invaded by debris, because of their geomorphological features.

affected for half of its extension, mosaics covered by debris. Major damages were: the detachment of mosaic tiles and fracture of decorations. Pictures in Fig. 6 show how areas at lower levels are easily flooded and are affected by high residence time, which increases damages to fragile decorative features, like mosaics and frescos, due to the prolonged exposure period to water or wet materials contact. Examining the photographs taken in 1991 after the debris flow event, it has been possible to deduce the areas that were hit and flooded by the flow, as shown in Fig. 7.

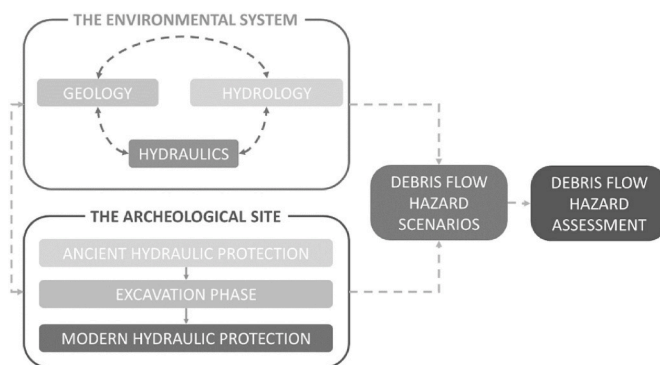
Fig. 10. Sketch of the suggested methodology for debris-flow hazard assessment at archaeological sites.

information about geomorphology, hydrogeological and geostructural setting, hydrology, soil composition, land use, etc. [56]. The analysis of geology, including not only surface morphology but also groundwater dynamics and terrain geotechnical characteristics, of past extreme weather-related events, and of current hydrological regime, i.e. of the environmental system, coupled to the knowledge of the past and present history of the site, including excavation and present protection structures, allows one a more reliable hazard assessment, which may be useful to develop effective strategies for risk mitigation. The entire process is summarized in Fig. 10.

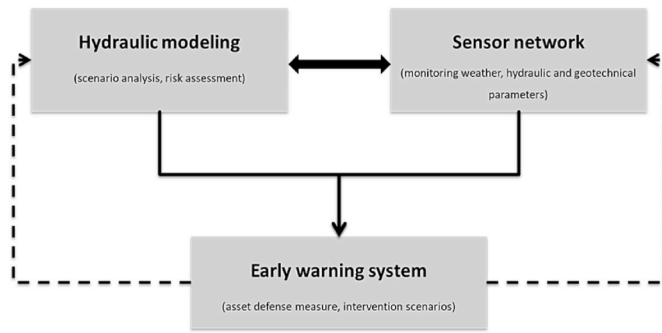
Fig. 11. Interaction between the different components of the early warning system.

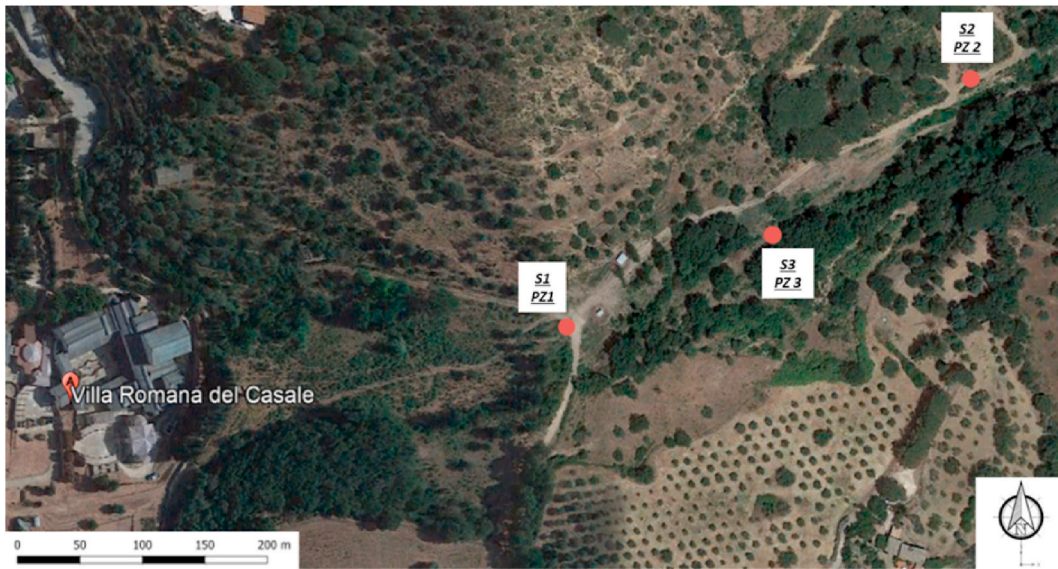
Fig. 19. Location of the three boreholes realized within the basin of the Villa Romana del Casale.
