A photographic collection of the coseismic geological effects induced by the 21 August 2017, M=4, Casamicciola earthquake (Ischia island, Italy)

Emergeo Working Group*

Accepted 19th July 2019 | *Accettato il 19 luglio 2019*

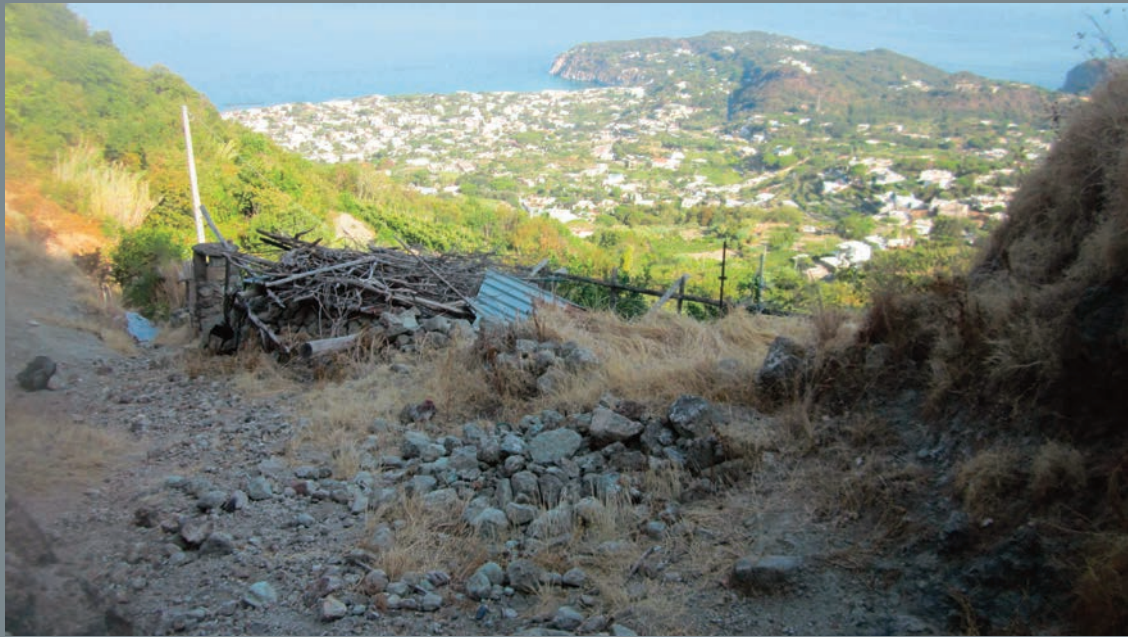
Photo 12

Pizzone fumarolic area with evidence of diffuse rockfalls.

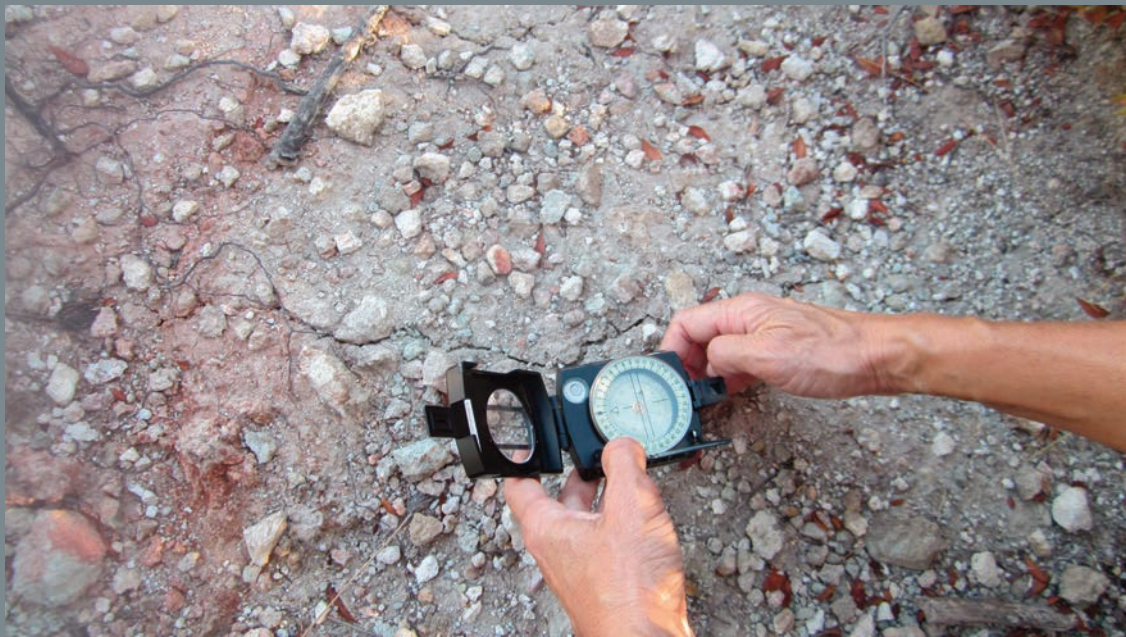
Photo 13

Fracture into the ground in Pantane fumarolic area (M.te Cito).

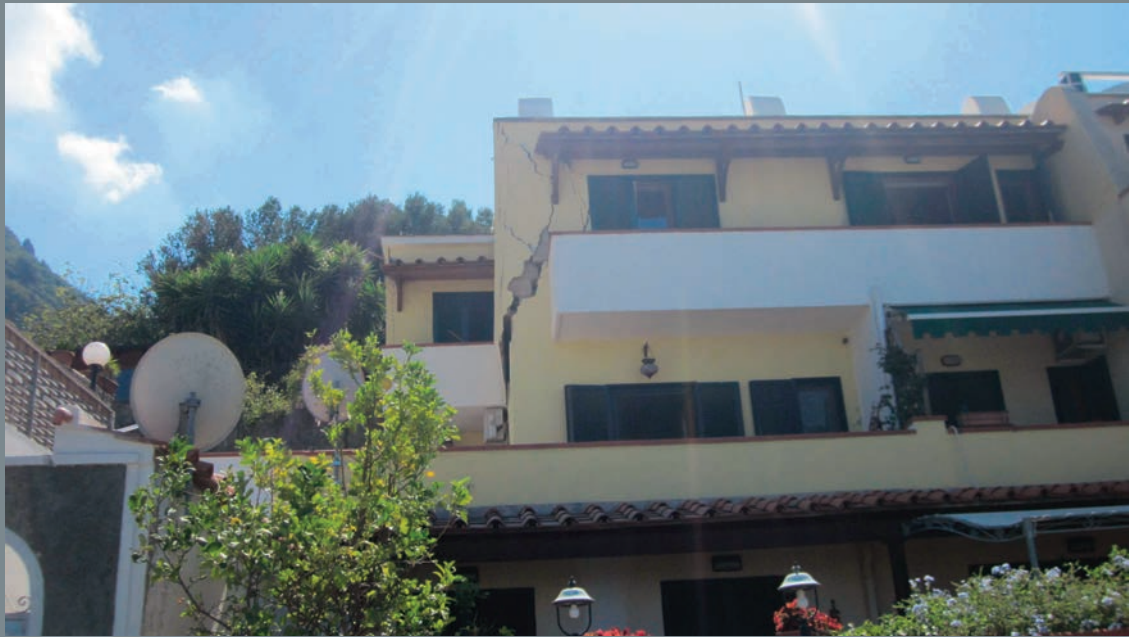
Photo 17

Severe damages on a detached house, in Via dei Carri.

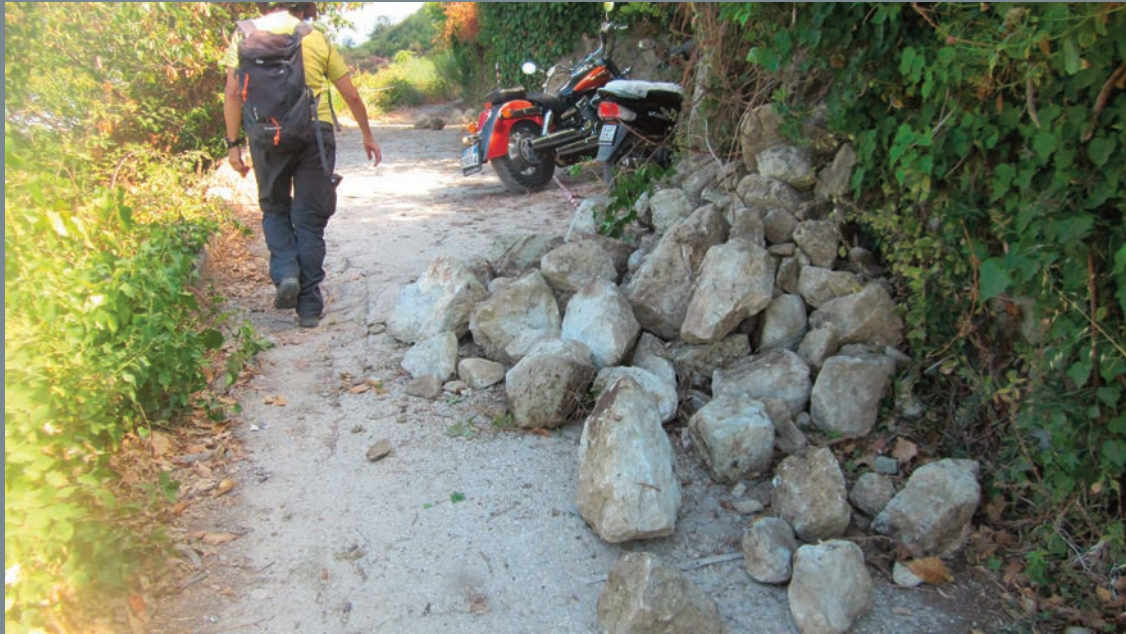
Photo 20

Collapse of drywalls as secondary seismic effects along Via dei Carri.

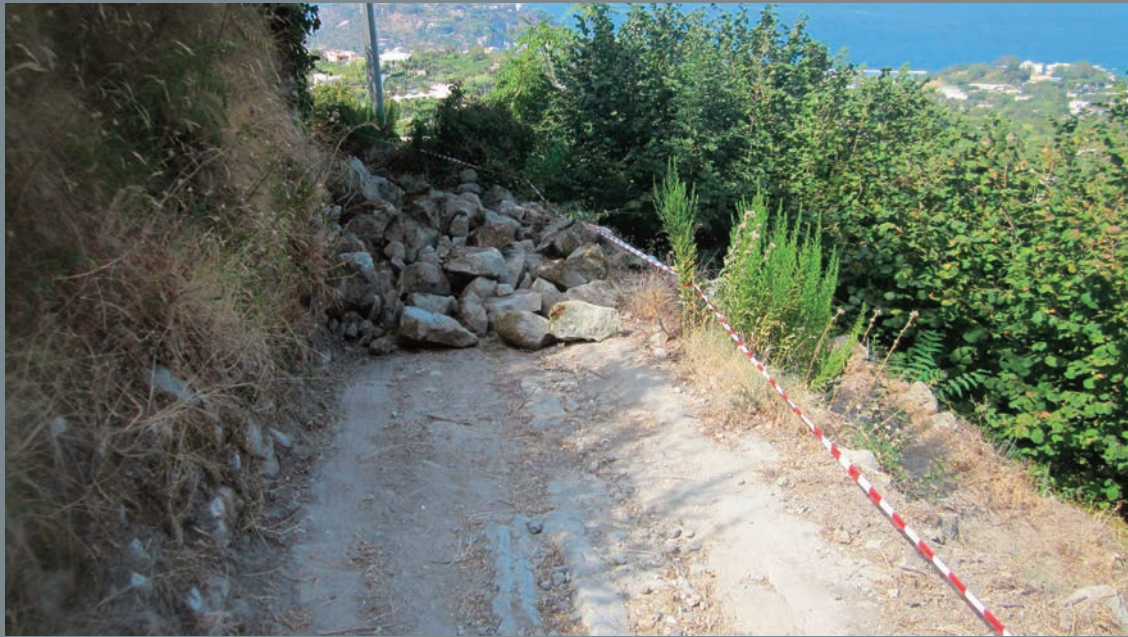
Photo 21

Collapse of drywalls bordering both sides of the road, along Via dei Carri.

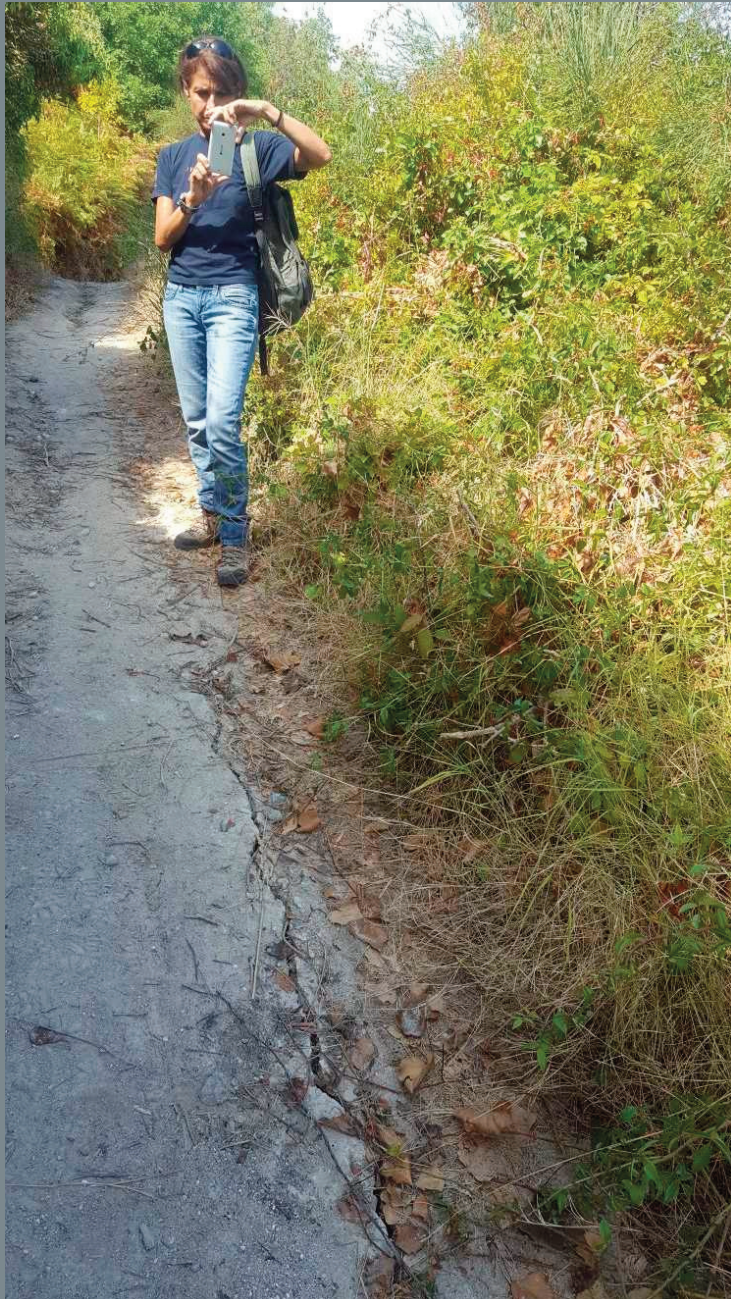
Photo 22

Coseismic fracture with few centimeters vertical displacement along Via dei Carri.

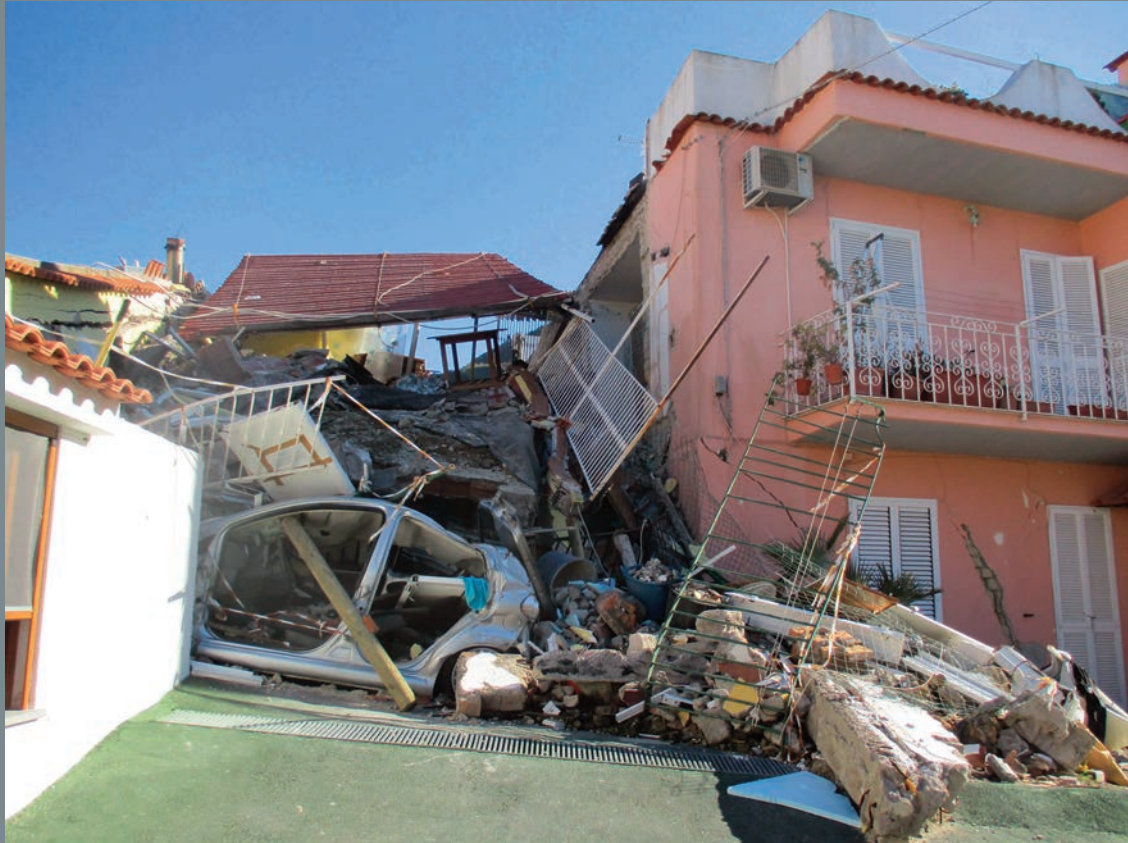
Photo 37

Collapse and severely damaged houses in a side street of Via D'Aloisio, along the E-W striking dip-slip system fault of the Mt. Epomeo northern flank.
